Field Measurement of Vertical Movement and Roof Moisture Performance of the Wood Innovation and Design Centre: Instrumentation and 1st Year's Performance

March 2015

301008940: Field Testing and Monitoring of WIDC Building

Confidential Contract Report

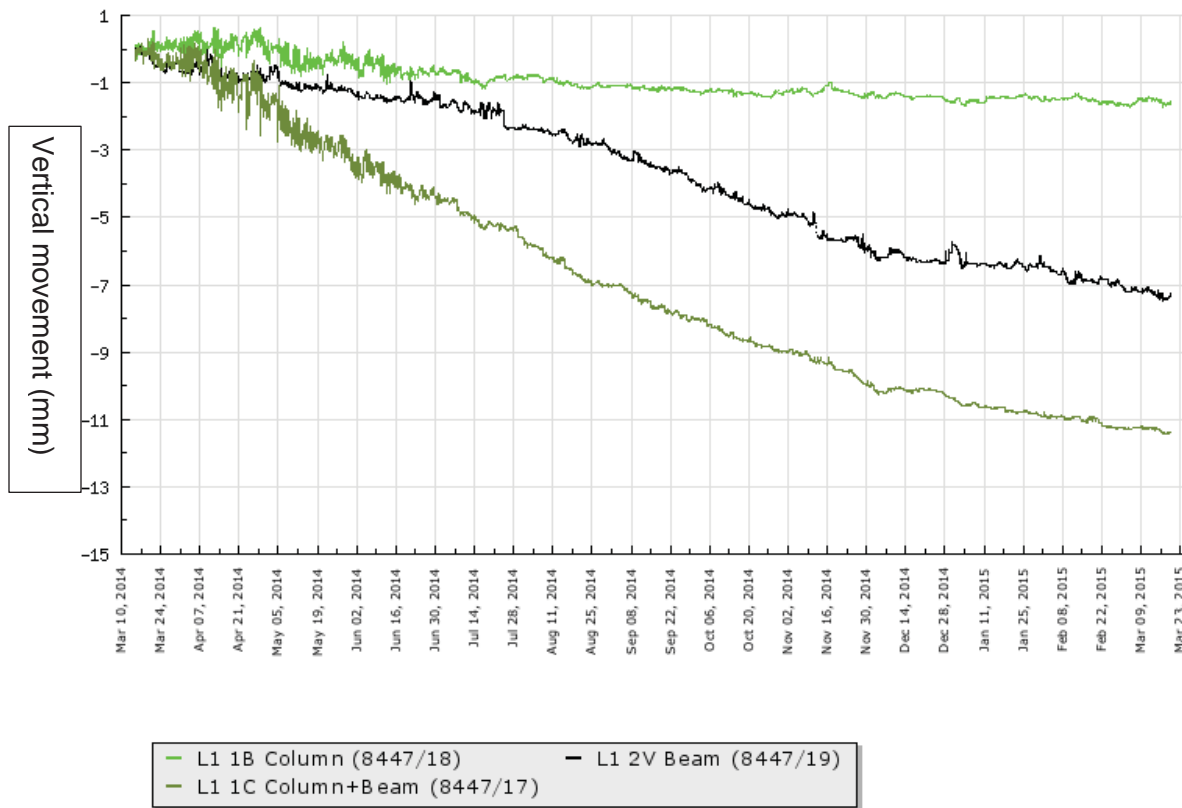
The results from the displacement sensor installed at Location 1, labelled "L1 1C Column", show that the glulam column was extremely stable under compression, with the maximum shortening amount of about 1.5 mm (Figure 9). The sensor labelled "L1 1B Column+Beam", covering the entire glulam column and the PSL beam above (with a metal connector between them), showed a shortening amount of about 11 mm. The sensor ("L1 2V Beam") measuring the PSL beam but excluding the two loading surfaces (i.e., excluding the contact areas with the CLT floor above and the glulam column below) showed a movement amount of about 7 mm. These measurements indicate that the PSL beam was a major contributor to the vertical movement at this location, with an estimated movement amount of 9 mm for this beam alone. Apparently deformation resulting from compression occurred not only at the surface loading areas, but also along the entire depth of the beam. From the two sensors installed over the PSL beam and showing the largest movement amounts observed in this study (i.e., "L1 1B Column+Beam" and "L1 2V Beam"), the movement increased over time; but it appears that the increases were faster before December 2014; both slowed down after that. Such changes should be attributable to changes in the indoor environment and consequently the wood MC. While the temperature inside the building was controlled around 20°C after the building was occupied, the RH change is mostly seasonal depending on the exterior conditions as well as the amount of heating and ventilation (i.e. air exchanges). Indoor environment tends to be very dry under heated conditions in such a cold and dry climate, unless the humidity is specifically controlled (e.g. by using humidifiers). The humidity in the building was found to become particularly low after mid-December, fluctuating

Figure 9 Vertical movement of glulam column, PSL beam, and combined column and beam at Location 1

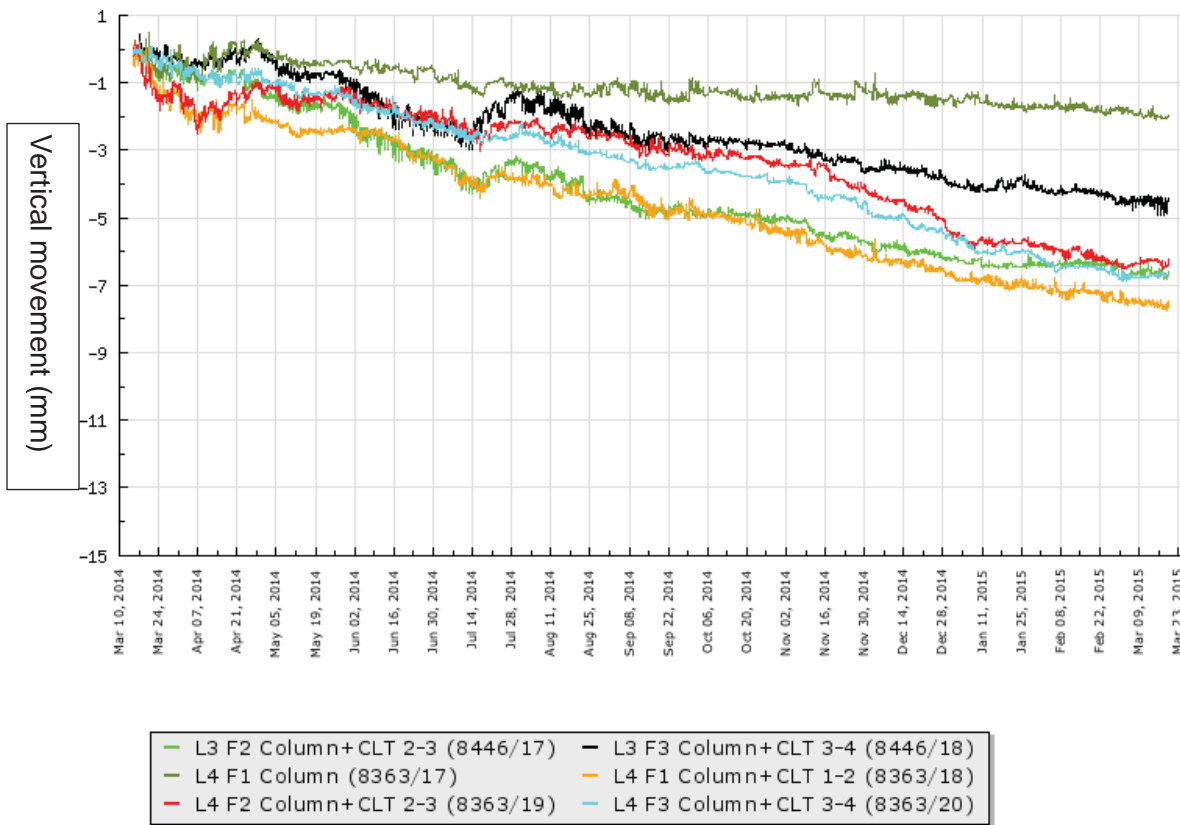
At Locations 3 and 4, the behaviour of the glulam column measured by the sensor “L4 F1 Column” was very consistent with the glulam at Location 1, with the maximum shortening of about 1.8 mm (Figures

10, 11). This glulam extends two floors, including the ground and the mezzanine level above. It is over 6 m tall and about 1 m taller than the glulam at Location 1. Wood is known to have the highest stiffness, strength, and dimensional stability in the longitudinal grain orientation (FPL 2010), and the measurements of these two columns demonstrate that glulam columns are highly stable when loaded in the longitudinal direction. Neither MC changes nor sustained loading led to considerable movement. When a small shrinkage coefficient, 0.005% per 1% change in MC (FPL 2010), was used to estimate wood shrinkage, the calculated shrinkage alone would have slightly exceeded the entire movement measured (shrinkage plus all other potential components) (Table 5). The good dimensional stability of wood in the longitudinal direction was certainly utilized in this building with glulam columns connected end-to-end using metal connectors along the height of the building, eliminating horizontal wood members in the load path. The total shortening would be expected to be approximately 8 mm based on the measurement, accounting for a total height of 24.5 m for connected glulam columns from Floor 1 to Floor 6. This did not take into consideration any potential settlement or deformation at connections between glulam columns, or effects of reduced loads on the top two floors. This amount is certainly much lower than the vertical movement observed in light wood-frame buildings (Wang *et al.* 2013; Wang and Ni 2014), but comparable with the measured movement from a similar six-storey mass timber building in Quebec City (Munoz *et al.* 2012).

When a measurement covered a glulam column, a CLT floor, and the connection between them, the movement amount increased greatly (Figure 10, Table 5). The floors of this building were built with two layers of vertically staggered CLT panels, which were structurally supported by glulam beams at each end. The glulam beams were supported by glulam columns using dovetail connections. It is believed that the beam should have a minor contribution to the vertical movement measurement since its vertical movement (including shrinkage) is restrained by the column and the connection. Being 5-ply and 169 mm thick, the bottom CLT panel was included in the corresponding measurement with a displacement box installed to sit on this panel (i.e., in the space created by the staggered CLT floor panels, right next to the supporting glulam column). The CLT panels are not major members for bearing gravity loads in this building and there should be no cumulative deformation resulting from compression. Similarly, the panels may deflect under loads, particularly over a large span, but that would not contribute to any vertical movement measured in this study. Shrinkage of the CLT panel (out-of-plane) resulting from drying must therefore be a major reason for the measured movement at each location. It was mentioned above that the sensor labelled "L4 F1 Column" showed a shortening amount of 1.8 mm. For comparison, the displacement sensor labelled "L4 F1 Column+CLT 1-2" showed a total shortening of 7.3 mm. These two sensors were installed from the bottom of the same glulam column, but the former ended at the upper end of the column (i.e., measuring only the glulam column) and the latter extended above the CLT floor (i.e., covering the glulam column, the CLT floor, and part of the glulam beam). This indicates that the difference of 5.5 mm between these two measurements was primarily caused by shrinkage of the CLT floor panel. The shrinkage for out-of-plane CLT can be estimated when the MC change and shrinkage coefficient are known. The CLT panels have a MC of $12\pm 2\%$ at time of production based on information from the manufacturer (<http://structurlam.com/products/cross-laminated-timber/>). When the field monitoring started in March 2014, the average MC of the panels was estimated to be 13% based on measurements using a portable capacitance moisture meter at the site

Figure 10 Vertical movement of glulam column and combined column and CLT floor at Locations 3 and 4

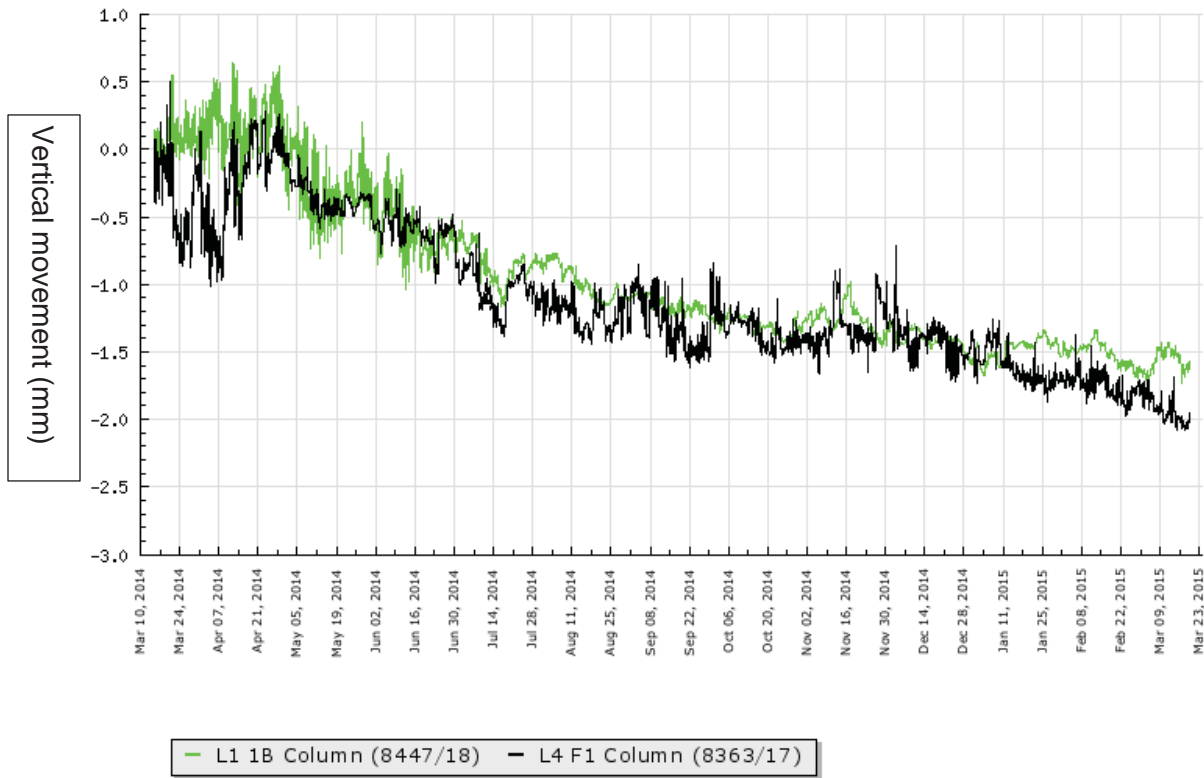
Figure 11 Vertical movement of two glulam columns at Locations 1 and 4

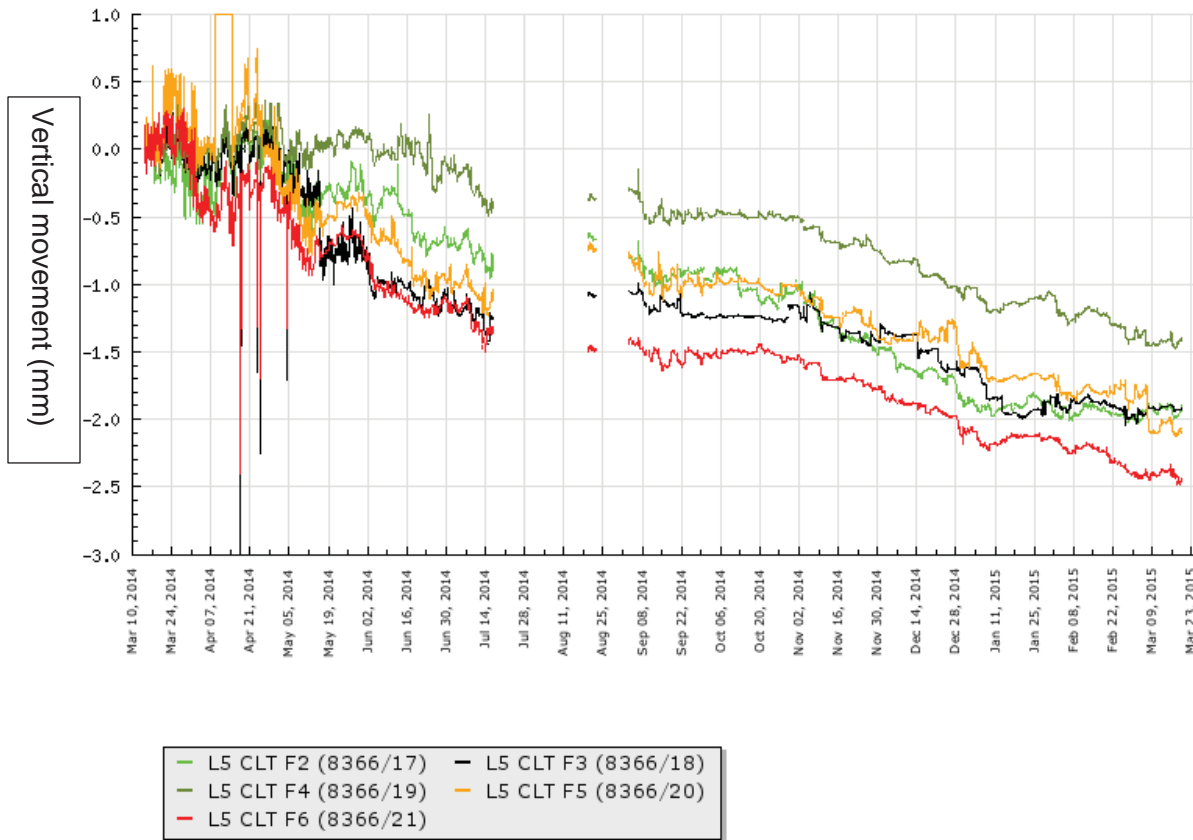
According to the drawings, the CLT walls in this building have a height of 24.5 m, with two horizontal step joints. The vertical movement was only partially monitored from the 2nd floor to the 6th floor, as described in Section 5.3. Similar to the measurements of the two glulam columns at Locations 1 and 4, the shortening amounts measured from the CLT wall were also found to be small, ranging from 1.3 mm to 2.3 mm on each floor (Figure 13, with the service environmental conditions shown in Figures 14 and 15). The measurements in this study confirmed that CLT was also highly dimensionally stable in its plane direction. Assuming that wood shrinkage and load-induced deformation were uniform along the height on each floor, and the movement amounts were proportional based on of the heights of the wall, the measurements showed that the total shortening of the CLT wall, from Floors 1 to 6, would be about 14 mm. This is larger than the vertical movement of a glulam line under the same indoor environment but the differential movement is quite small for such a building.

Figure 13 Vertical movement of CLT wall from Floors 2 to 6 at Locations 5

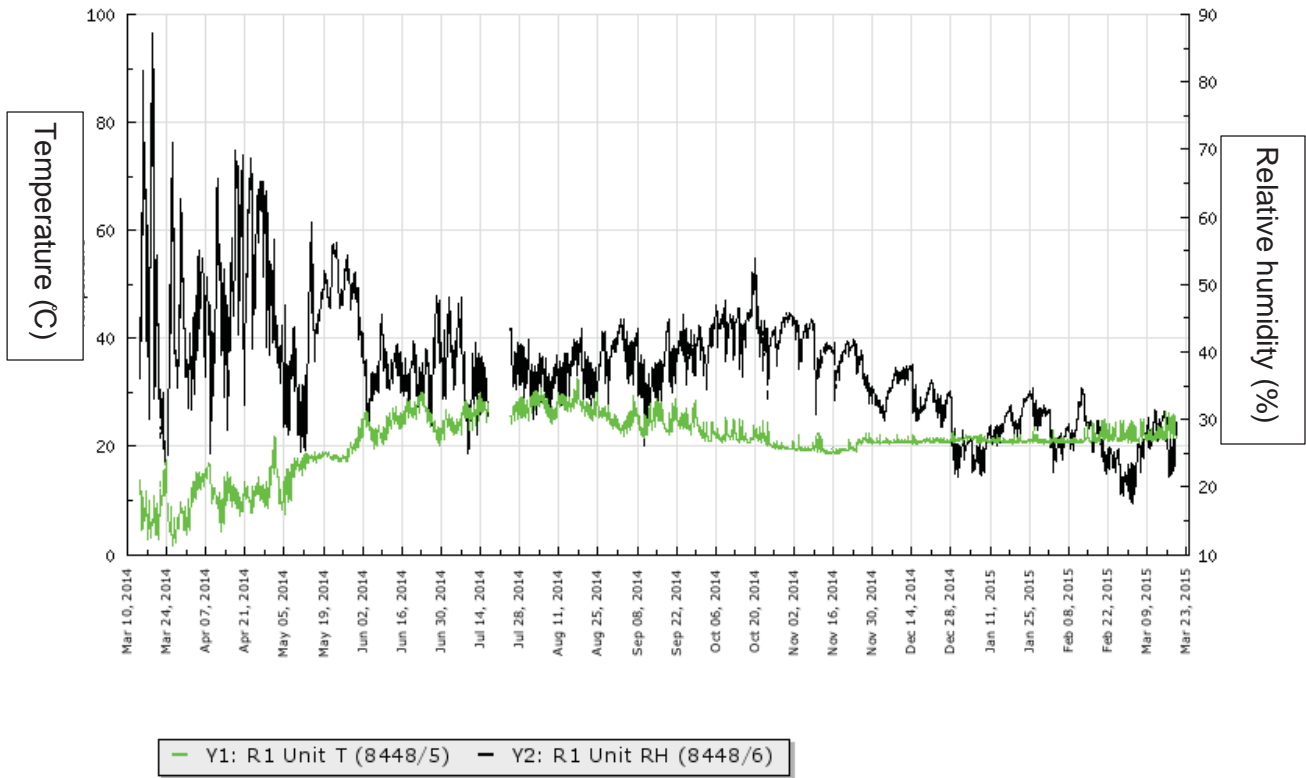
The wood roof structure was generally very dry during this monitoring period. Figure 16 shows RH and temperature measured from Location R1 to represent environmental conditions in the roof area. Consistent with the ambient conditions measured from areas closer to the walls, most locations of the roof showed RH below 50% in the summer of 2014, and the humidity reached very low levels in December 2014. As a result of the dry indoor environment, both the plywood roof sheathing (Figure 17) and the CLT panels below (Figure 18) produced very low MC readings at these five monitoring locations (i.e., except R4). It should be noted that the resistance-based measurement systems showed a lower MC limit of 11% in this study, with calibration based on lodgepole pine (due to the use of “SPF” CLT and plywood sheathing). Therefore a reading of around 11% may not reflect the real wood MC. The electrical resistance becomes too high to be accurately measured when the wood MC is too low. The sheathing of a flat roof would be typically subjected to the highest risk when wetting occurs during

Figure 16 Relative humidity and temperature at Roof 1 location
