Fire Performance of Cross-Laminated Timber Panel-to-Panel Joints

Date: March 31st 2015

By: Christian Dagenais, Eng., M.Sc., Advanced Building Systems

TYPE OF REPORT : Test Report

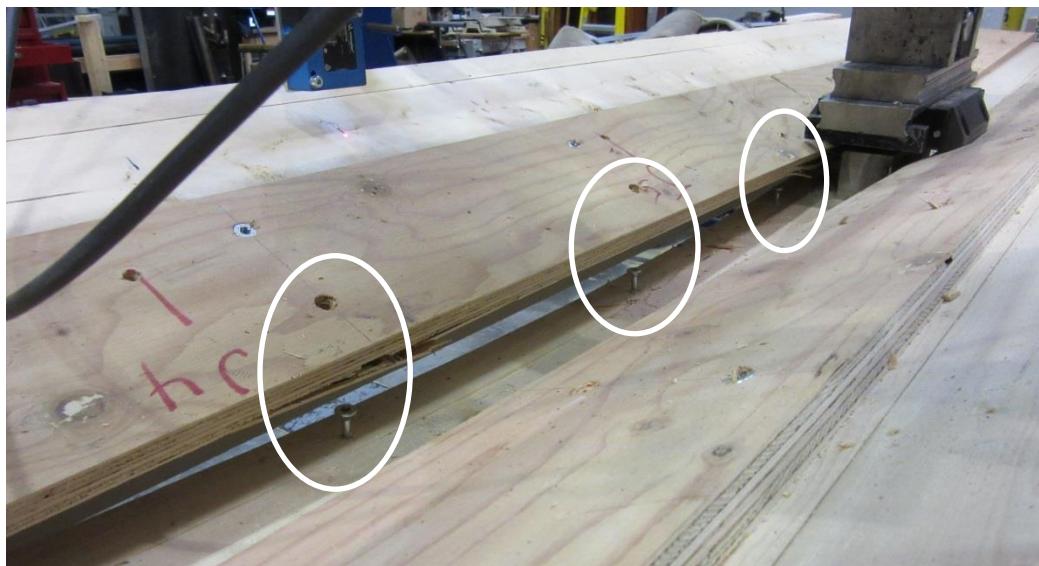
Two specimens were evaluated and exhibit very similar behaviour. As expected, the fasteners were the weakest link; the failure mode was the screw heads pulling through the plywood splines (Figure 5). This confirmed that the loading conditions used in the fire-resistance tests need to be such that failure of the fasteners will not occur prematurely (i.e. pull-through should not occur, but withdrawal or lateral crushing could, or simply burn-through at the joints).

Figure 5 – Head pull-through in CLT bending test under ambient conditions

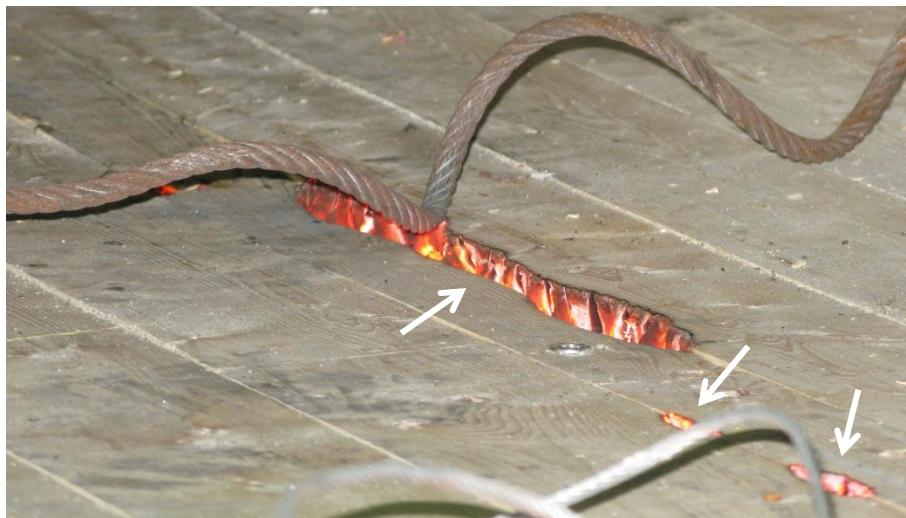
A load of 32 kN, representing a full loading condition, was applied prior to the fire exposure as shown in Figure 6. However, the bending stiffness of a 3-ply CLT floor slab is quickly reduced when the exposed layer in the strength direction chars. As such, the applied load was modified during the test. It can be seen that indeed the maximum 20 cm deflection was reached very early into the test. Nevertheless, the test continued until glowing at the unexposed surface was observed at the portion of the joint located between the loading points. The test failure time was recorded as 45 min.

Figure 7 – Failure of the 3-ply half-lapped joint

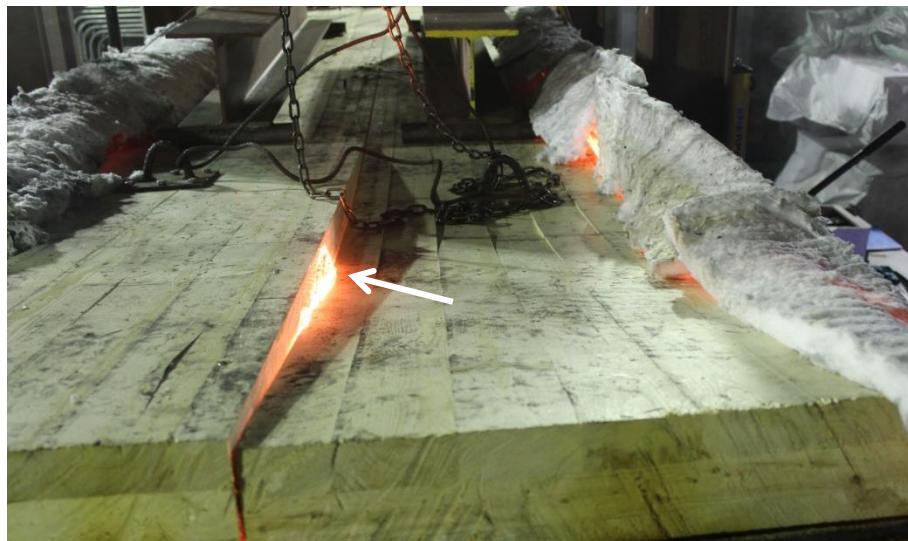
A load of 41 kN, representing a 54% loading condition determined from an initial 20 mm deflection, was applied prior to the fire exposure as shown in Figure 11. The test continued until differential deflection occurred between the 2 CLT panels (Figure 12). The test failure time was recorded as 98 min.

Figure 12 – Failure of the 5-ply half-lapped joint

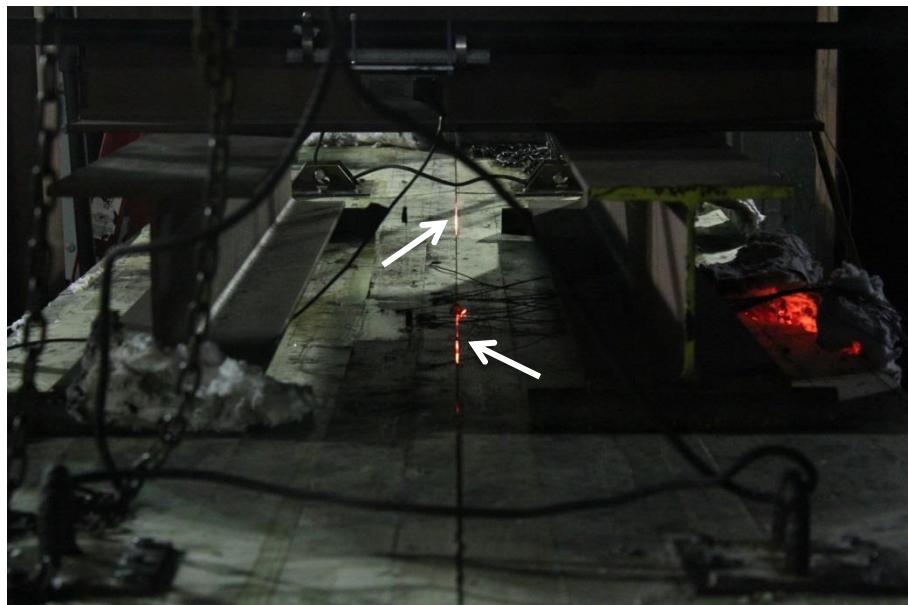
A load of 50 kN, representing a 37% loading condition limited by the load cell capacity, was applied prior to the fire exposure (Figure 16). The test continued until glowing at the unexposed surface was observed at the portion of the joint located between the loading points, as shown in Figure 17. As with the 5-ply half-lapped test, differential deflection also occurred between the 2 CLT panels (Figure 18). The test failure time was recorded as 140 min.

Figure 17 – Failure of the 7-ply half-lapped joint

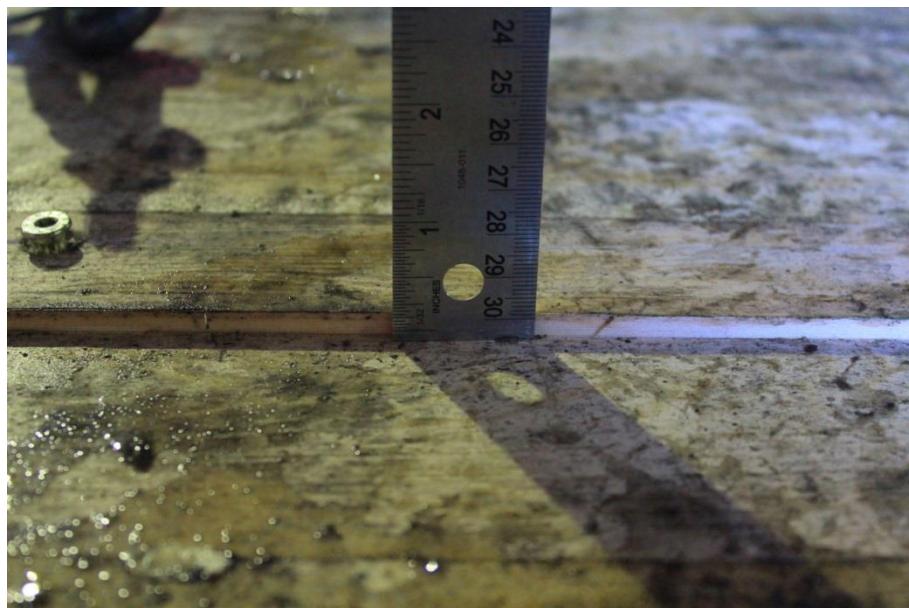
Figure 18 – Differential deflection of the 7-ply half-lapped joint

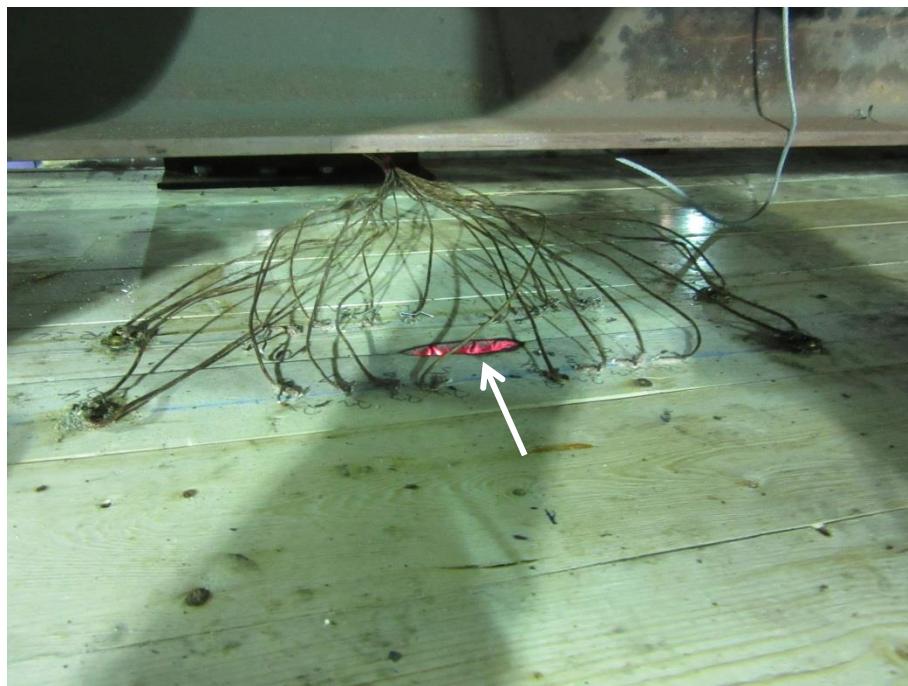
However, from visual observations and manual timing, glowing at the surface (unexposed) was observed at the joint around 35 min after the test (Figure 23). The burn-through was located close to mid-span where the spline was butt-jointed. It is noted that since the burners were not controlled properly, the furnace temperature could not be verified.

Figure 23 – Failure of the 3-ply internal spline

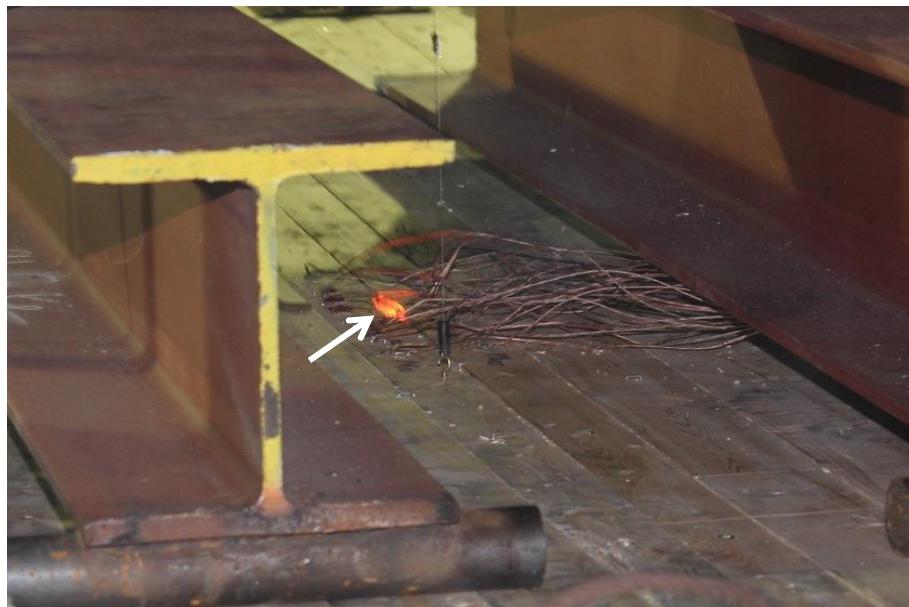
A load of 42 kN, representing a 55% loading condition determined from an initial 20 mm deflection was applied prior to the fire exposure as shown in Figure 24. The test continued until glowing at the unexposed surface was observed at the joint, located at mid-span where the spline was butt-jointed, as shown in Figure 25. The test failure time was recorded as 76 min.

Figure 25 – Failure of the 5-ply internal spline

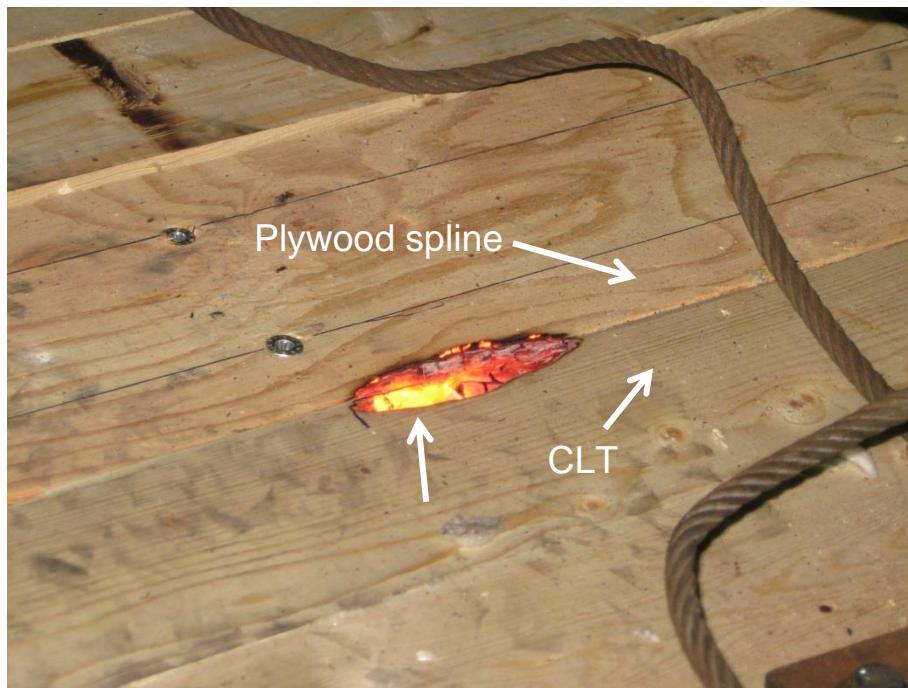
A load of 32 kN, representing a full loading condition, was applied (Figure 36). The test continued until glowing at the surface (unexposed) was observed at the portion of the joint located between the spline and the CLT, close to a loading point, as shown in Figure 37. The test failure time was recorded as 43 min.

Figure 37 – Failure of the 3-ply double surface splines

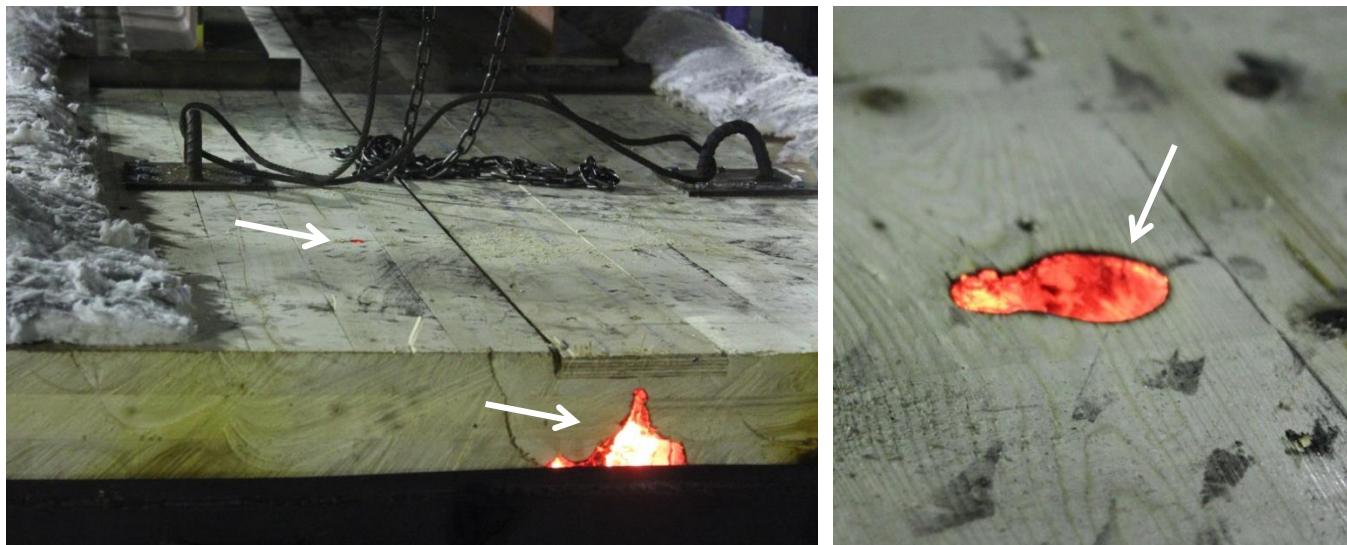
A load of 42 kN, representing a 55% loading condition determined from an initial 20 mm deflection, was applied (Figure 41). After 90 min, it was decided to end the test due to laboratory equipment safety concerns (several burn-through locations occurred along the sides and ends of the specimen). However, it was noted that a small burn-through occurred close to the surface spline (but within the CLT, not at the joint interface) at 82 min as shown in Figure 42. The actual reason for this burn-through is unclear as it occurred at a distance from the panel-to-panel joint and close to an end support.

Figure 42 – Failure of the 5-ply double surface spline

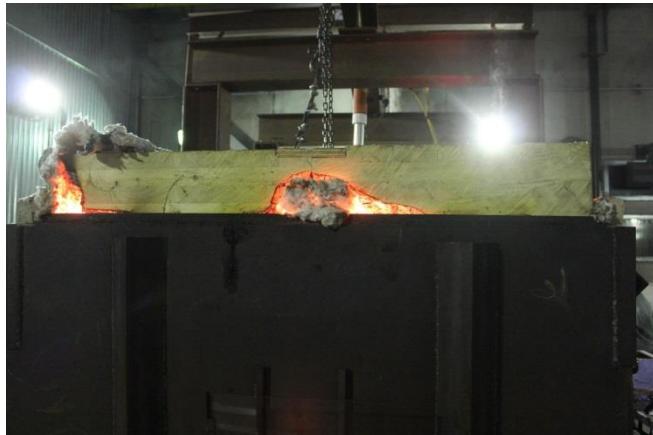
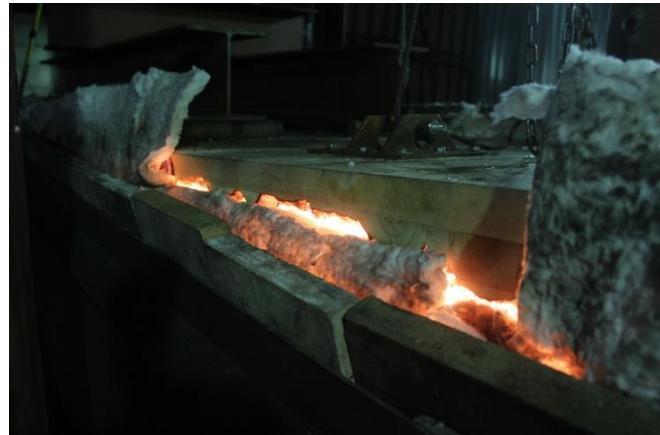
A load of 50 kN, representing a 37% loading condition limited by the load cell capacity, was applied (Figure 46). Shortly after 180 min into the test, a loud sound was heard due to a structural failure. As such, it was decided to end the test due to laboratory equipment safety concerns. Several burn-through locations occurred along the sides and ends of the specimen. However, no burn-through was observed at the unexposed surface or next to the panel-to-panel joint. No failure time was recorded.

Figure 47 – Burn-through along the perimeter of the 7-ply double surface spline
