Fire Performance of Cross-Laminated Timber Panel-to-Panel Joints

Date: March 31st 2015

By: Christian Dagenais, Eng., M.Sc., Advanced Building Systems

TYPE OF REPORT : Test Report

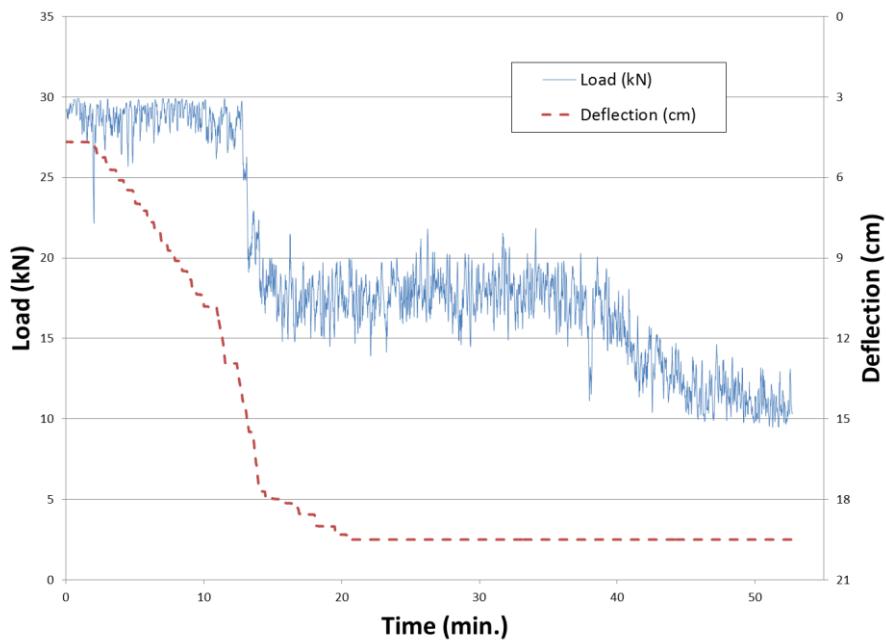
Figure 6 - 3-ply half-lapped joint load and deflection measurements

A load of 32 kN, representing a full loading condition, was applied prior to the fire exposure as shown in Figure 6. However, the bending stiffness of a 3-ply CLT floor slab is quickly reduced when the exposed layer in the strength direction chars. As such, the applied load was modified during the test. It can be seen that indeed the maximum 20 cm deflection was reached very early into the test. Nevertheless, the test continued until glowing at the unexposed surface was observed at the portion of the joint located between the loading points. The test failure time was recorded as 45 min.

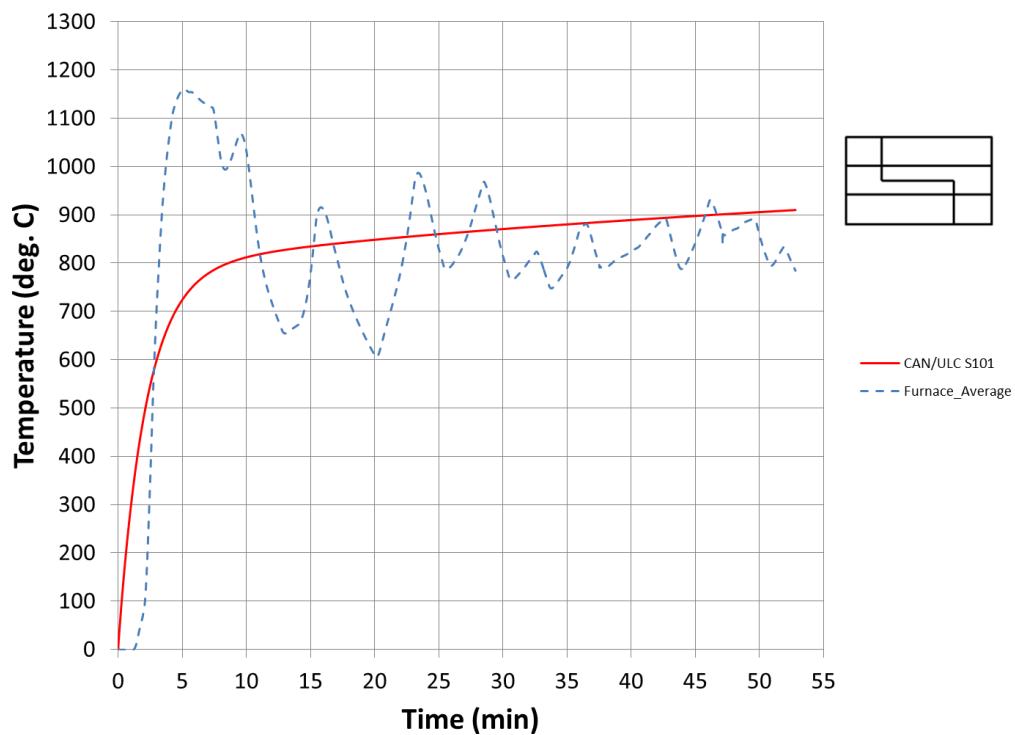
Figure 8 – Furnace temperature for the 3-ply half-lapped joint (average values)

Throughout the test, there were significant difficulties trying to properly follow the standard fire curve, especially during the first 20 minutes as shown in Figure 8. Figure 9 and Figure 10 show the temperature profiles recorded throughout the CLT and at the junction of the half-lapped joint. The 300°C isotherm was reached at 17.5 mm after 28 min, yielding a charring rate of 0.63 mm/min. At the end of the test (at 53 min), the maximum temperature reading at the joint was 290°C, indicating that the char front (300°C isotherm) was very close to this point; this result gives a charring rate of 0.99 mm/min.

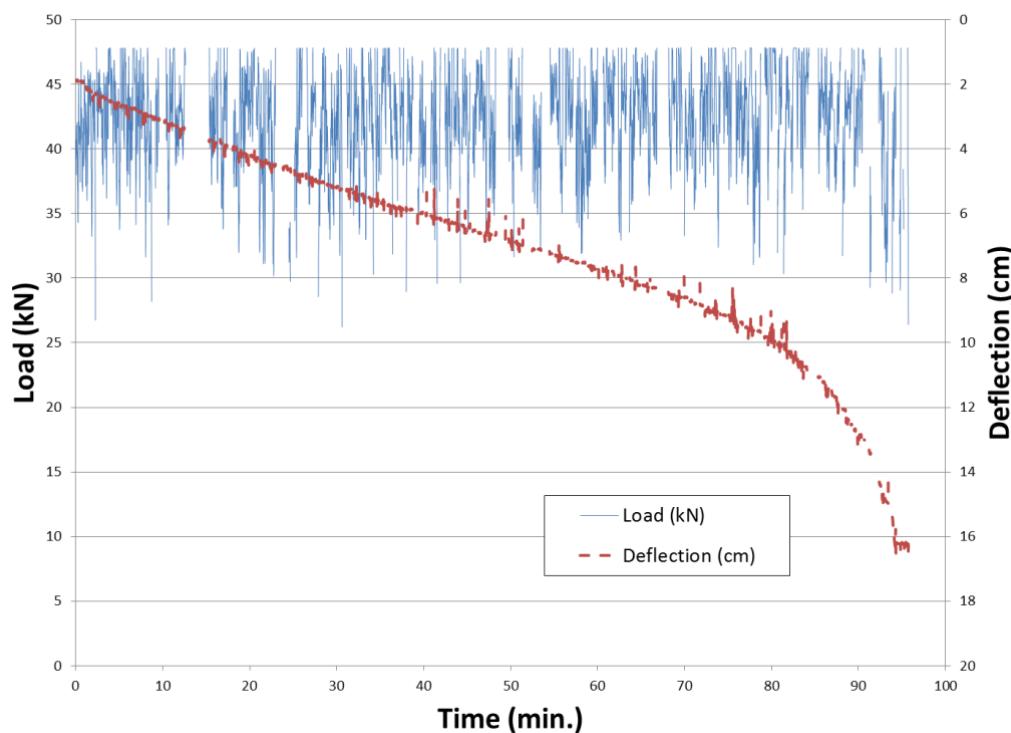
Figure 11 - 5-ply half-lapped joint load and deflection measurements

A load of 41 kN, representing a 54% loading condition determined from an initial 20 mm deflection, was applied prior to the fire exposure as shown in Figure 11. The test continued until differential deflection occurred between the 2 CLT panels (Figure 12). The test failure time was recorded as 98 min.

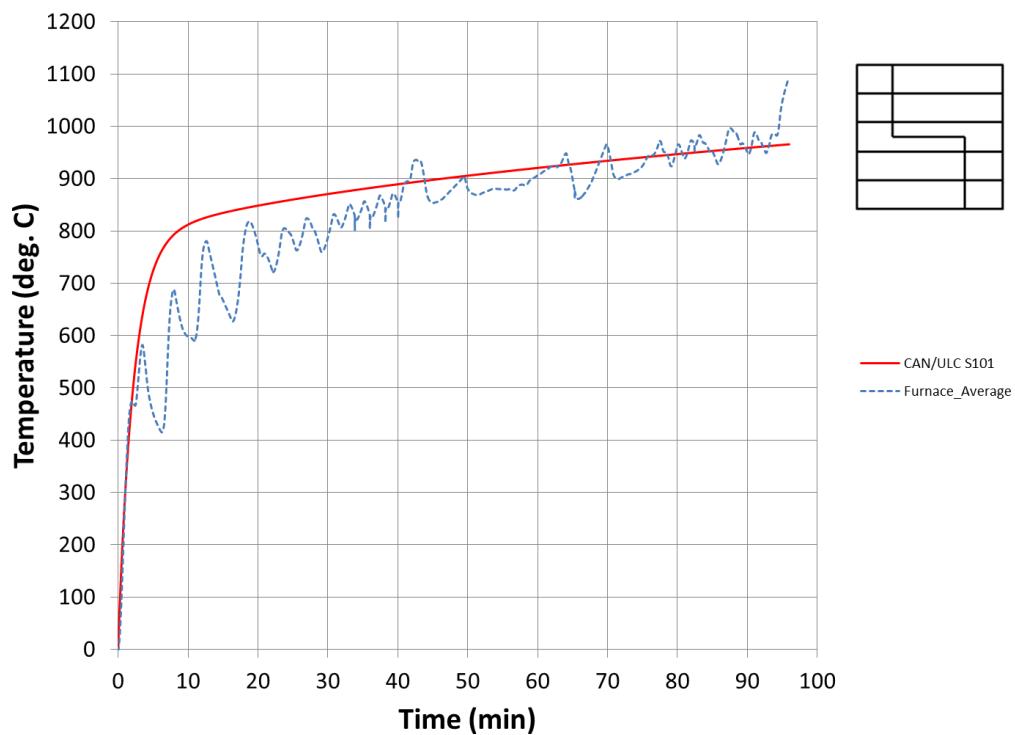
Figure 13 – Furnace temperature curve for the 5-ply half-lapped joint (average values)

Figure 13 illustrates the temperature recorded inside the furnace during the test. It can be seen that the temperature, although lower for most of the test, followed closely the standard curve. Figure 14 and Figure 15 show the temperature profiles recorded throughout the CLT and at the junction of the half-lapped joint. The 300°C isotherm was reached at 17.5 mm and 35 mm after 51 min and 74 min, yielding a charring rate of 0.34 and 0.47 mm/min, respectively. As shown in Figure 15, no significant temperature rises were recorded at the 2nd glue line (70 mm) or at the joint interface.

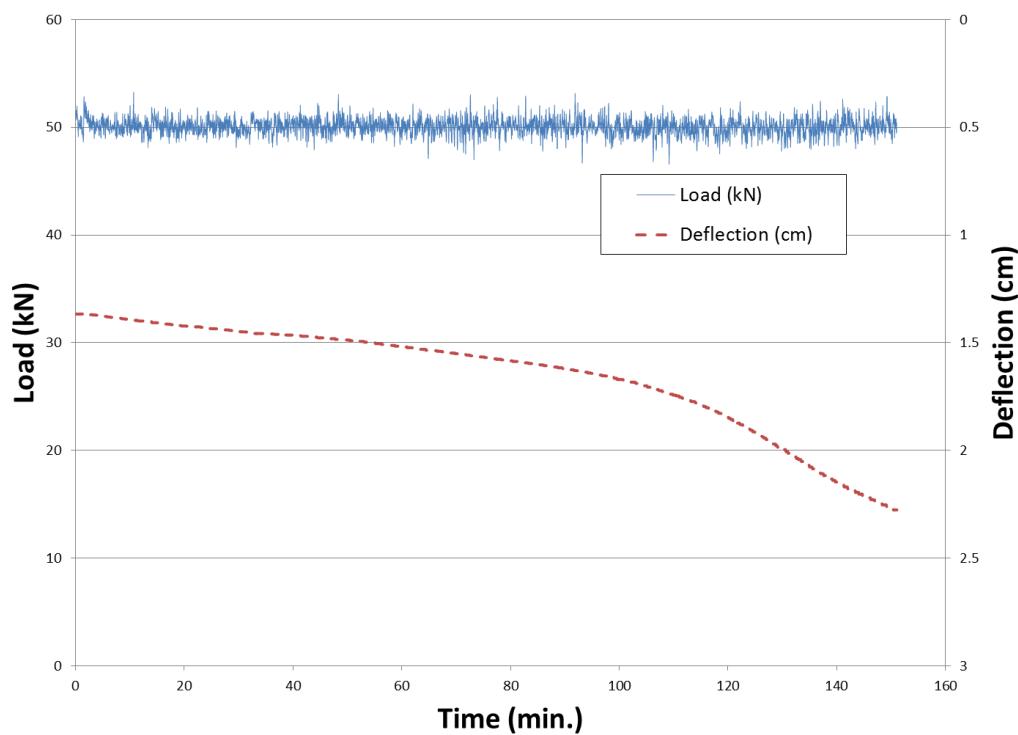
Figure 16 - 7-ply half-lapped joint load and deflection measurements

A load of 50 kN, representing a 37% loading condition limited by the load cell capacity, was applied prior to the fire exposure (Figure 16). The test continued until glowing at the unexposed surface was observed at the portion of the joint located between the loading points, as shown in Figure 17. As with the 5-ply half-lapped test, differential deflection also occurred between the 2 CLT panels (Figure 18). The test failure time was recorded as 140 min.

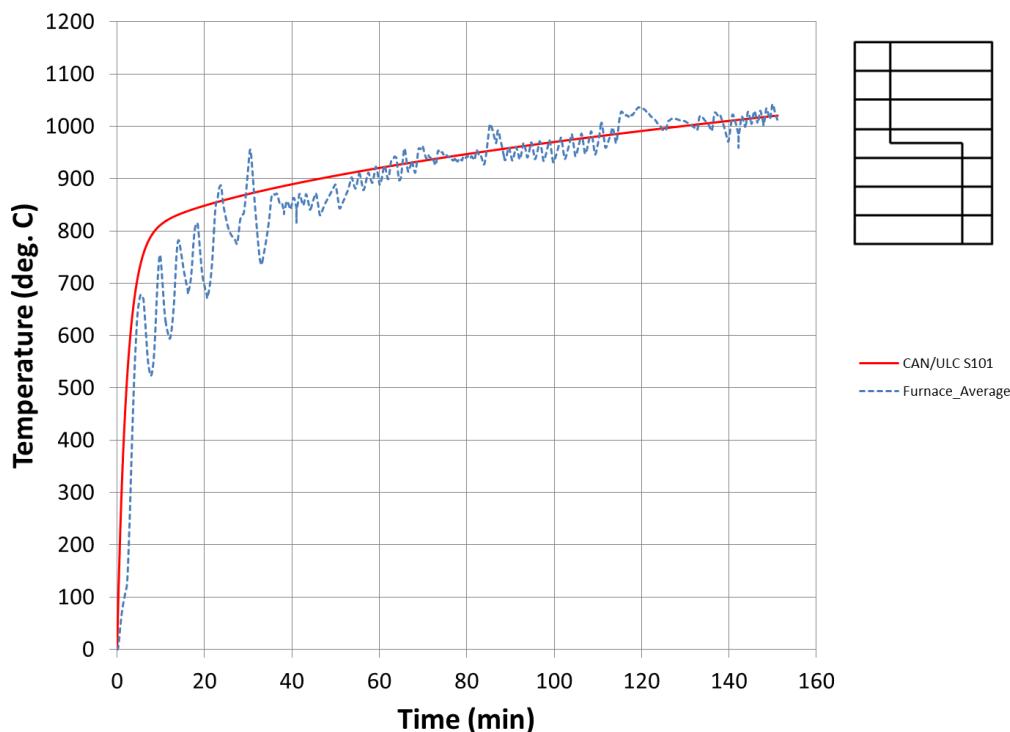
Figure 19 – Furnace temperature curve for the 7-ply half-lapped joint (average values)

Figure 19 illustrates the temperature recorded inside the furnace during the test. It can be seen that the temperature followed closely the standard curve. Figure 20 and Figure 21 show the temperature profiles recorded throughout the CLT and at the junction of the half-lapped joint. The 300°C isotherm was first reached at 17.5, 35, 70 and 105 mm after 47, 74, 117 and 144 min, yielding a charring rate of 0.37, 0.47, 0.60 and 0.73 mm/min respectively. The half-lapped interface reached 300°C at 96 min.

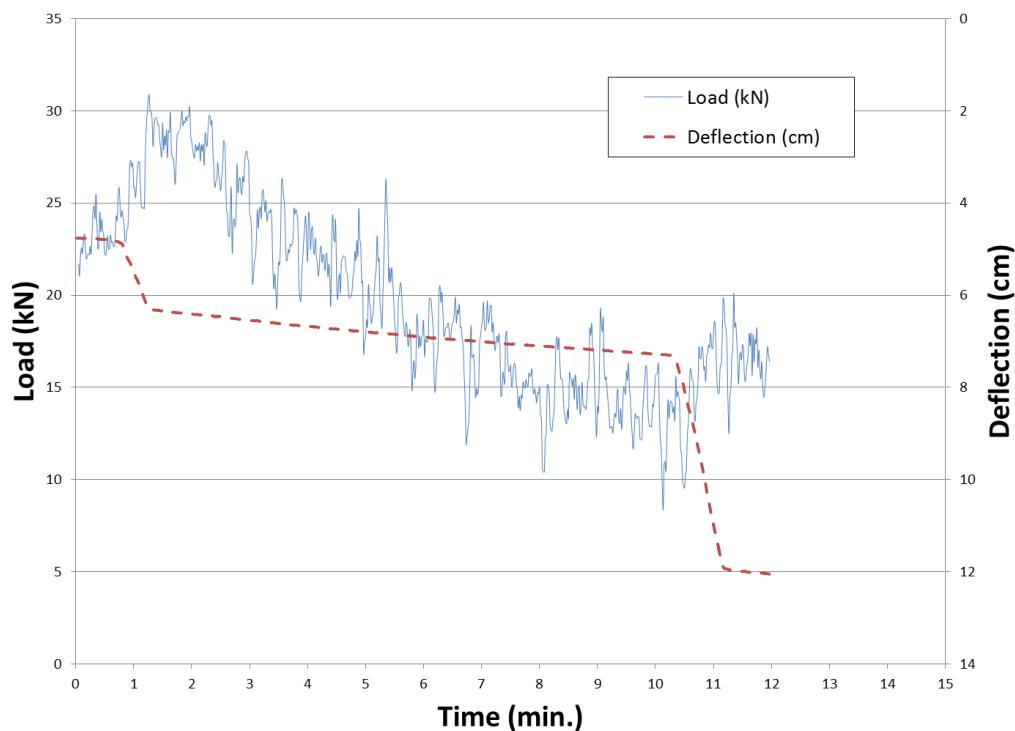
Figure 22 - 3-ply internal spline load and deflection measurements

A load of 32 kN, representing a full loading condition, was applied prior to the fire exposure (Figure 29). Significant problems occurred throughout the test, namely with the burners due to the very cold indoor conditions (problem in the air/propane mixture). In addition, problems with the data acquisition system occurred. As such, no data has been properly recorded for this specific test, including the furnace temperature.

However, from visual observations and manual timing, glowing at the surface (unexposed) was observed at the joint around 35 min after the test (Figure 23). The burn-through was located close to mid-span where the spline was butt-jointed. It is noted that since the burners were not controlled properly, the furnace temperature could not be verified.

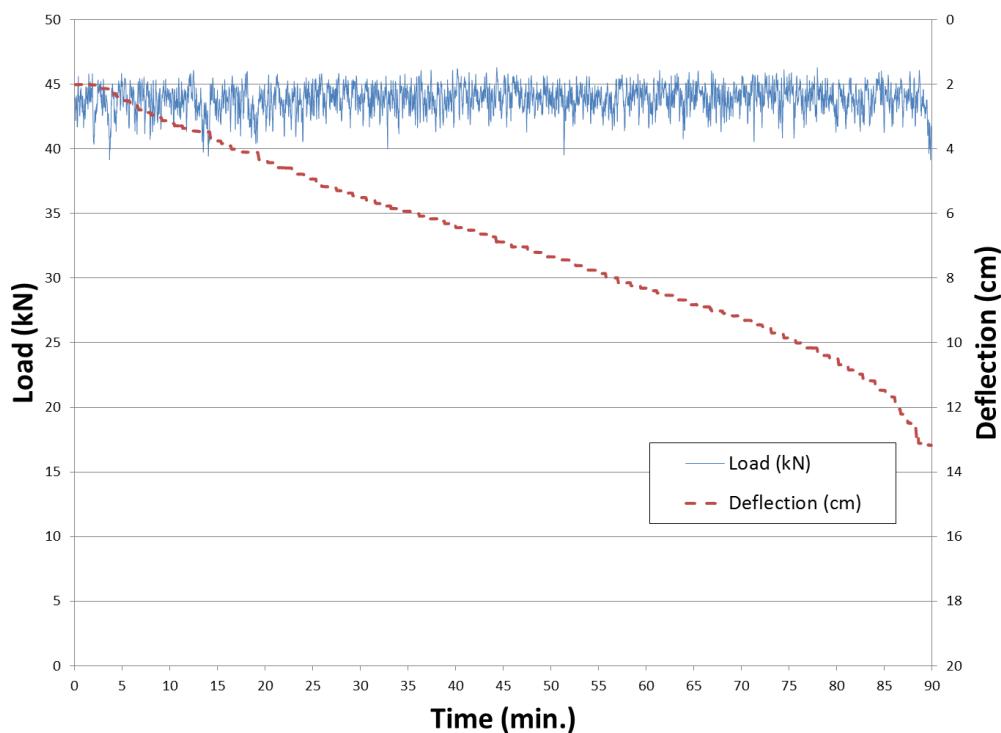
Figure 24 - 5-ply internal spline load and deflection measurements

A load of 42 kN, representing a 55% loading condition determined from an initial 20 mm deflection was applied prior to the fire exposure as shown in Figure 24. The test continued until glowing at the unexposed surface was observed at the joint, located at mid-span where the spline was butt-jointed, as shown in Figure 25. The test failure time was recorded as 76 min.

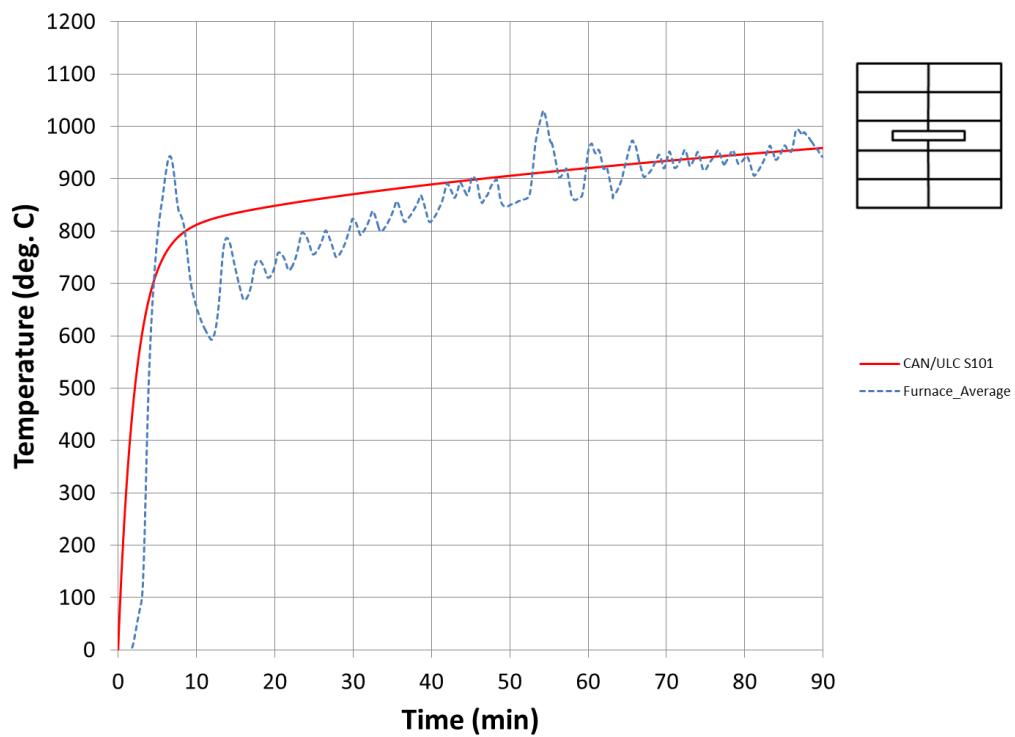
Figure 26 – Furnace temperature curve for the 5-ply internal spline (average values)

Figure 30 illustrates the temperature recorded inside the furnace during the test. It can be seen that the temperature was lower for most of the test but followed closely the standard curve. Figure 27 and Figure 28 show the temperature profiles recorded throughout the CLT and at the junction of the internal spline. The 300°C isotherm was reached at 17.5, 35 and 70 mm after 29, 61 and 85 min, yielding a charring rate of 0.60, 0.57 and 0.82 mm/min respectively. The bottom and the top of the internal spline reached 300°C respectively at 75 and 81 min.

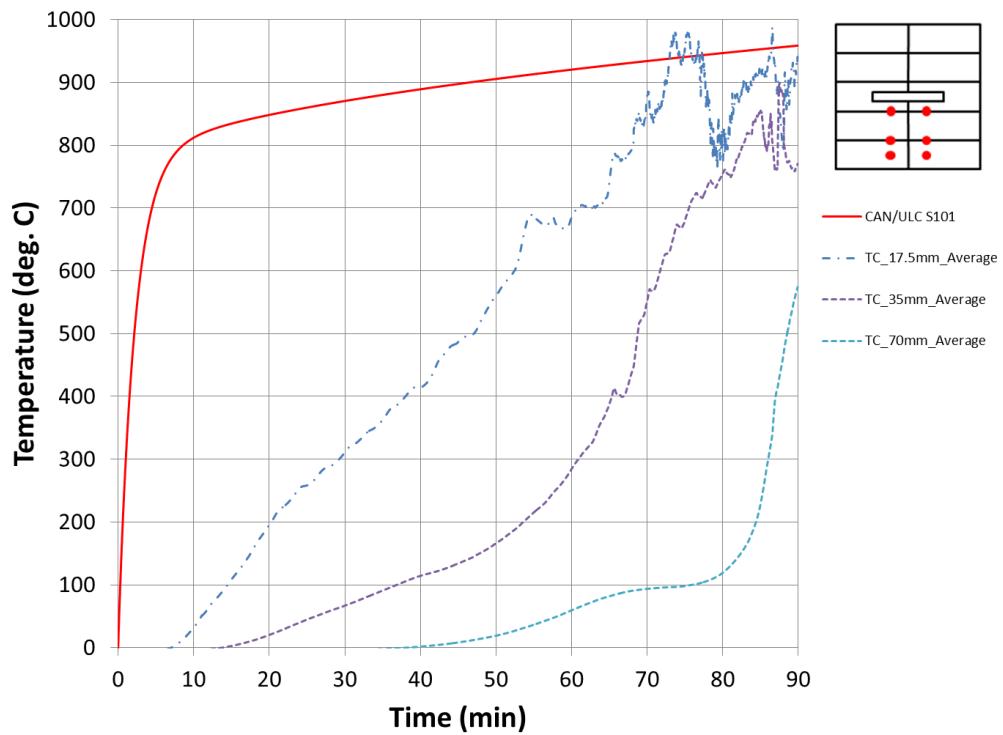
Figure 27 – Temperature profiles for the 5-ply internal spline (average values)

Handbook. It is however unclear as to why the char front reached the spline quicker than at the 2nd glueline (70 mm). The spline is located at 78 mm from the exposed surface. According to Figure 27 and Figure 28, the char front reached the spline at 75 min while thermocouple readings at the 2nd glueline indicate a time of 85 min. Nevertheless, the burn-through failures obtained from both tests occurred where the spline was butt-jointed. A potential reason for such rapid burn-through may be due to the internal pressure within the furnace, forcing fresh air to flow into the CLT assemblies through relatively small gaps such as one that could be generated when butt-jointing plywood splines.

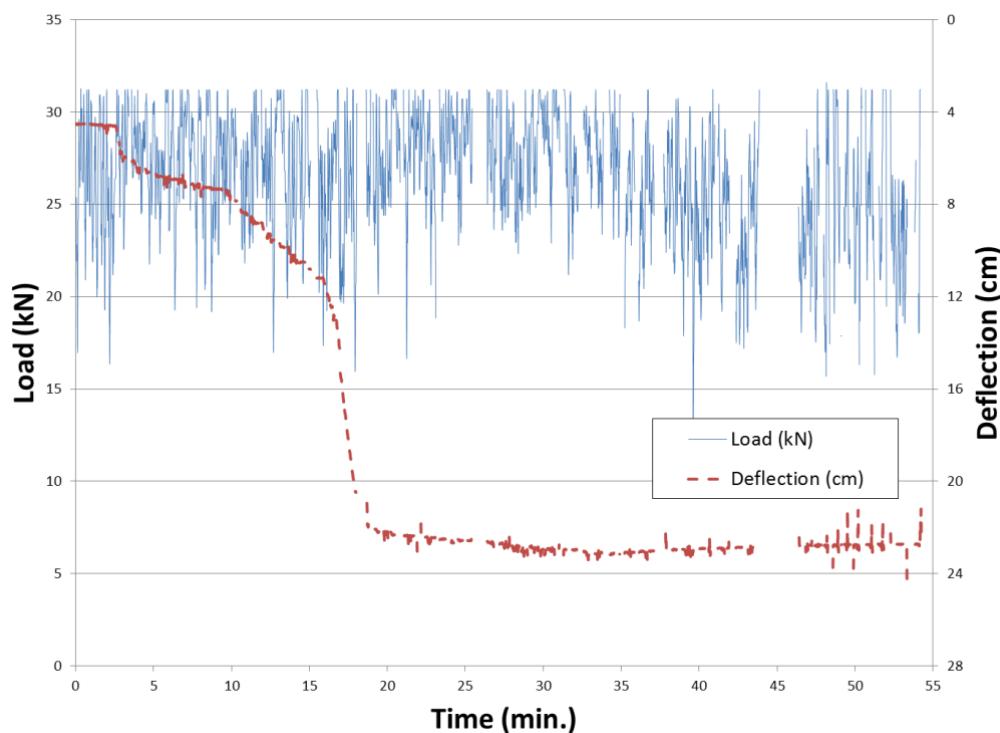
Figure 29 - 3-ply single surface spline load and deflection measurements

A load of 32 kN, representing a full loading condition, was applied. As explained in subsection 5.1 of this report, the maximum deflection (20 cm) was reached early in the test. After 54 min into the test, it was decided to end the test due to laboratory equipment safety concerns. As such, no failure time was recorded.

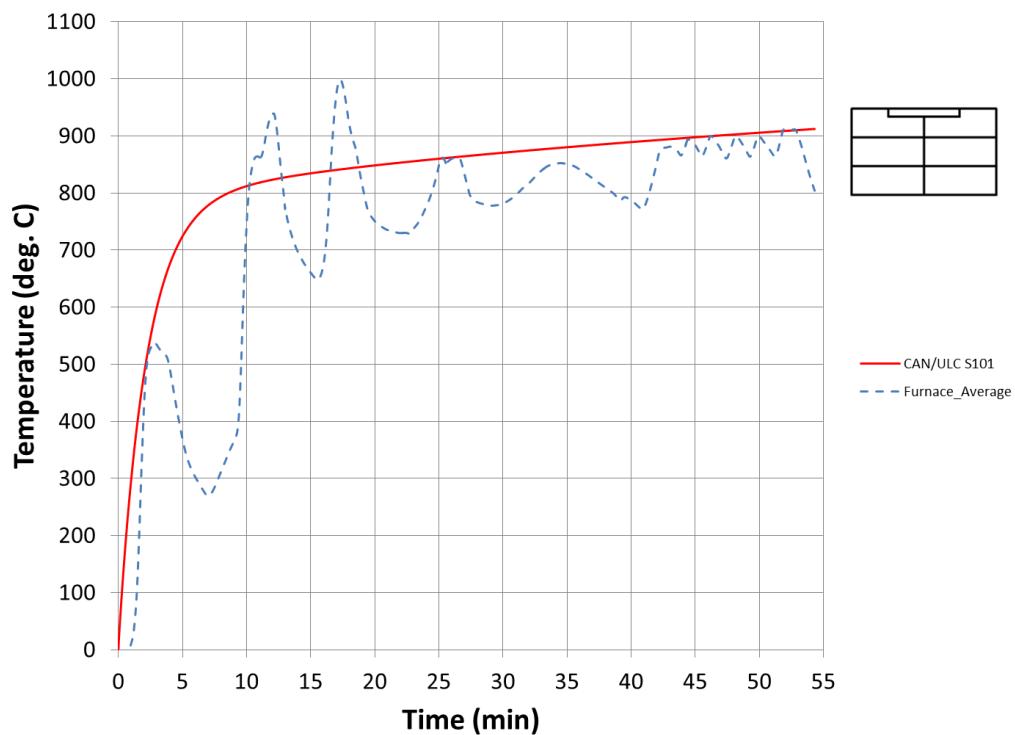
Figure 30 – Furnace temperature for the 3-ply single surface spline (average values)

Throughout the test, there were significant difficulties in properly following the standard fire curve (Figure 30). Figure 31 and Figure 32 show the temperature profiles recorded throughout the CLT and at the junction of the half-lapped joint. The 300°C isotherm was reached at 17.5 and 35 mm after 30 and 52 min, yielding a charring rate of 0.58 and 0.67 mm/min. No significant temperature rises were recorded at the 2nd glue line (70 mm) and at the joint interface, as shown in Figure 32.

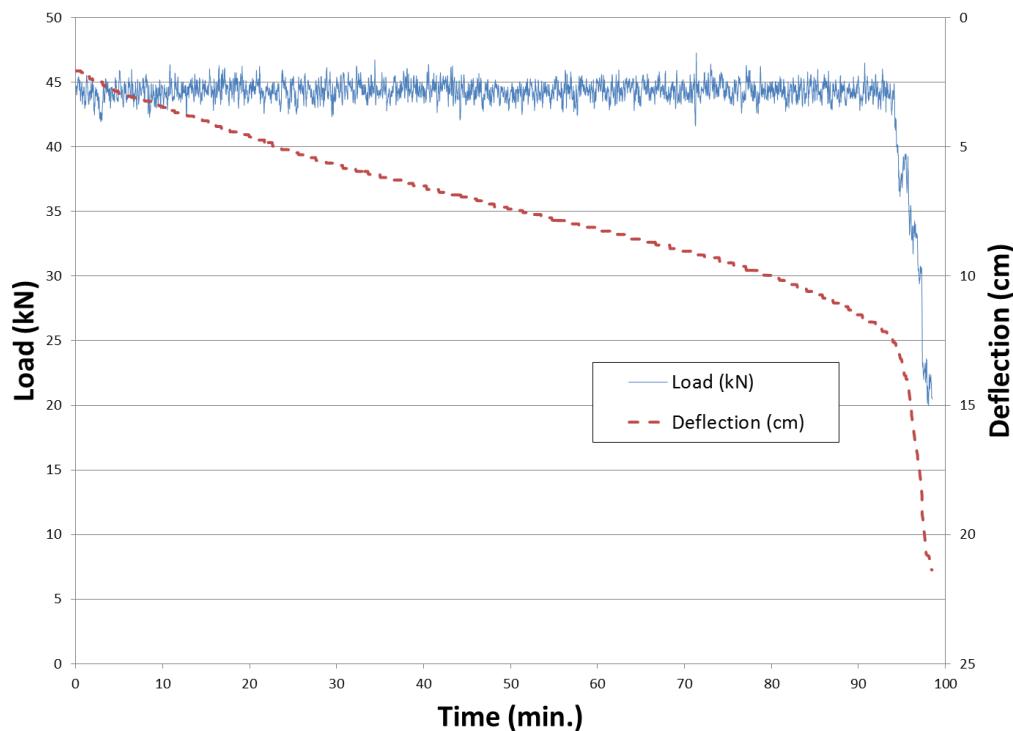
Figure 33 - 5-ply single surface spline load and deflection measurements

A load of 42 kN, representing a 55% loading condition determined from an initial 20 mm deflection was applied as shown in Figure 11. After roughly 98 min, it was decided to end the test due to laboratory equipment safety concerns (several burn-through locations occurred along the sides of the specimen). As such, no failure time was recorded.

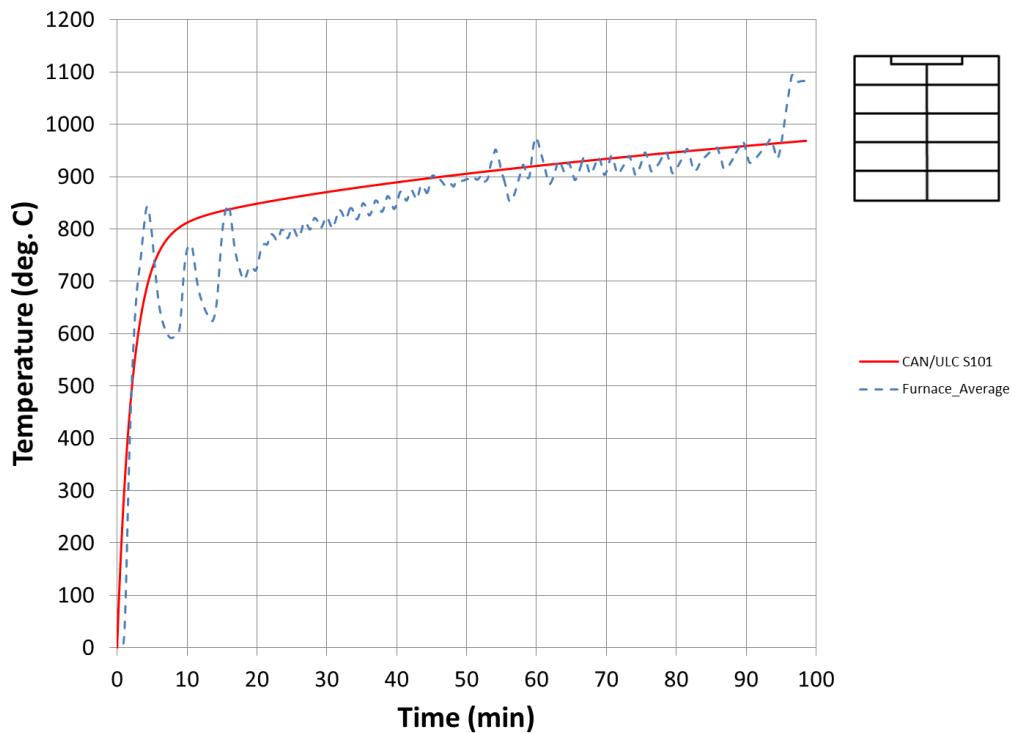
Figure 34 – Furnace temperature curve for the 5-ply single surface spline (average values)

Figure 34 illustrates the temperature recorded inside the furnace during the test. It can be seen that the temperature was slightly lower in general but followed closely the standard curve. Figure 35 shows the temperature profiles recorded throughout the CLT and at the junction of the surface spline. The 300°C isotherm was reached at 17.5 and 35 mm after 45 and 78 min, yielding a charring rate of 0.39 and 0.45 mm/min respectively. No significant temperature rises were recorded at the 2nd glue line (70 mm) and at the spline-CLT interface (thus not shown in Figure 35 beyond 70 mm).

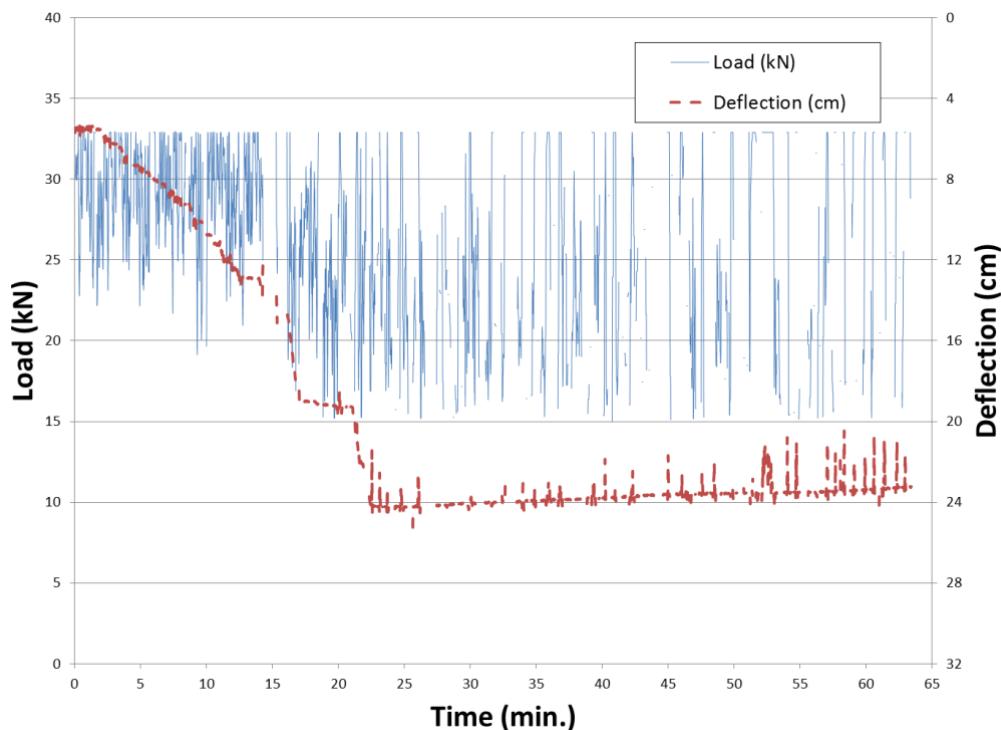
Figure 36 - 3-ply double surface spline load and deflection measurements

A load of 32 kN, representing a full loading condition, was applied (Figure 36). The test continued until glowing at the surface (unexposed) was observed at the portion of the joint located between the spline and the CLT, close to a loading point, as shown in Figure 37. The test failure time was recorded as 43 min.

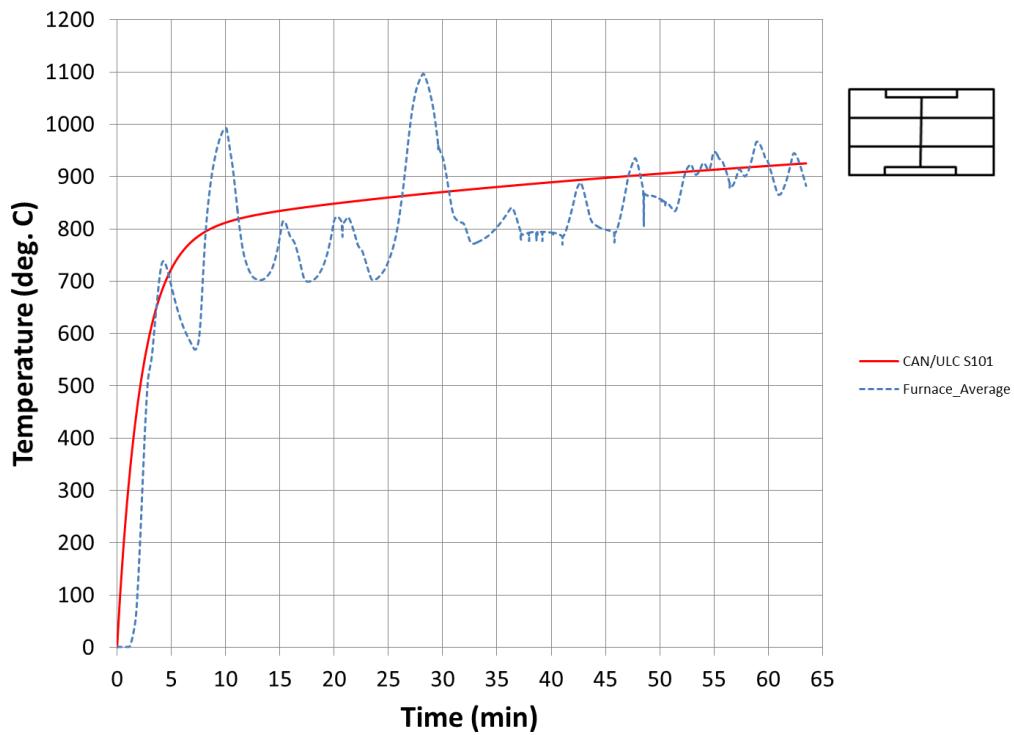
Figure 38 – Furnace temperature curve for the 3-ply double surface spline (average values)

There were difficulties in attempting to properly follow the standard time-temperature curve as shown in Figure 38. Figure 39 and Figure 40 show the temperature profiles recorded throughout the CLT and at the junction of the surface splines (top and bottom). The 300°C isotherm was reached at 17.5 and 35 mm after 46 and 60 min, yielding to a charring rate of 0.38 and 0.58 mm/min. No significant temperature rises were recorded at the 2nd glue line (70 mm). The bottom spline reached 300°C at 28 min. No significant temperature rise was recorded underneath the top surface spline.

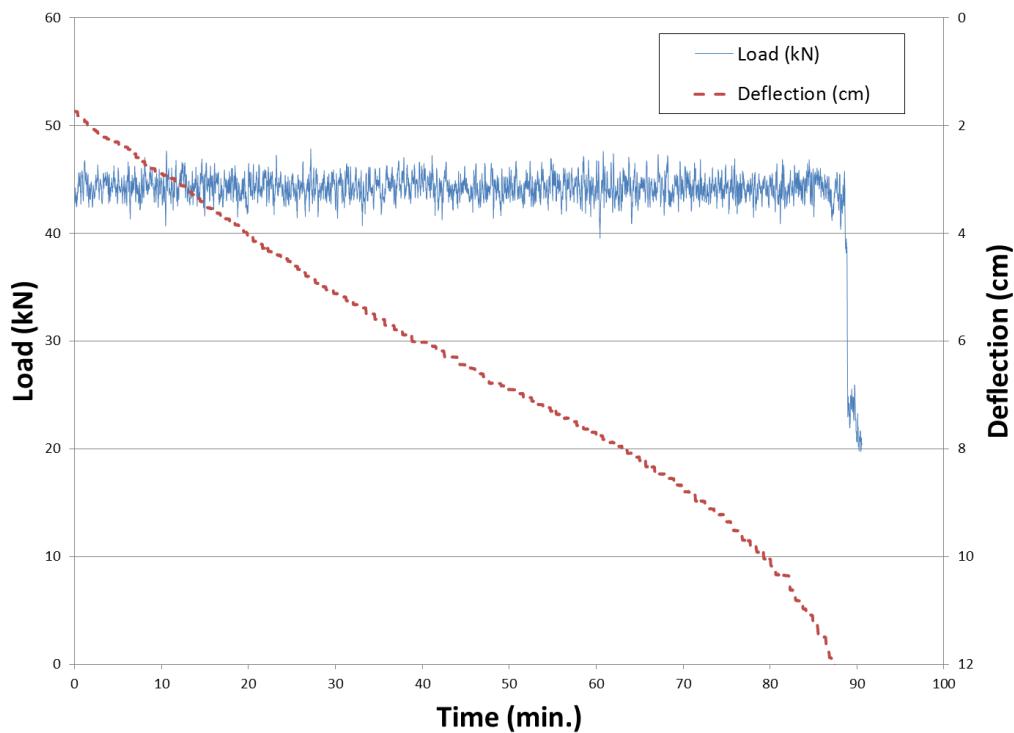
Figure 41 - 5-ply double surface spline load and deflection measurements

A load of 42 kN, representing a 55% loading condition determined from an initial 20 mm deflection, was applied (Figure 41). After 90 min, it was decided to end the test due to laboratory equipment safety concerns (several burn-through locations occurred along the sides and ends of the specimen). However, it was noted that a small burn-through occurred close to the surface spline (but within the CLT, not at the joint interface) at 82 min as shown in Figure 42. The actual reason for this burn-through is unclear as it occurred at a distance from the panel-to-panel joint and close to an end support.

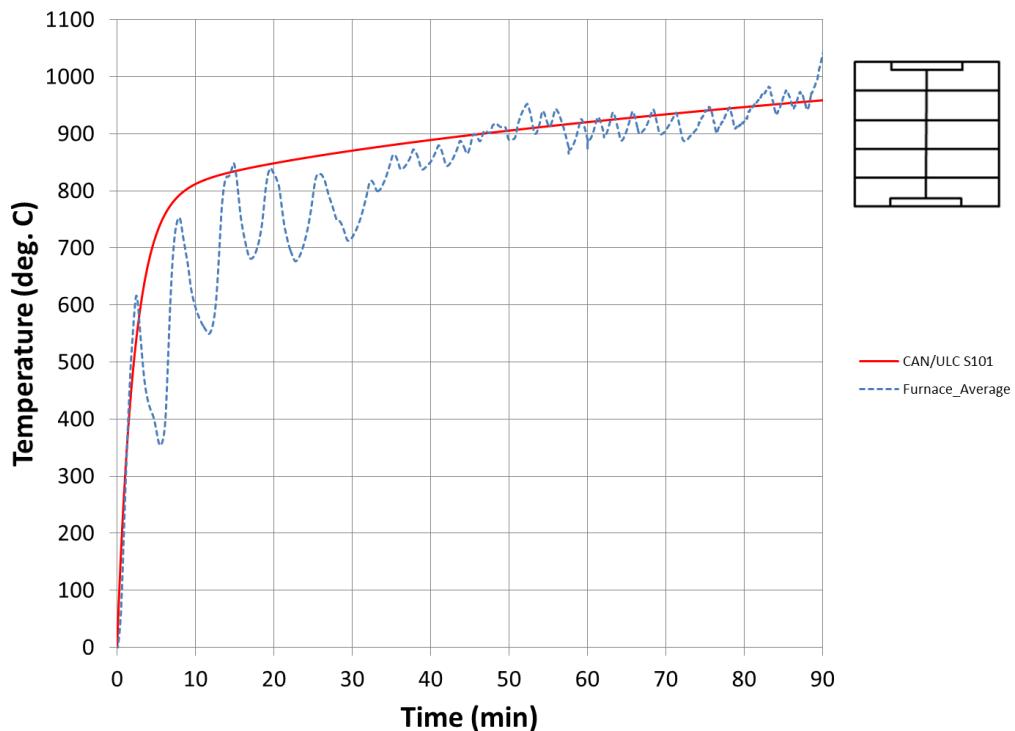
Figure 43 – Furnace temperature curve for the 5-ply double surface spline (average values)

The furnace temperature, although lower for most of the test as shown in Figure 43, accurately followed the standard time-temperature curve. Figure 44 and Figure 45 show the temperature profiles recorded throughout the CLT and at the junction of the surface splines (top and bottom). The 300°C isotherm was reached at 17.5, 35 and 70 mm after 32, 43 and 89 min, yielding a charring rate of 0.55, 0.81 and 0.79 mm/min, respectively. No significant temperature rises were recorded at the 3rd glue line (105 mm) and beyond (thus not shown in Figure 44 and Figure 45 beyond 105 mm). The top of the bottom spline reached 300°C at 25 min.

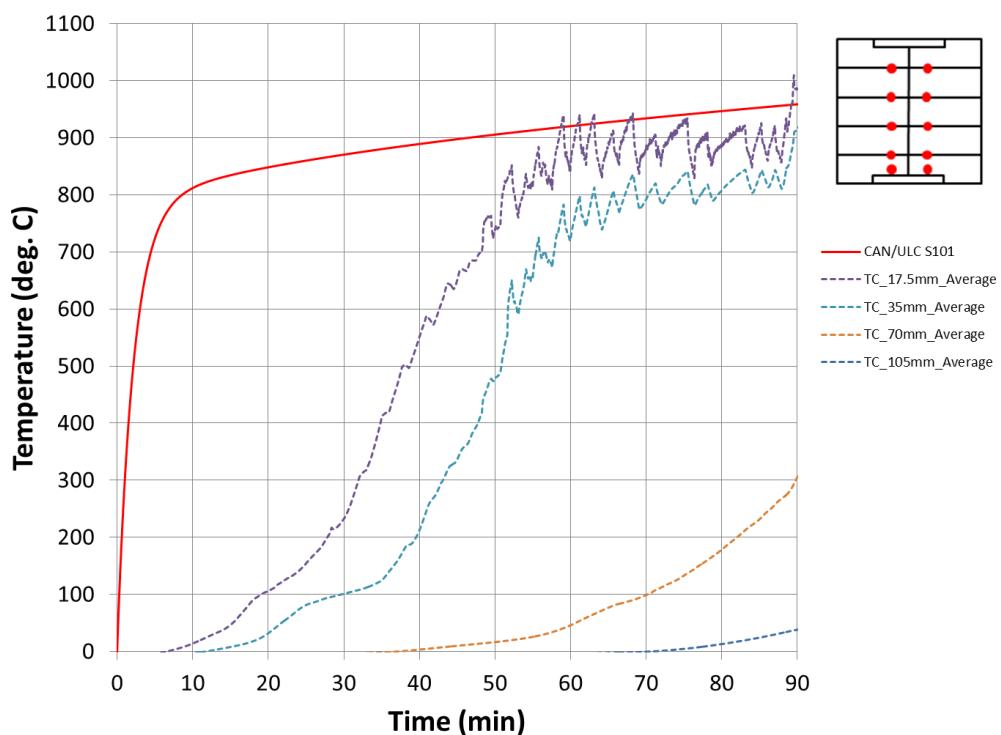
Figure 44 – Temperature profiles for the 5-ply double surface spline (average values)

As mentioned previously, the reason for the failure time (82 min) is unclear since very little temperature rise was recorded at the 4th glueline (140 mm) (Figure 44) and none underneath the top surface spline (Figure 45).

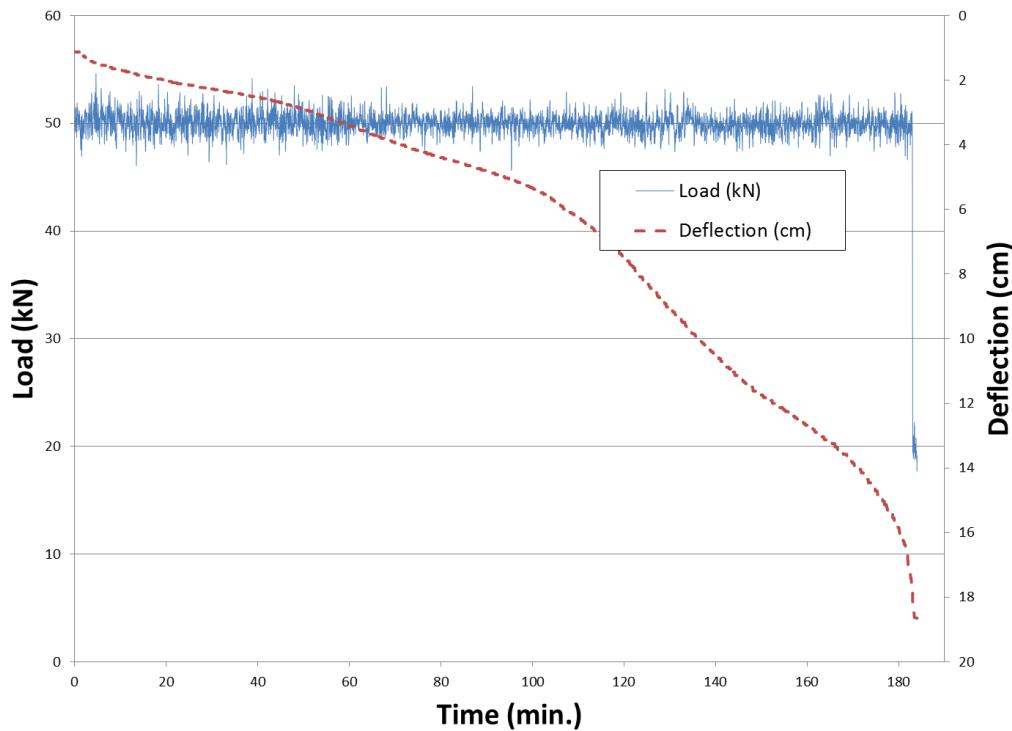
Figure 46 - 7-ply double surface spline load and deflection measurements

A load of 50 kN, representing a 37% loading condition limited by the load cell capacity, was applied (Figure 46). Shortly after 180 min into the test, a loud sound was heard due to a structural failure. As such, it was decided to end the test due to laboratory equipment safety concerns. Several burn-through locations occurred along the sides and ends of the specimen. However, no burn-through was observed at the unexposed surface or next to the panel-to-panel joint. No failure time was recorded.

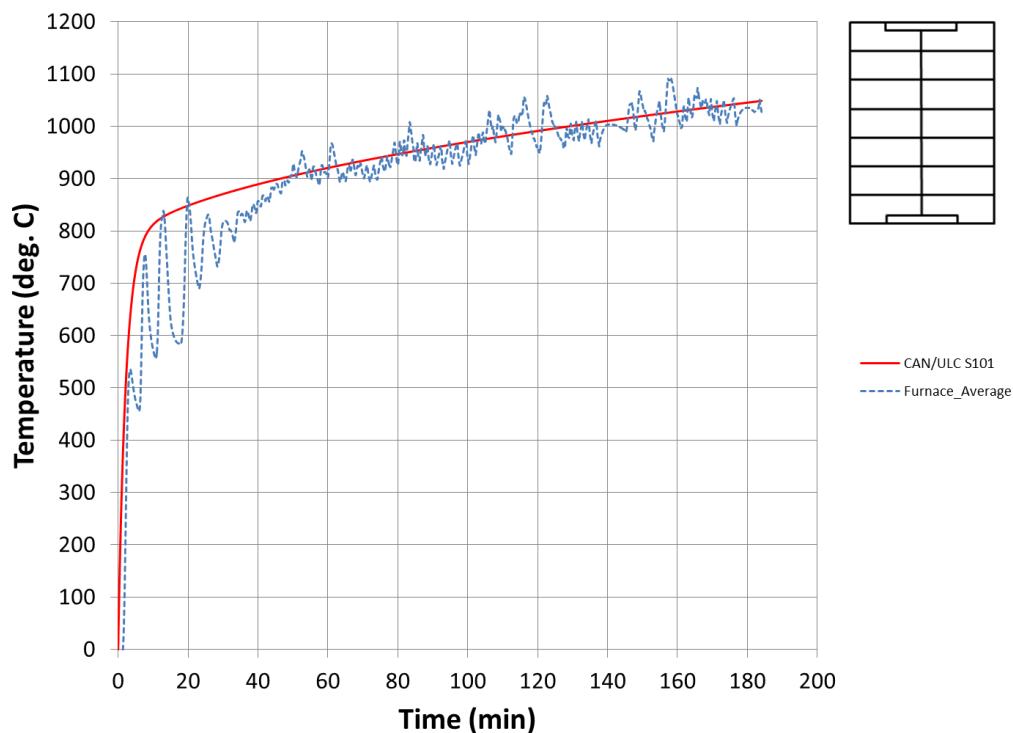
Figure 48 – Furnace temperature curve for the 7-ply double surface spline (average values)

The furnace temperature, although being lower in the early stage of the test, followed well the standard time-temperature curve (Figure 48). Figure 49 and Figure 50 show the temperature profiles recorded throughout the CLT and at the junction of the surface splines (top and bottom). The 300°C isotherm was reached at 17.5, 35, 70 and 105 mm after 52, 51, 114 and 167 min, yielding to a charring rate of 0.34, 0.69, 0.61 and 0.63 mm/min, respectively. No significant temperature rises were recorded beyond the 3rd glue line (105 mm) and at the top surface spline (thus not shown in Figure 49 and Figure 50 beyond 140 mm). The top of the bottom spline reached 300°C at 46 min.
