FLAME SPREAD IN CONCEALED MASS TIMBER SPACES

REPORT TO FORESTRY INNOVATION INVESTMENT LTD.

March 31, 2020
PROJECT NO 301013624 – Floor Voids

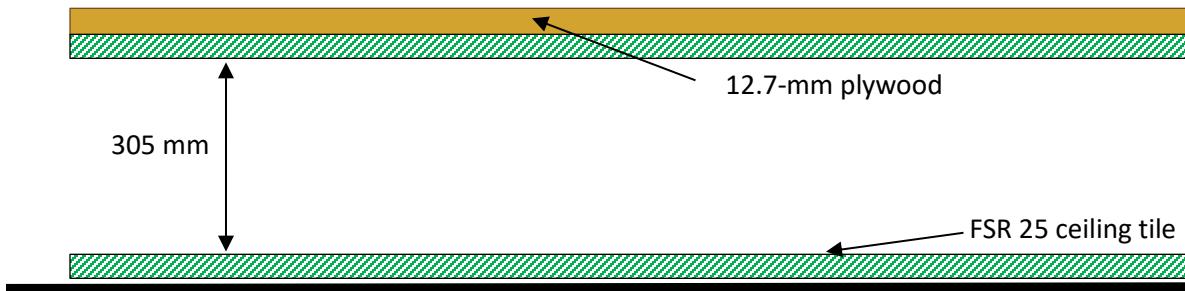
For test 1, the 7,315-mm (24-ft) long tunnel had 12.7-mm ($\frac{1}{2}$ -in.) plywood protected by 19-mm ($\frac{3}{4}$ -in.) acoustic ceiling tiles with a FSR and FSI of not more than 25 [11]. The ceiling tiles were T-bar type acoustic ceiling tiles that are common in most commercial buildings. The plywood pieces were 2,435 mm (8 ft) long, and the ceiling tiles were 1,219 mm (4 ft) long; both 500 mm (20 in.) wide. The other three surfaces of the tunnel, i.e. the two walls and the floor, were also lined with the same ceiling tiles. The tiles on the base of the tunnel were cut to 448 mm (17 5/8 in.), the tiles on the wall where there was no window were cut to 280 mm (11 in.), and the wall side with the windows pieces were 100 mm (4 in.). The flame spread test is a visual test that evaluates how quickly flames move down the tunnel under specific test conditions, so it was necessary to not block the windows. The setup is shown in Figure 1, and the tunnel during construction is shown in Figure 2. A side view of the ceiling tiles is shown in Figure 3.

This configuration was designed to be essentially compliant with NFPA 13 - 9.2.1.11, for which sprinklers would be exempt. The intent was to run the test for an additional 20 minutes. The ceiling tiles met the ASTM E84 and CAN/ULC-S102 requirements of having an FSI of not more than 25 [11], but there is no data on their performance in an extended 30-minute test. The goal was to create a 305-mm (12-in.) deep cavity. However, with the inclusion of the gypsum board on the floor of the tunnel, the maximum depth was 290 mm (11 ½ in.).

Figure 1. Test 1 setup. NFPA 13 - 9.2.1.11 compliant. Ceiling tiles line three sides of tunnel.

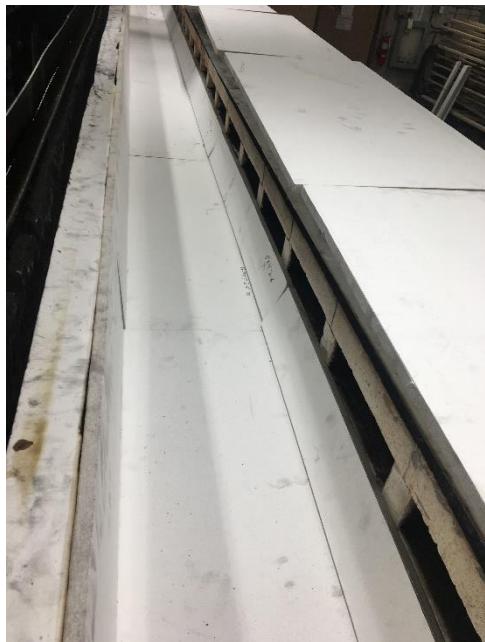
Figure 2. Test 1 during construction

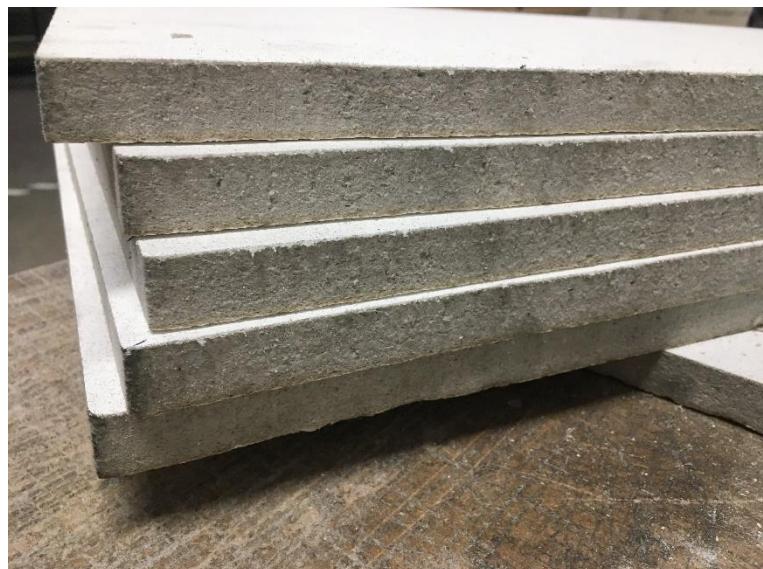
Figure 3. Ceiling tiles with FSR of not more than 25

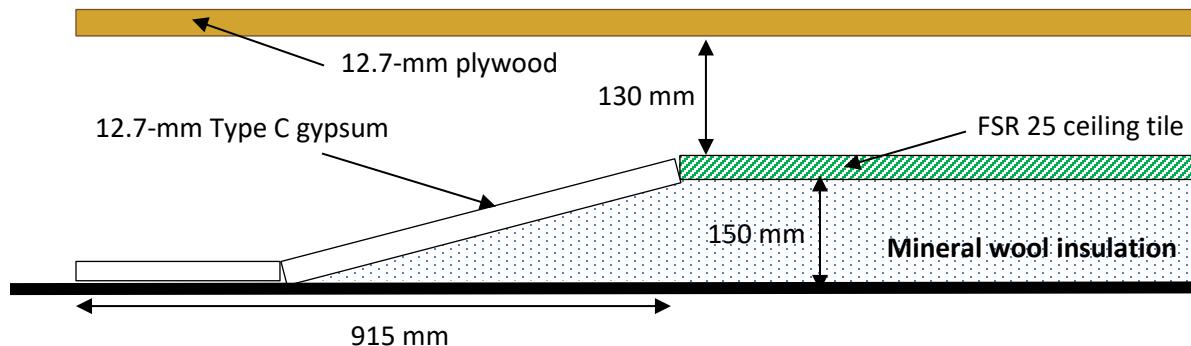
Test 2 was designed to be compliant with NFPA 13 - 9.2.1.5, for which sprinklers would be exempt. A concealed space of 130 mm (5 1/8 in.) was formed between 12.7-mm (½-in.) plywood and 19-mm (¾-in.) acoustic ceiling tiles with an FSI/FSR of not more than 25. The ceiling tiles on the floor of the tunnel were supported by mineral wool insulation. Ceiling tiles were also placed along the wall with no windows (a total of two surfaces were covered); the windows were partially blocked by the assembly, leaving no room for ceiling tiles on that side. Once all the materials were in place the depth of the cavity was 127 mm (5 in.). The test setup is shown in Figure 4, and the tunnel under construction is shown in Figure 5.

To ensure that flames did not propagate beneath the ceiling tiles, two pieces of Type C gypsum board (305 mm and 610 mm in length) were used to transition from the base of the tunnel to the height of the ceiling tiles above the mineral wool insulation (placed on an angle).

Figure 4. Test 2 setup. NFPA 13 - 9.2.1.5 compliant. Ceiling tiles line one wall and floor.

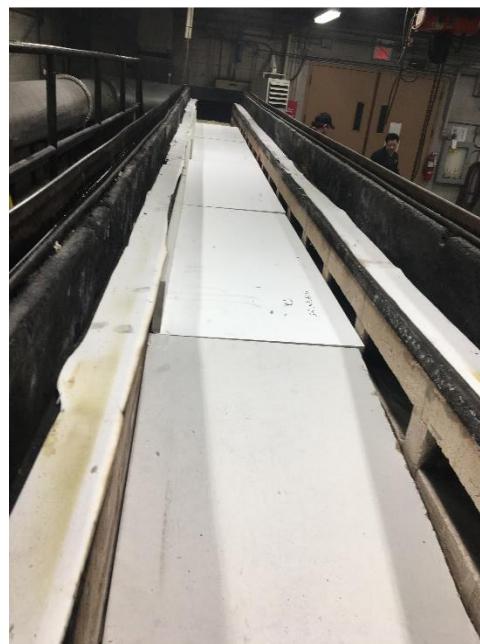
Figure 5. Test 2 during construction

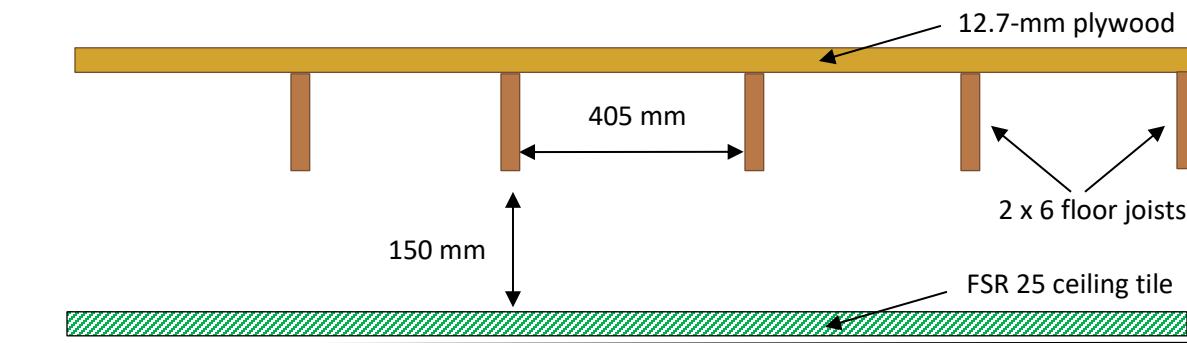
Test 3 was designed to also be compliant with NFPA 13 9.2.1.5 where a ceiling is within 150 mm (6 in.) of wood joists. 2 x 6 lumber, to replicate joists, were cut into 430-mm (17-in.) pieces and screwed into 500 mm wide 12.7-mm ($\frac{1}{2}$ -in.) plywood; this way the plywood rested on top of the tunnel, and the joists fit inside the cavity. Boards were spaced at 405-mm (16-in.) intervals. The first joist started 405 mm down the tunnel. 19-mm ($\frac{3}{4}$ -in.) acoustic ceiling tiles lined the floor of the tunnel and the two walls (the height of the boards under the windows on one side was 120 mm and up to the height of the joists on the other, 150 mm). The test setup is shown in

Figure 6. Test 3 setup. NFPA 13 - 9.2.1.5 compliant. Ceiling tiles line two sides of tunnel.

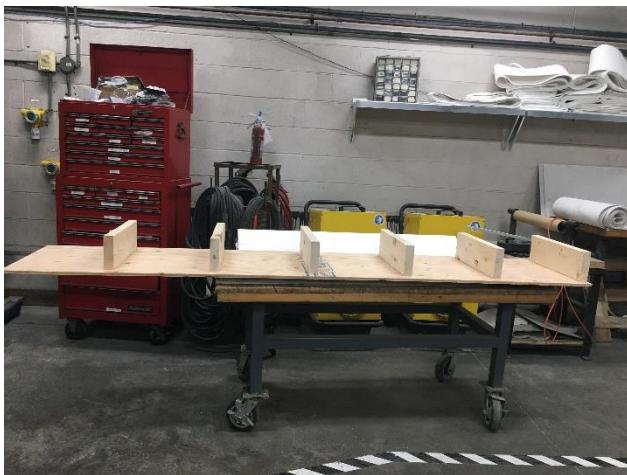
Figure 7. Test 3 wood assembly

Figure 6, construction of the wood components is shown in Figure 7, and construction in the tunnel is shown in Figure 8.

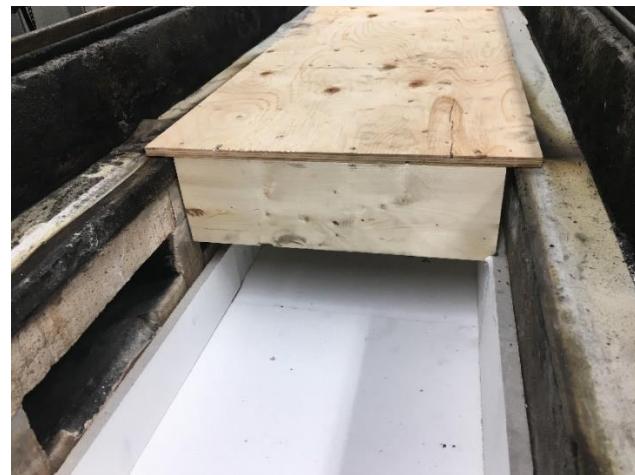
Figure 8. Test 3 preparations in the tunnel

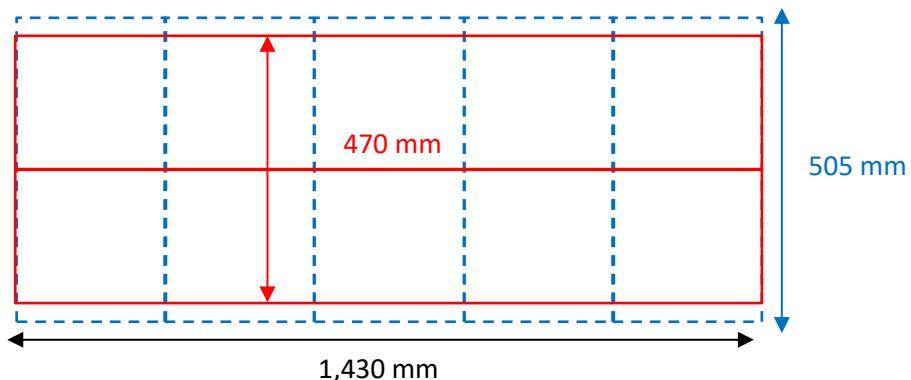
The mass timber panels were built using 2 x 12 and 2 x 10 lumber on flat. The 2 x 12s were cut into 500-mm (19 ½-in.) wide pieces to be laid perpendicular to the tunnel to create the exposed surface. Two 2 x 10s were screwed perpendicular to the back of the 2 x 12s to hold the boards in place using 57-mm (2-¼ in.) wood screws in two rows every 305 mm (12 in.). These panels were constructed in 1,430 mm (56 in.) and 1,600 mm (63 in.) lengths; Figure 9 illustrates the panel design. To reach the 7,315-mm (24-ft.) length, four panels of 1,430 mm and

Figure 9. Construction details of replicated mass timber panels

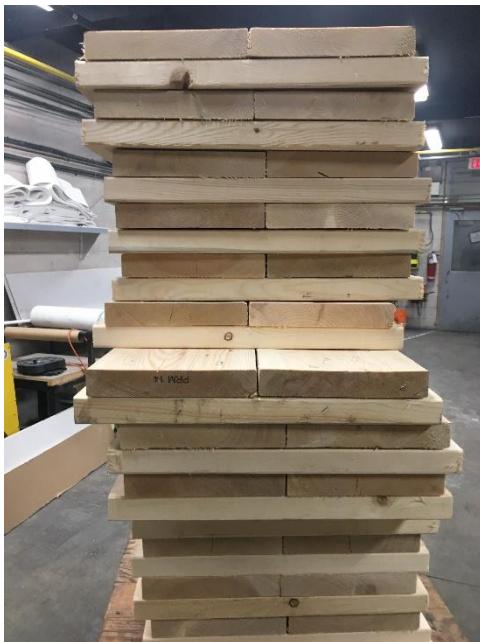
Figure 10. Ends of mass timber panels

one 1,600 mm were used. The mass timber panels are shown in Figure 10. Some gaps up to 3 mm developed between some of the lumber boards on the exposed surface, shown in Figure 11.

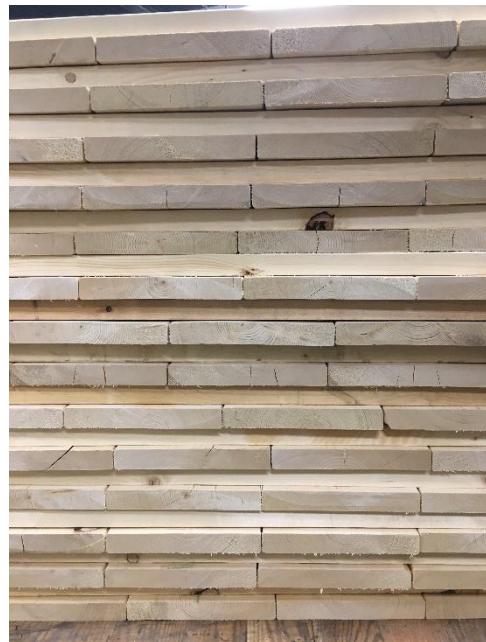
Figure 11. Edges of mass timber panels

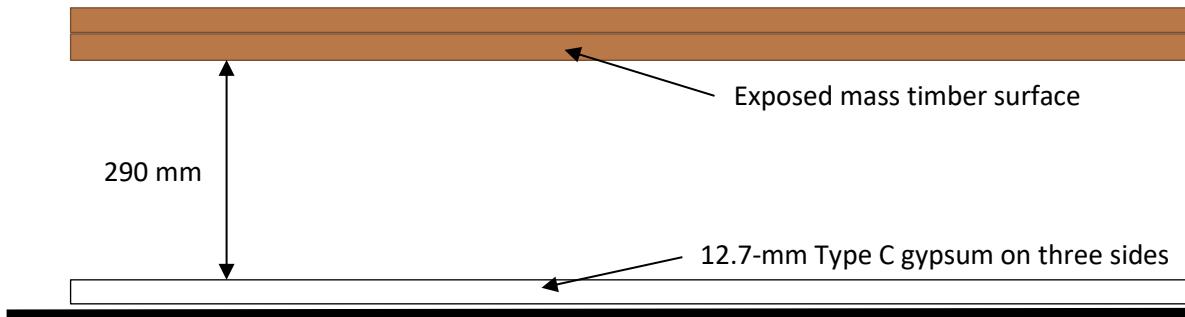
Test 4 had an exposed mass timber surface along the top of the tunnel and 12.7-mm ($\frac{1}{2}$ -in.) Type C gypsum boards along the floor of the tunnel and the two walls (with heights of 120 mm and 300 mm). The intent was to create a 305-mm (12-in.) deep cavity. However, with the inclusion of the gypsum board on the floor of the tunnel, the maximum depth was 290 mm (11 $\frac{1}{2}$ in.). The setup is shown in Figure 12; the installation of the gypsum board is shown in Figure 13 and the mass timber on the tunnel in Figure 14.

Figure 12. Test 4 setup. Mass timber surface with 12.7-mm Type C gypsum lining three sides of tunnel.

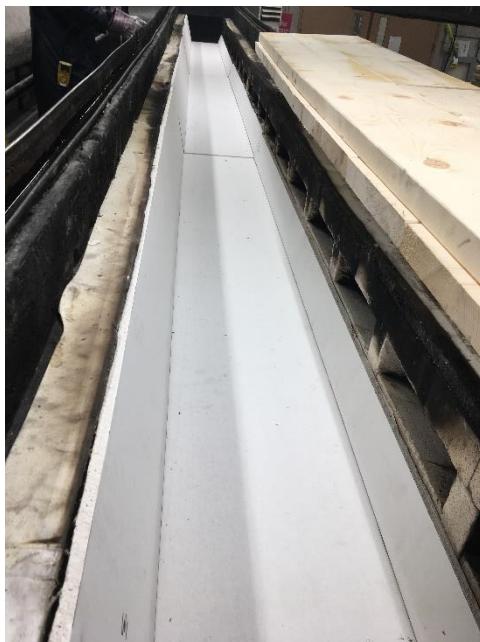
Figure 13. Construction of test 4

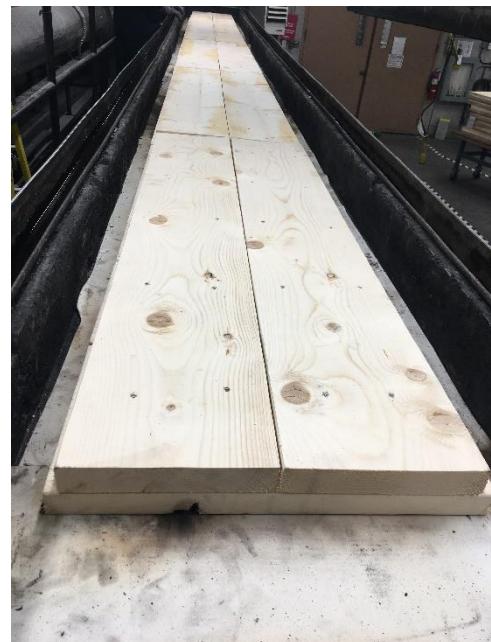
Figure 14. Mass timber installed test 4

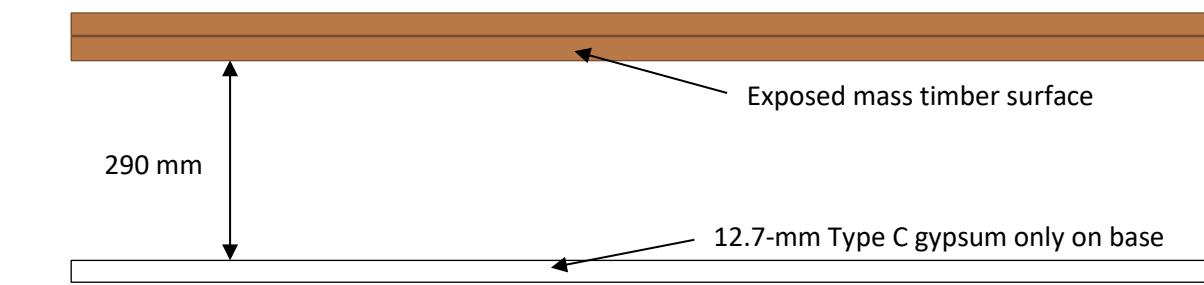
Test 5 was like test 4, except gypsum only lined the floor of the tunnel (not on the walls). This potentially represents more closely to what a construction of a concealed space might look like. The test setup is shown in Figure 15, and the test under construction is shown in Figure 16.

Figure 15. Test 5 setup. Mass timber surface with 12.7-mm Type C gypsum lining three sides of tunnel.

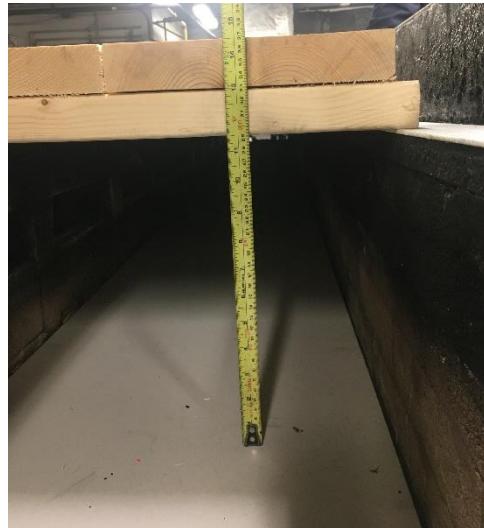
Figure 16. Test 5 construction

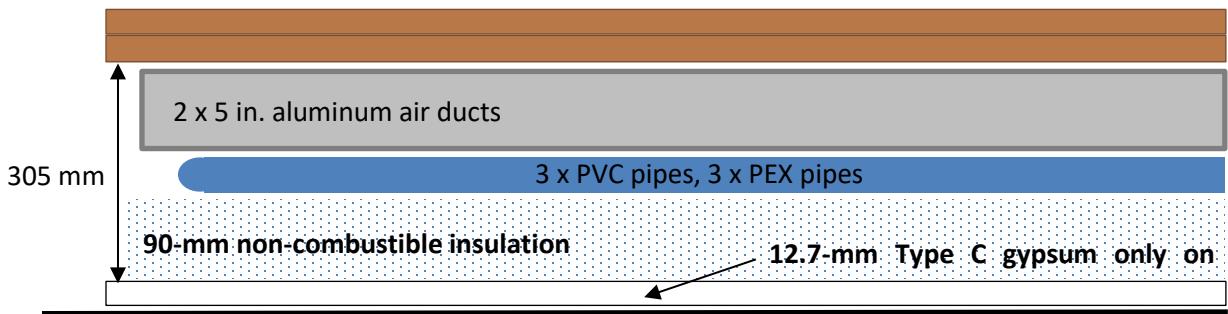
Test 6 was intended to recreate how a fire might spread in a concealed space that was filled with typical materials and services. The setup was the same as Test 5 with the addition of two 125-mm (5-in.) aluminum air ducts, three 38-mm (1-½ in.) PVC pipes (grey), three 12.7-mm (½-in.) PEX pipes (blue) and 90 mm (3 ½ in.) of noncombustible fiberglass insulation. Both the PVC and PEX pipes had FSRs of not more than 25 [12] [13]. The pipes were placed on the side of the tunnel away from the windows to allow for a clear view into the space. The ends of the pipes were stuffed with mineral wool insulation and then covered with foil tape to prevent flames from entering the pipes. The setup and configuration of the materials are shown in Figure 17 and Figure 18. The tunnel during installation is shown in Figure 19.

Figure 17. Test 6 setup. Mass timber surface with replicated services and gypsum on base.

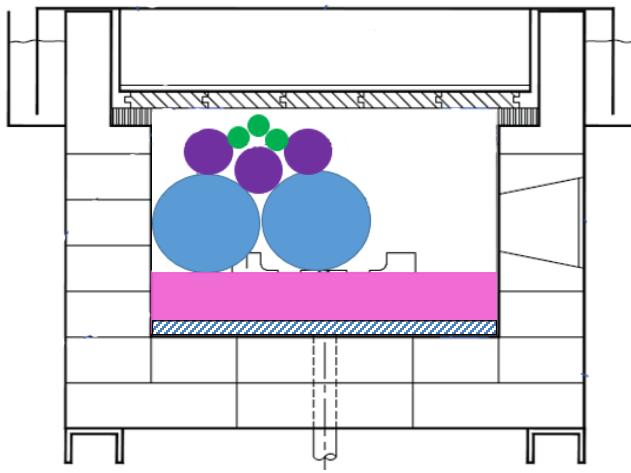
Figure 18. Test 6 layout of material in tunnel

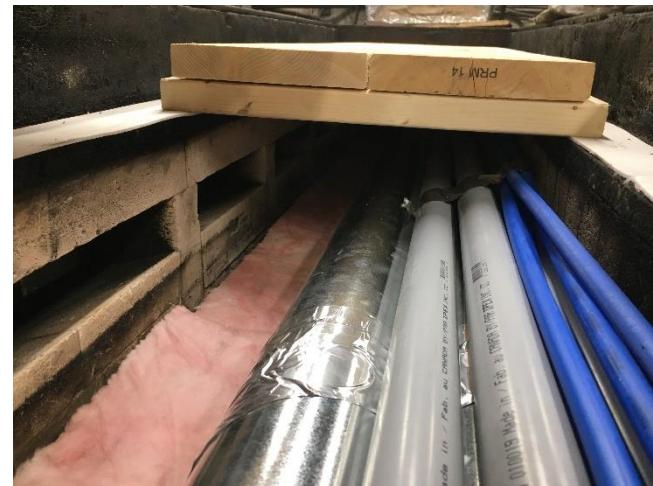
Figure 19. Test 6 test construction

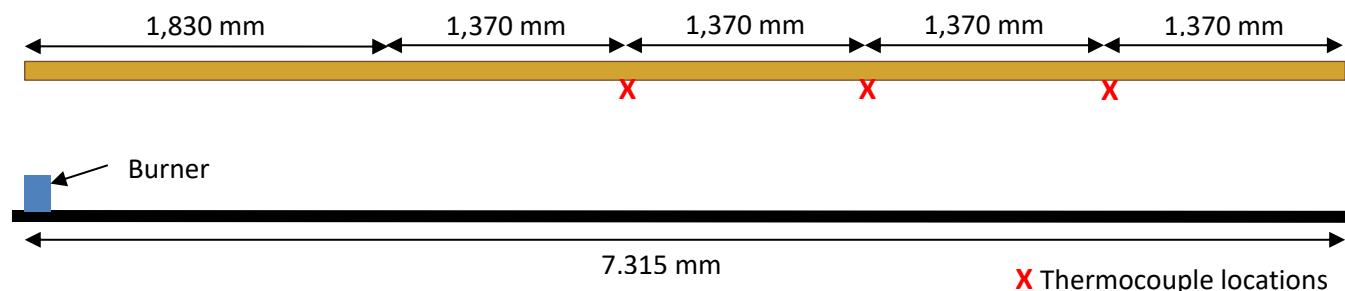
Additional thermocouples were added to the ceiling surface to evaluate temperatures along the length of the tunnel. Three thermocouples were installed at 3,200 mm (10 ½ ft.), 4,570 mm (15 ft.) and 5,940 mm (19 ½ ft.). The locations are shown in Figure 20. In Test 1 the thermocouples were on the ceiling tile surface; in the other tests the thermocouples were on the exposed wood surface. In test 3 thermocouples were installed on the bottom of joists closest to the measurement locations, which were closer to 3,200 mm (10 ½ ft.), 4,480 mm (14.7 ft.) and 6,096 mm (20 ft.).

The thermocouple wires ran along the tunnel along the unexposed side of the wood surface. The wires came out the end of the tunnel through the last window that was replaced with the metal plate that is used for anemometer readings. Any openings were covered with foil tape.

Figure 20. Test 6 layout of material in tunnel

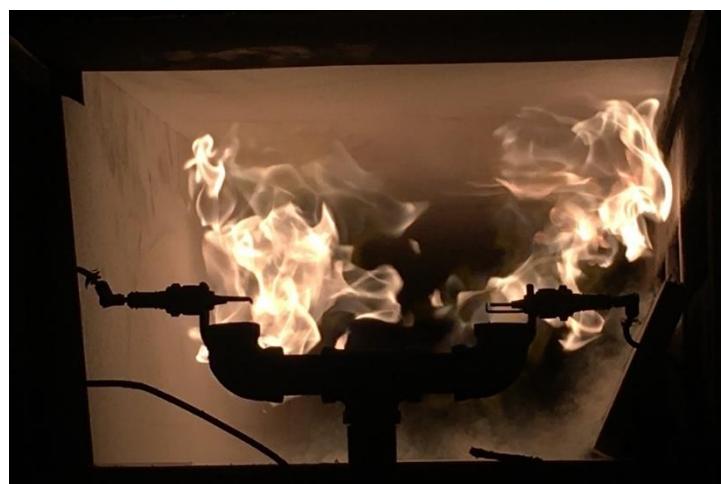
Test 1 was conducted on January 27, 2020. Before the test the average air flow in the tunnel was measured with an anemometer across three points to be 239 ft/min. Flames quickly moved down the tunnel within 2 minutes. Flames in the void at the beginning of the test are shown in Figure 21. It appeared as though the surface paper on the ceiling tiles burned quickly. The ceiling tiles along the walls and floor were cut, exposing their edges. During the test some ceiling tile paper delaminated. After 7 minutes the flames began to subside, receding to 4,875 mm (16 ft.) down the tunnel, then at about 9 minutes the flames were confined to the burner location for the remainder of the test. The test was run for an additional 20 minutes, for a total of 30 minutes. The calculated FSV was 192.

Figure 21. Test 1 at beginning of test

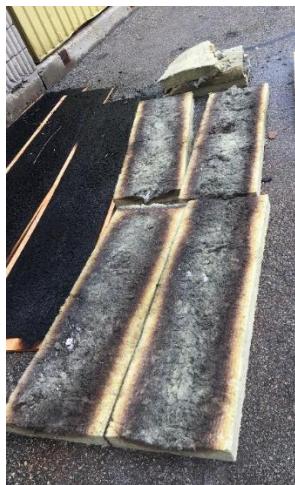
The top of the insulation, which was placed on the floor of the tunnel and was protected with ceiling tiles, charred, shown in Figure 22; the plywood surface can also be seen on the left of the figure.

Figure 22. Test 2 insulation and plywood after the test

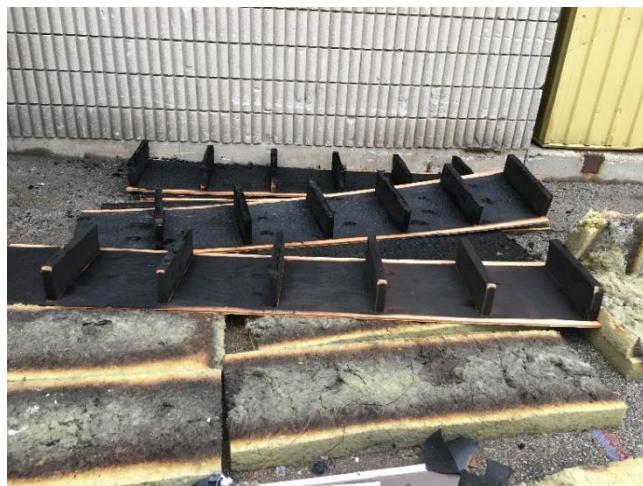
At the beginning of the test, the first joist (at 450 mm (1.5 ft.) down the tunnel) caused additional turbulence in the flames. Once the plywood surface ignited, fire moved down the tunnel. The flames advanced more slowly than in tests 1 and 2. The final reading for the test was at 5,638 mm (18.5 ft.) because that was the location of the last visible joist; flames did not progress from the base of the joist to the plywood surface at the end of the tunnel,

it was only the base of the joists that was burning. The charred wood assemblies after the test are shown in Figure 23.

Figure 23. Test 3 wood assembly after the test

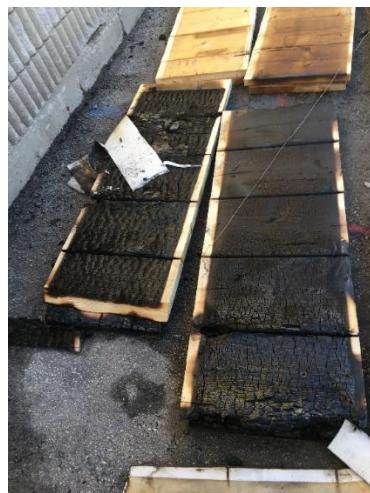
Test 5 was conducted on January 29, 2020. The average air flow in the tunnel measured at three locations was 234 ft/min, within the standard range. The construction of test 5 was similar to test 4, except there was no Type X gypsum board included along the walls. This assembly performed better than test 4, with a lower maximum flame distance of 2,285 mm (7.5 ft.); flames did not reach the end of the tunnel. The flames slowly increased to a maximum distance of 2,285 mm (7.5 ft.), but then decreased back down to 457 mm (1.5 ft.), then increasing again to 1,065 mm (3.5 ft.) 10 minutes into the test. The flame front then stayed in the 760-mm (2.5-ft.) to 1,370-mm (4.5-ft.) range for the remainder of the test. The calculated FSV was calculated to be 29. The condition of the mass timber board after the test at different locations along the tunnel are shown in Figure 24 and Figure 25. The wood charred close to the burners but only lightly charred or had smoke staining near the end of the tunnel. The gypsum board paper also appeared lightly charred up to 915 mm (3 ft.) down the tunnel.

Figure 24. Test 5 wood panels after the test (near burner)

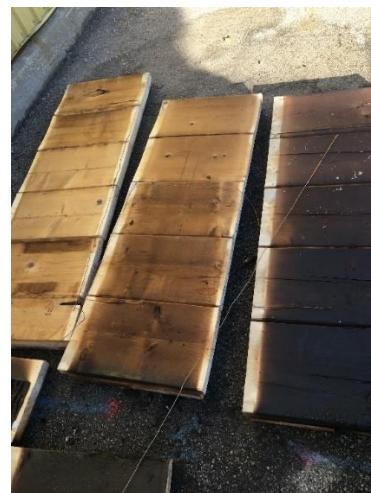
Figure 25. Test 5 wood panels after test (from end of tunnel)

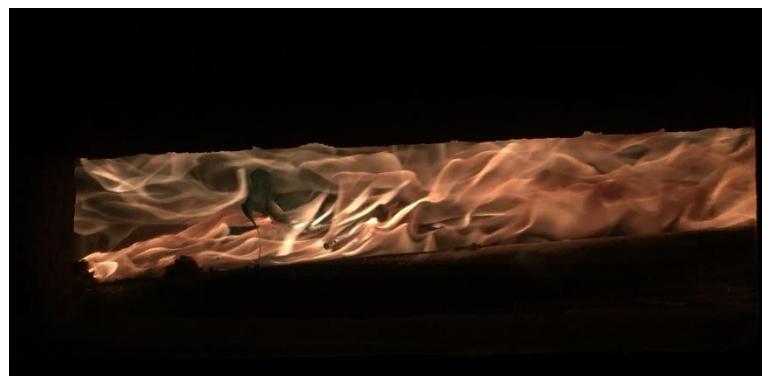
Ignition was the fastest in test 6 out of all the tests, at 28 seconds, and flames quickly reached the end of the tunnel within 2 minutes. It appeared as though the PVC and PEX pipes began burning first, but it was difficult to discern what was actually burning. Once the pipes ignited, they began to melt. The pipes burning and melting near the beginning of the tunnel are shown in Figure 26. The PEX can PVC pipes were placed above the aluminum air duct, although orientation in the field could be either way.

PVC is combustible in accordance with CAN/ULC-S135 [14] and has a low flame spread rating but a high SDC; the products used had a rating of not more than 25. PEX piping is also combustible. Having the combustible material placed so close to the mass timber surface likely resulted in reradiation between the two surfaces leading to faster flame spread down the tunnel.

Figure 26. Test 6 combustible piping material burning in the tunnel

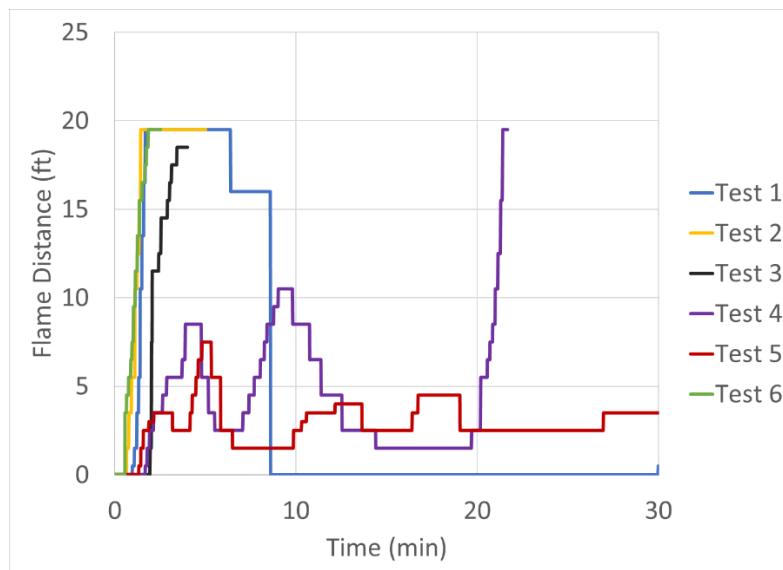
A summary of the results from the tests is presented in Table 3. A graph of the flame spread distance for the tests is shown in Figure 27. The FSV is calculated using the total area under the flame spread time-distance curve, as per CAN/ULC-S012 for 10 minutes [4]. Any flame front recession is ignored, so the maximum point that the flame front reached is used for the remainder of the test. FSR is calculated as the average of three FSV values, rounded to the nearest multiple of 5. Each assembly design was unique, having different exposed surfaces, material configurations and varying degrees of protection along the walls and/or floor. It is difficult to determine what the quantitative effect of these different paraments had on the calculated FSV values.

Figure 27. Flame distance along tunnel

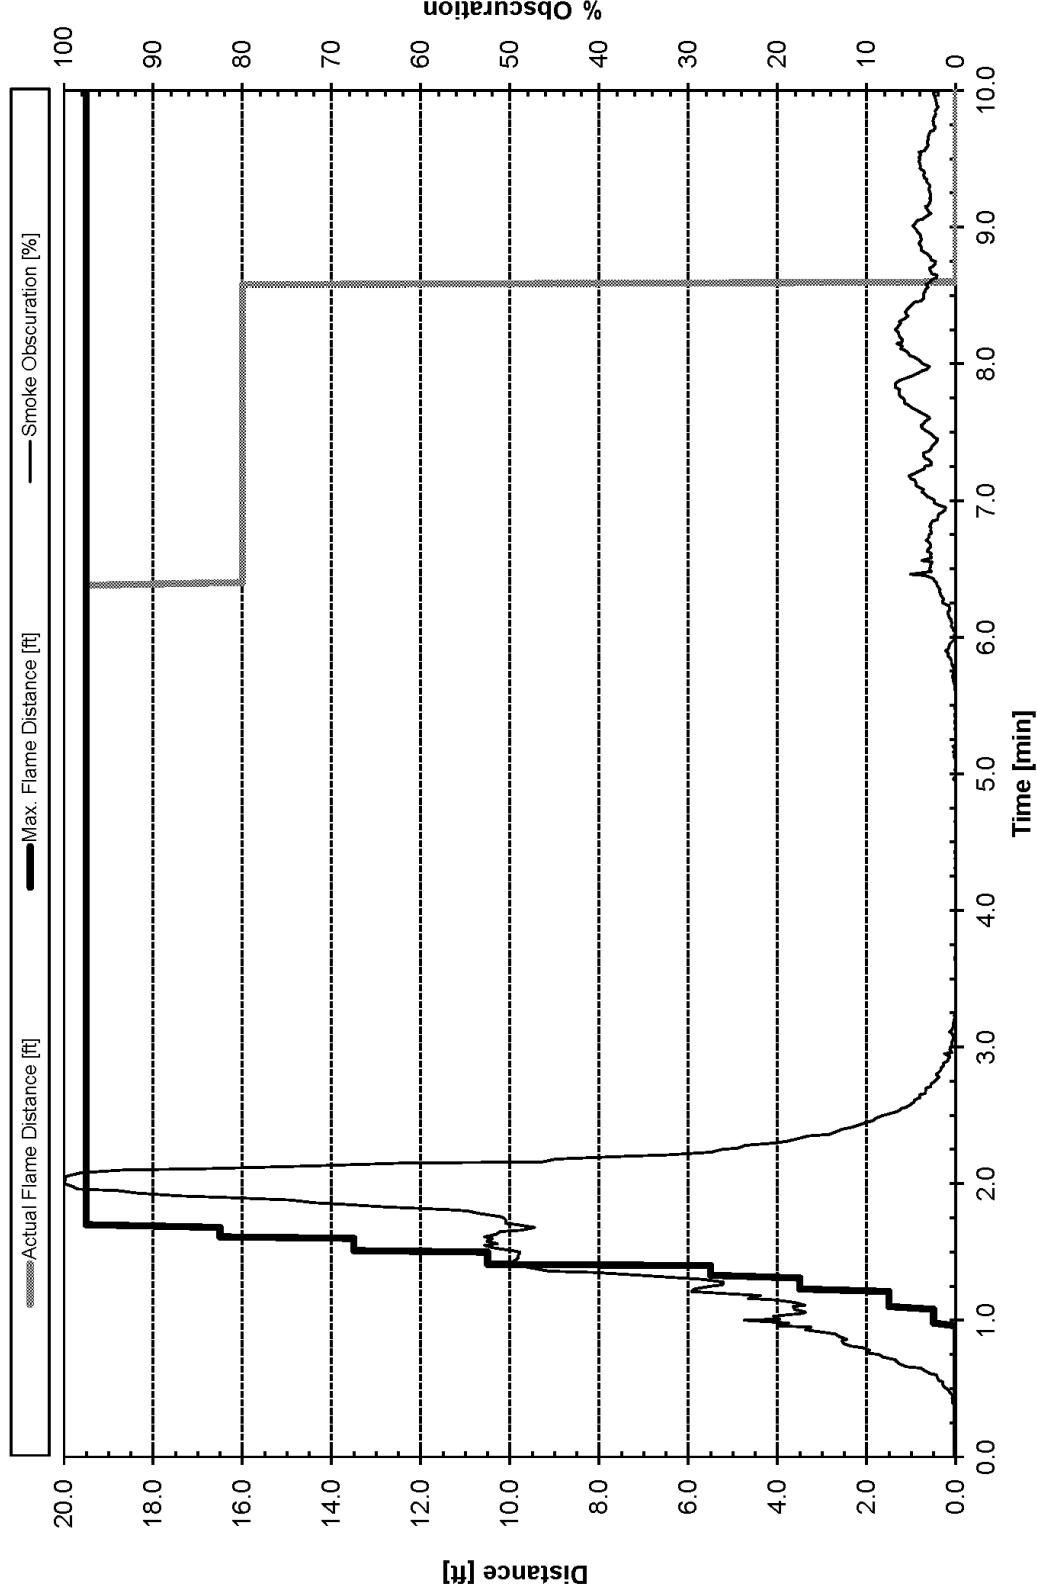
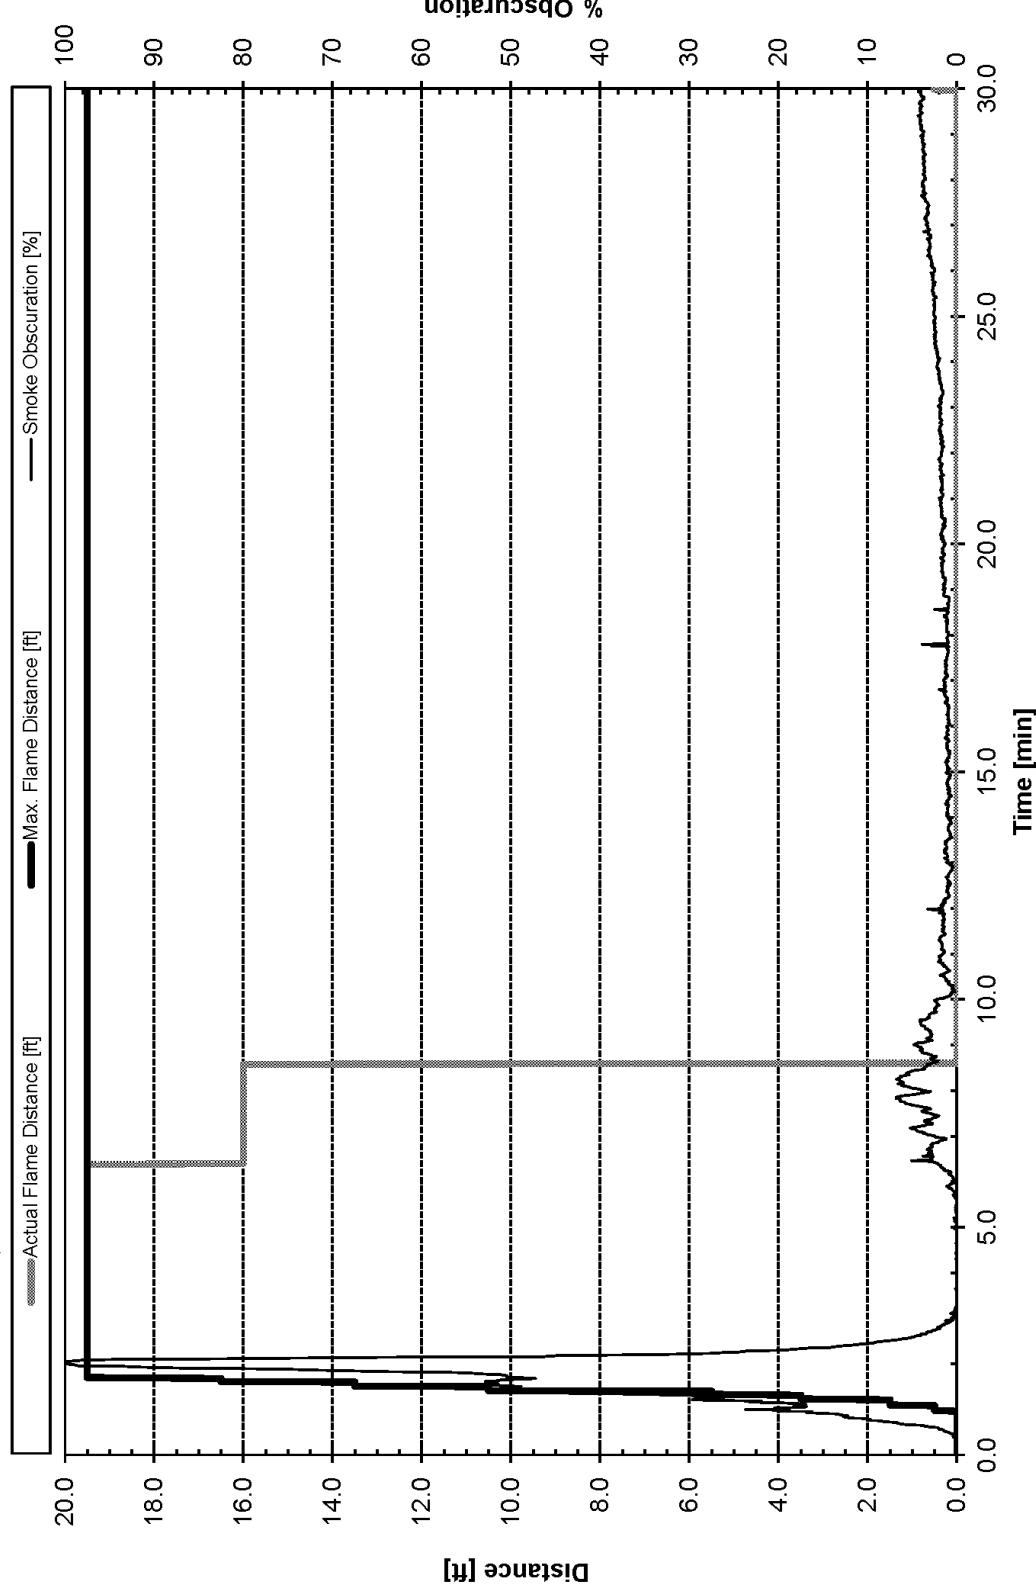
SURFACE BURNING CHARACTERISTICS
FP INNOVATIONS
Floor Void Assembly 1

Test #1: FSV = 192.0; SDV = 59.7

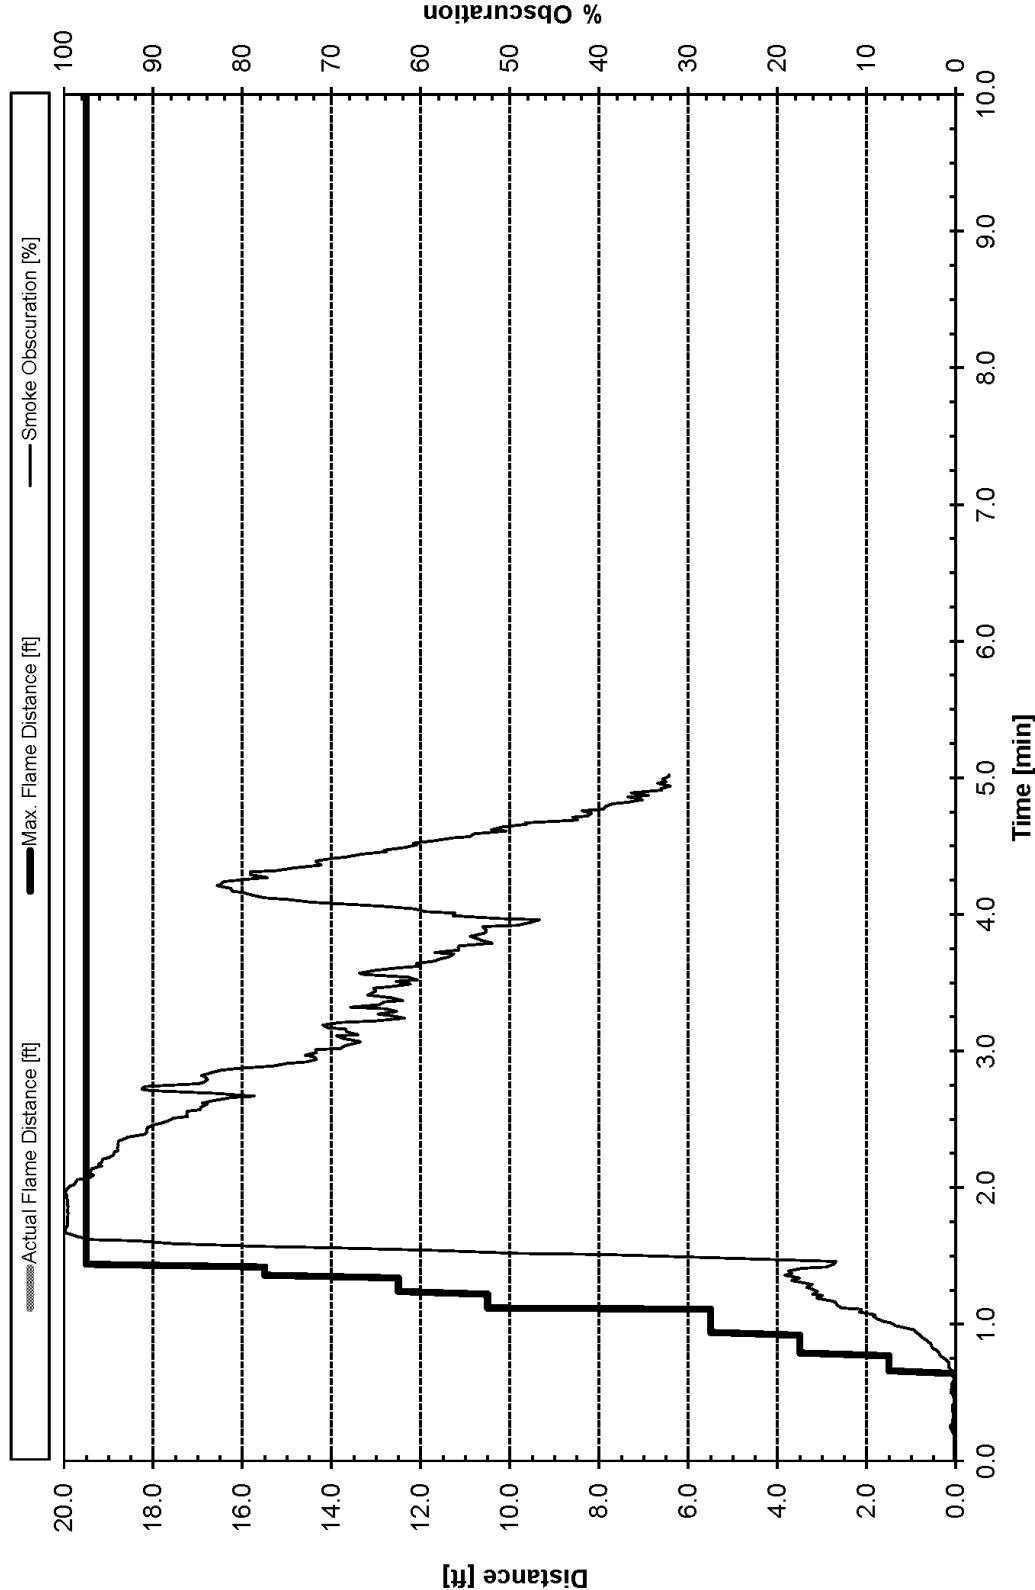
SURFACE BURNING CHARACTERISTICS
FP INNOVATIONS
Floor void assembly 2

Test #2: FSV = 243.7; SDV = 285.4

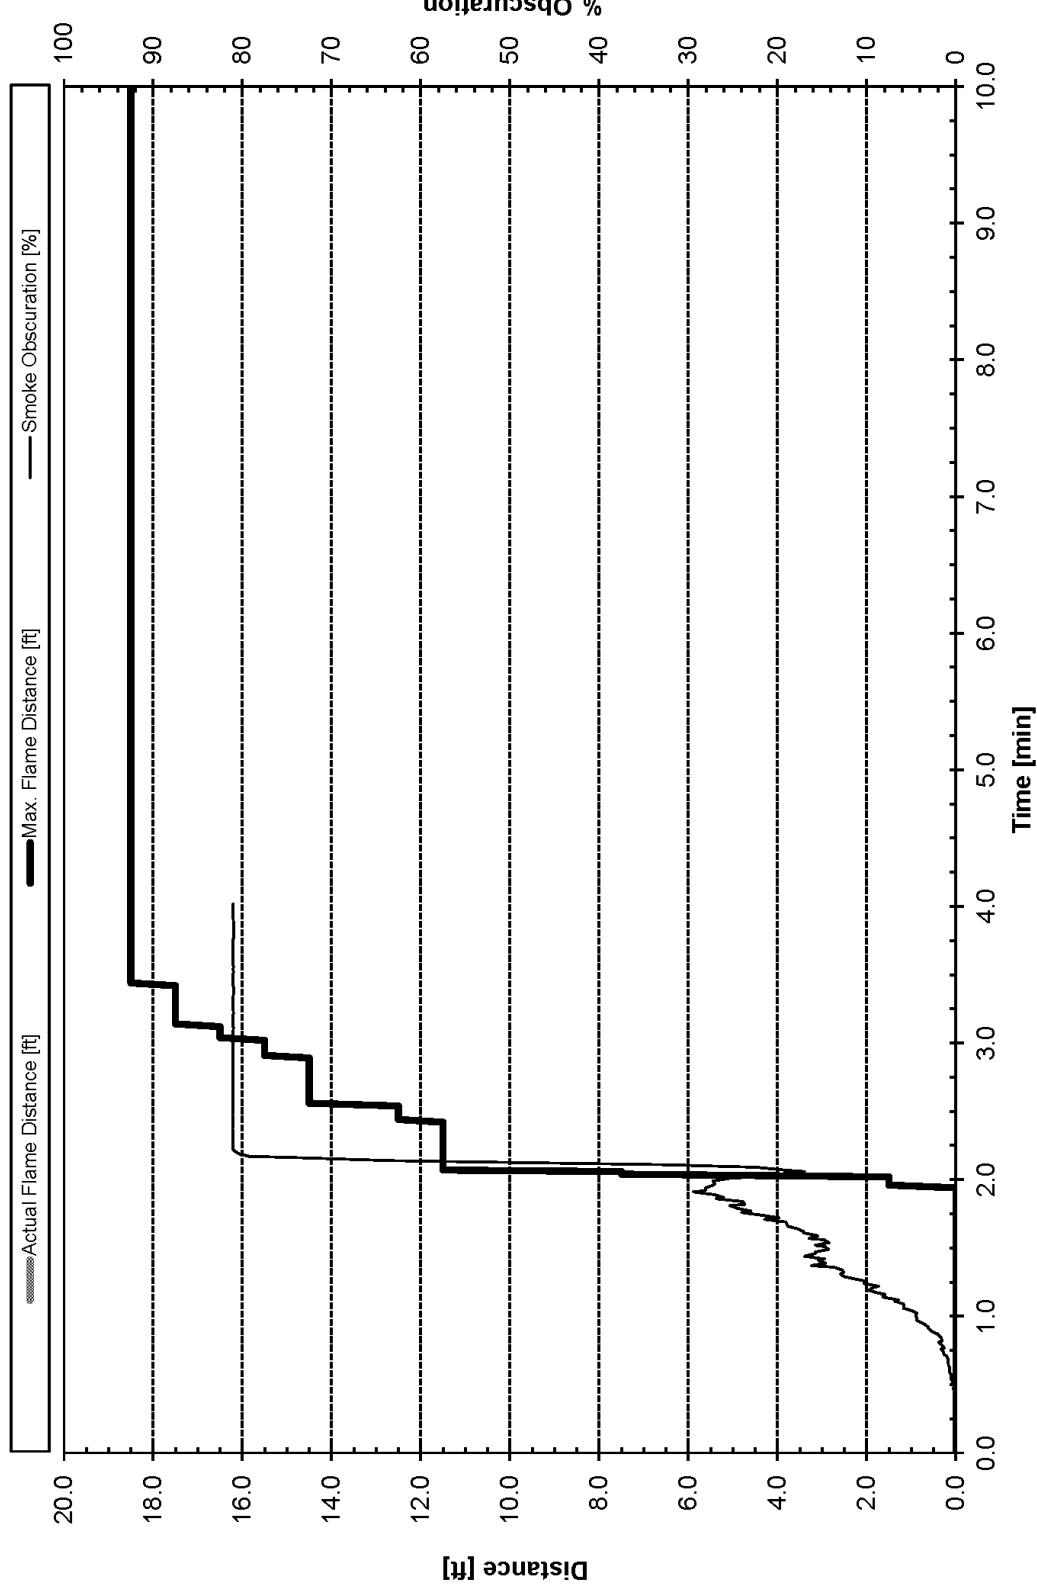
SURFACE BURNING CHARACTERISTICS
FP INNOVATIONS
Floor void assembly 3

Test #3: FSV = 101.0; SDV = 443.7

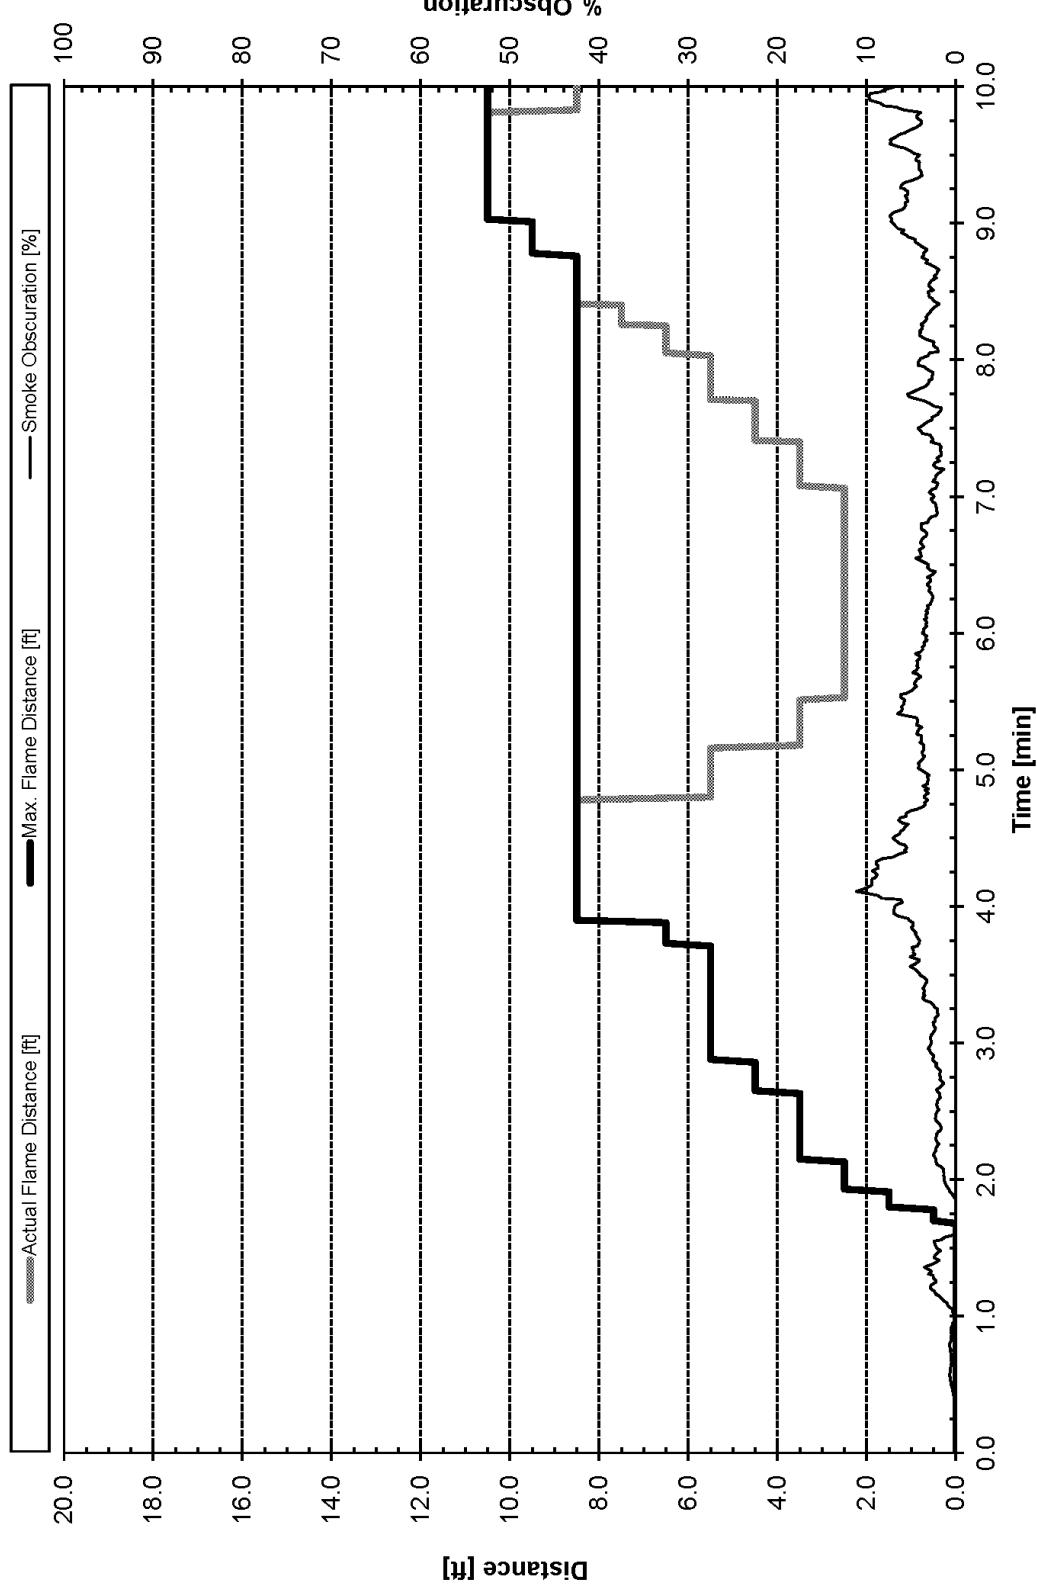
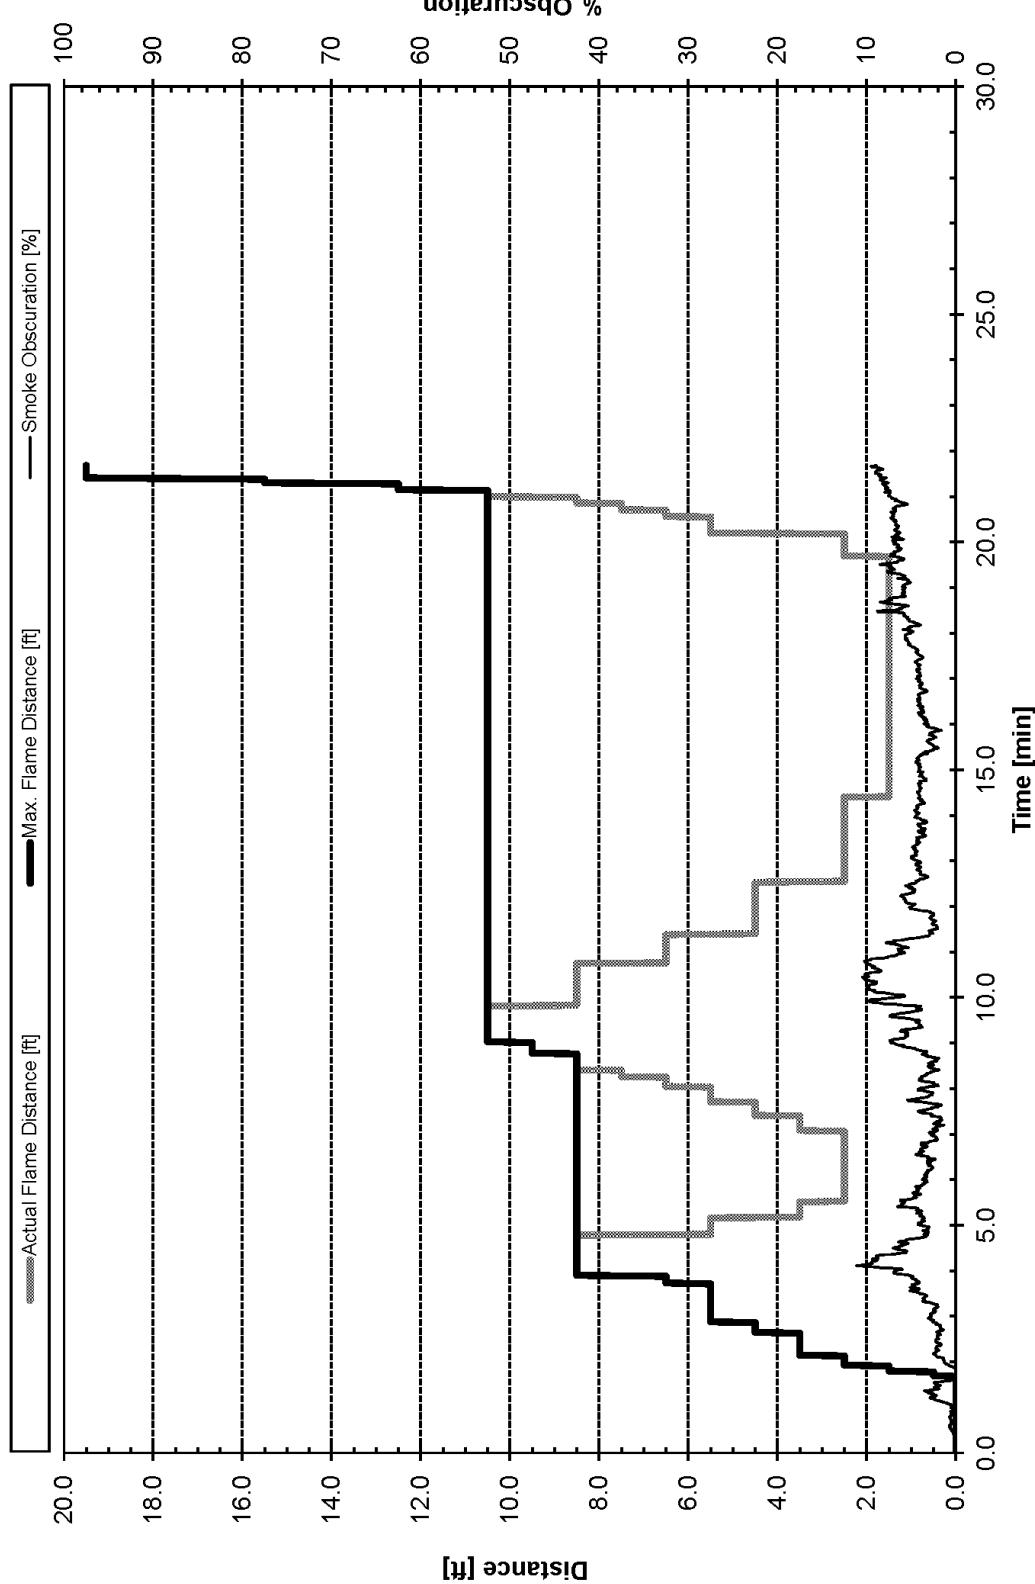
SURFACE BURNING CHARACTERISTICS
FP INNOVATIONS
Floor void assembly 4

Test #4: FSV = 35.8; SDV = 22.6
