FLAME SPREAD IN CONCEALED MASS TIMBER SPACES

REPORT TO FORESTRY INNOVATION INVESTMENT LTD.

March 31, 2020
PROJECT NO 301013624 – Floor Voids

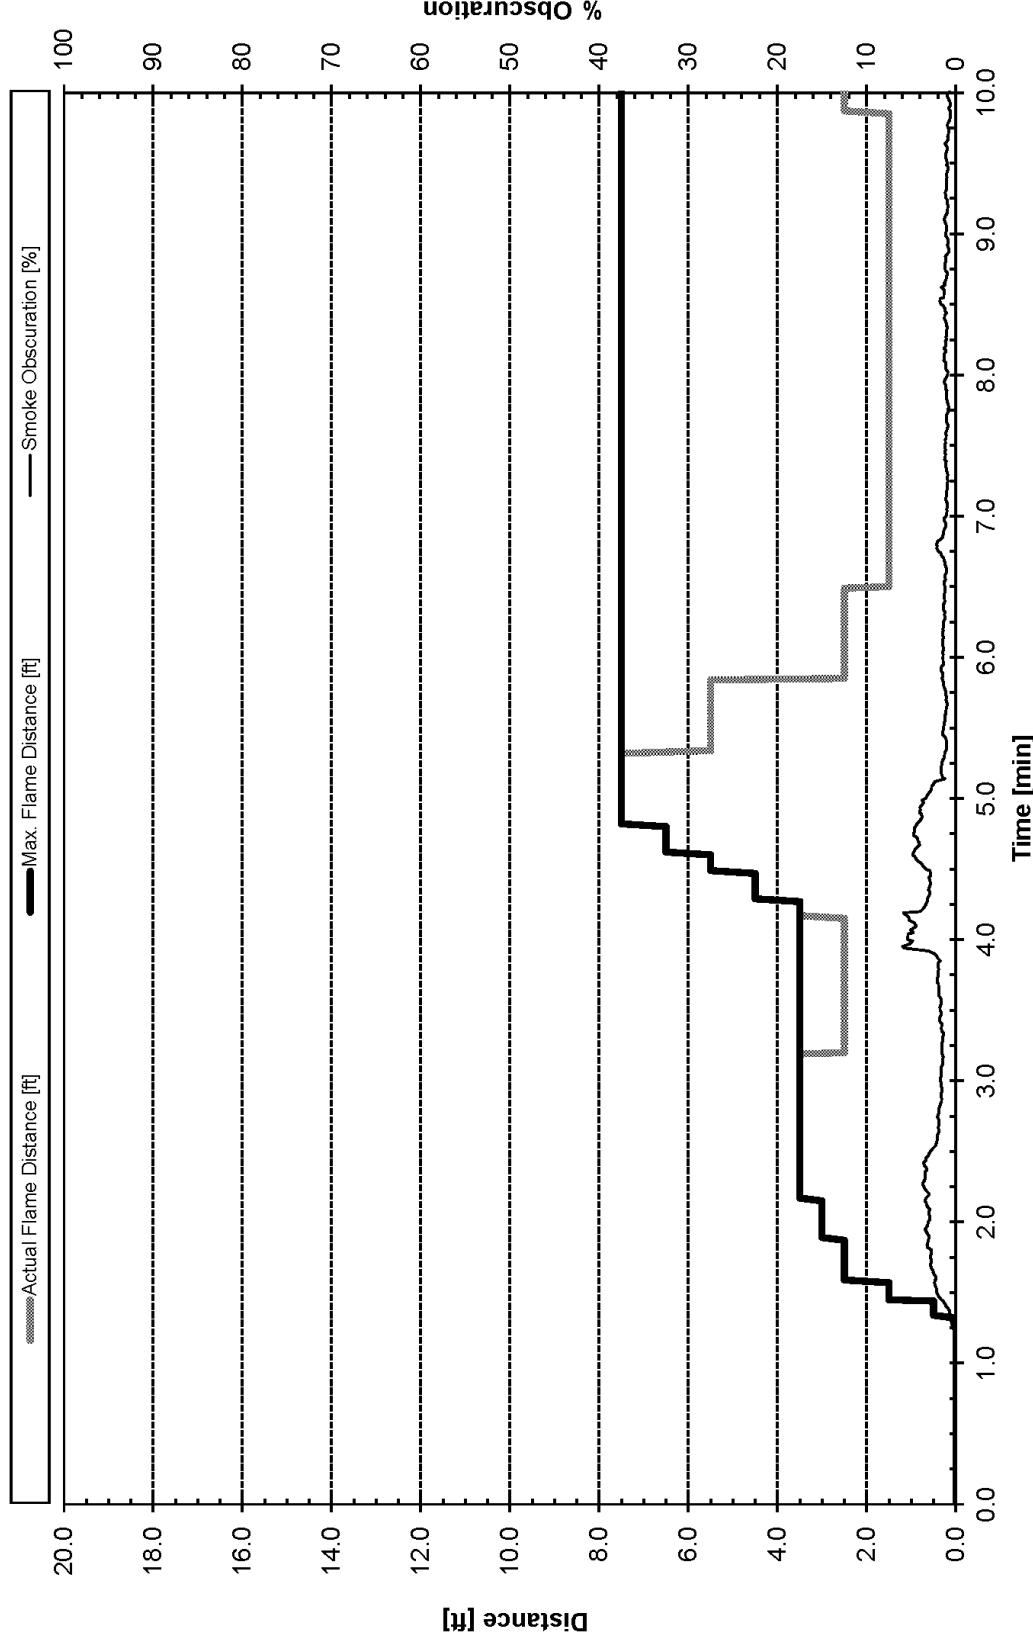
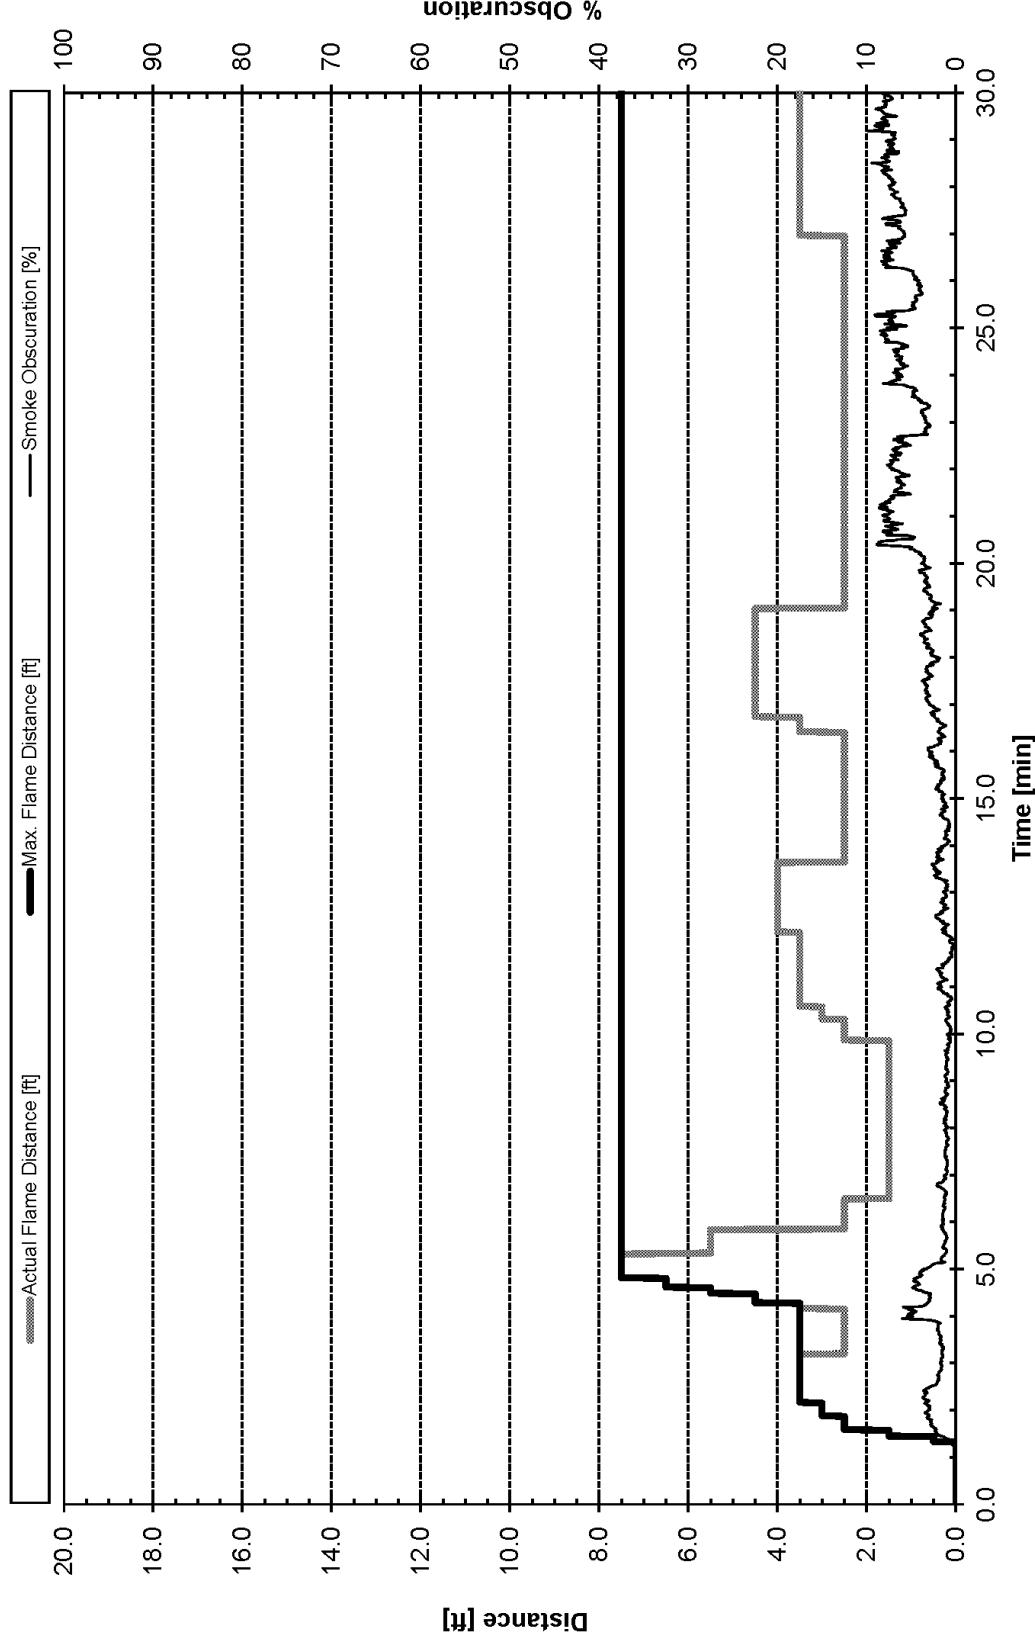
SURFACE BURNING CHARACTERISTICS
FP INNOVATIONS
Floor void assembly 5

Test #5: FSV = 28.8; SDV = 11.1

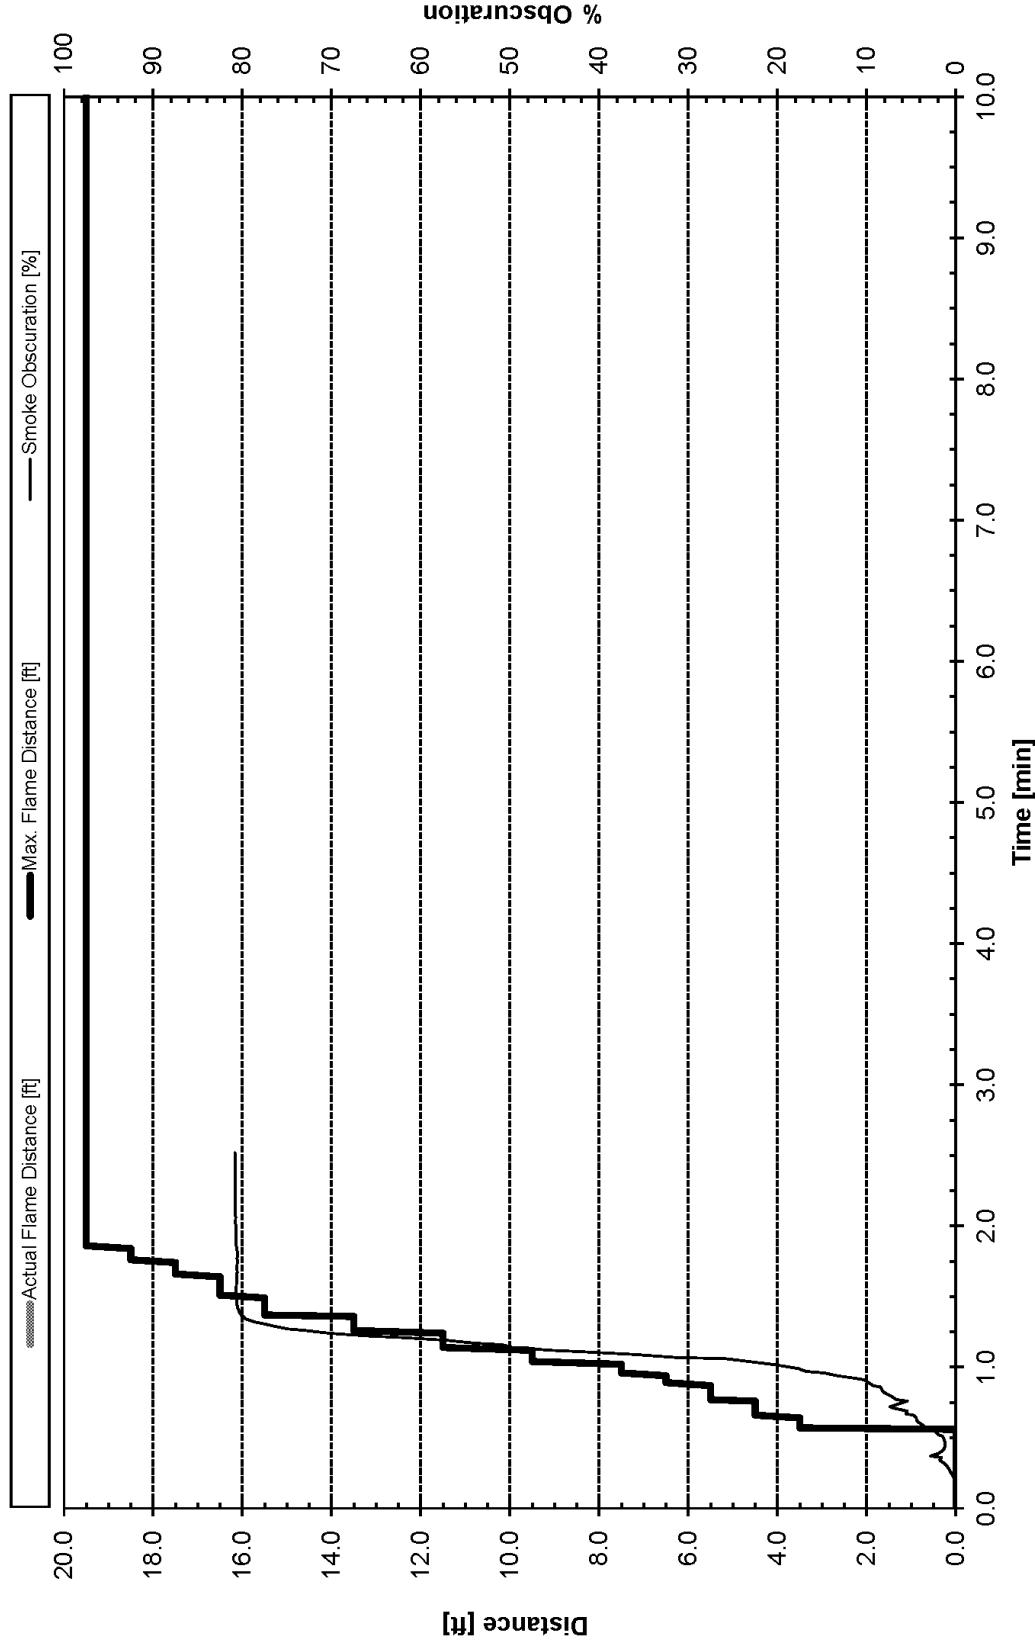
SURFACE BURNING CHARACTERISTICS
FP INNOVATIONS
Floor void assembly 6

Test #6: FSV = 251.4; SDV = 486.9
