EVALUATING FIRE PERFORMANCE OF NAIL-LAMINATED TIMBER: INFLUENCE OF GAPS

March 31, 2019

Client: Forestry Innovation Investment Ltd.

PROJECT NO. 301013024

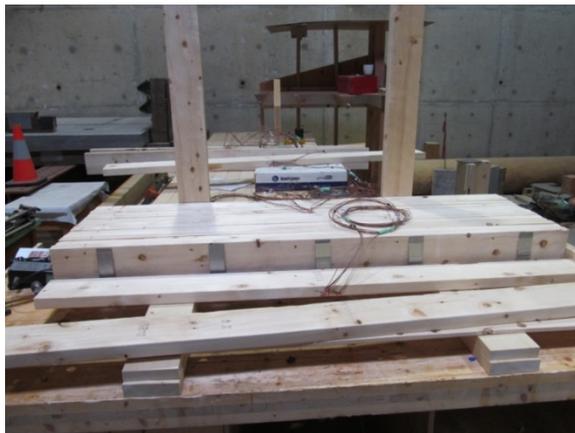
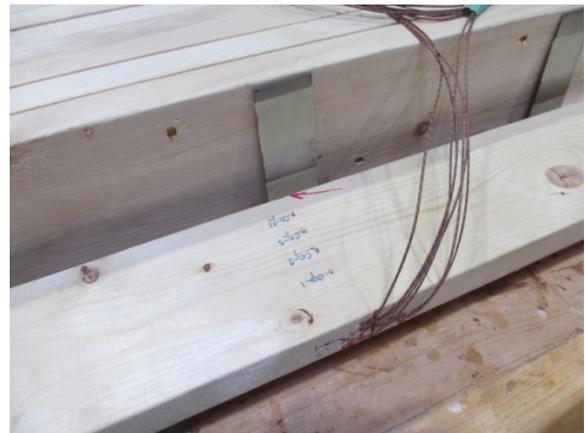
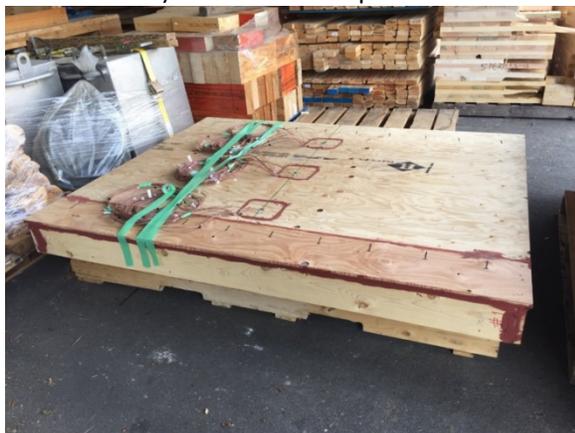
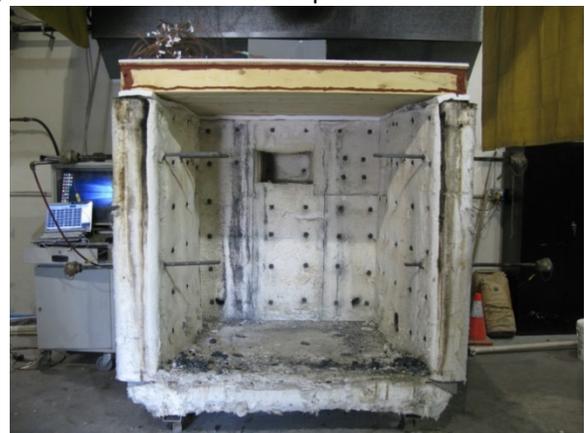
a) installation of spacers

b) installation of thermocouples on outside of boards

c) completed assembly

d) assembly on furnace before test

Figure 3. Construction of Test 1 assembly

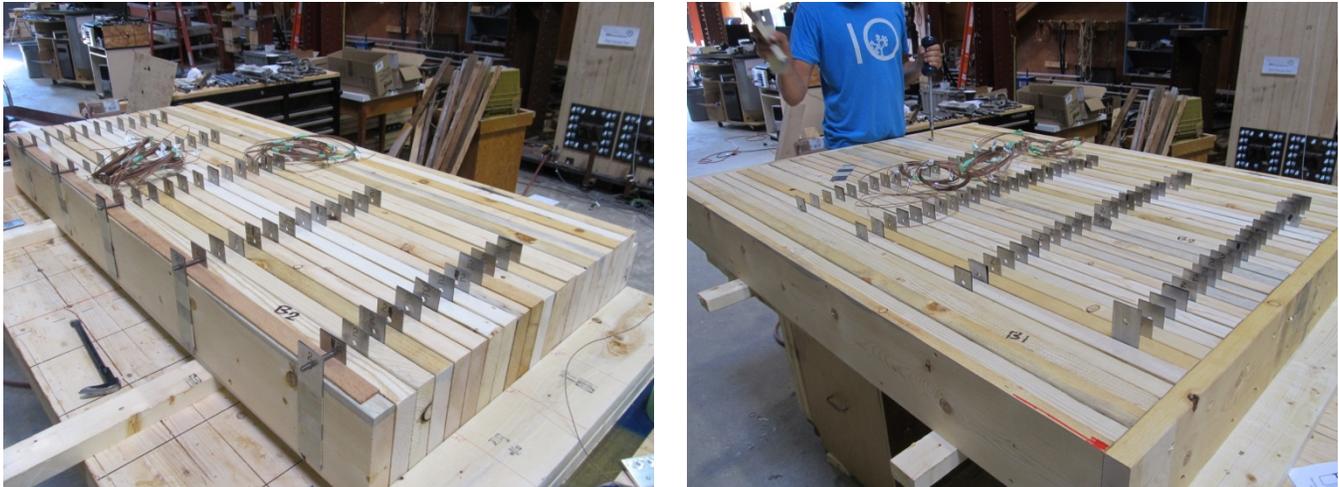
a) b)
Figure 7. Construction on Test 2 assembly. Installation of spacers

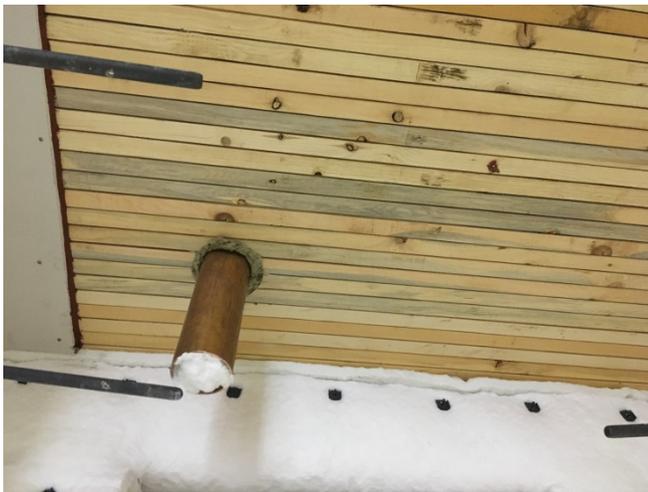
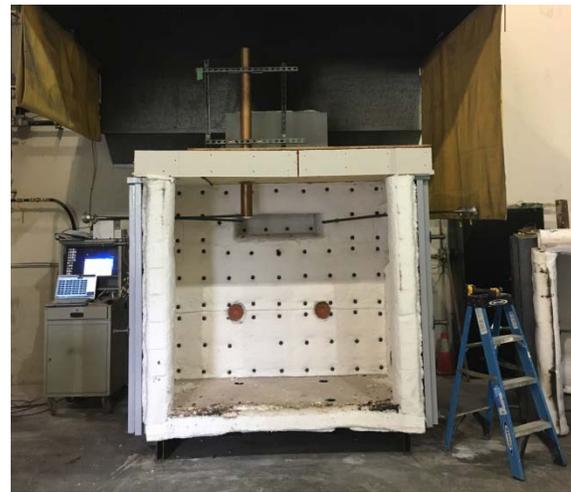
a) penetration through NLT

b) assembly installed on furnace

Figure 10. Test 2 assembly in furnace

A nominal 100 mm (4 in.) Type L copper pipe was installed in a 155 mm (6 in.) diameter hole with a 12.7 mm (½ in.) offset. The hole was centred between 4 boards. The annular space was packed with mineral wool until flush with top and bottom faces of the NLT. The annular space above the mineral wool was filled with firestop sealant until flush with the top of the plywood (12.7 mm depth). The penetration details are shown in Figure 9, images of the completed assembly are shown in Figure 10.

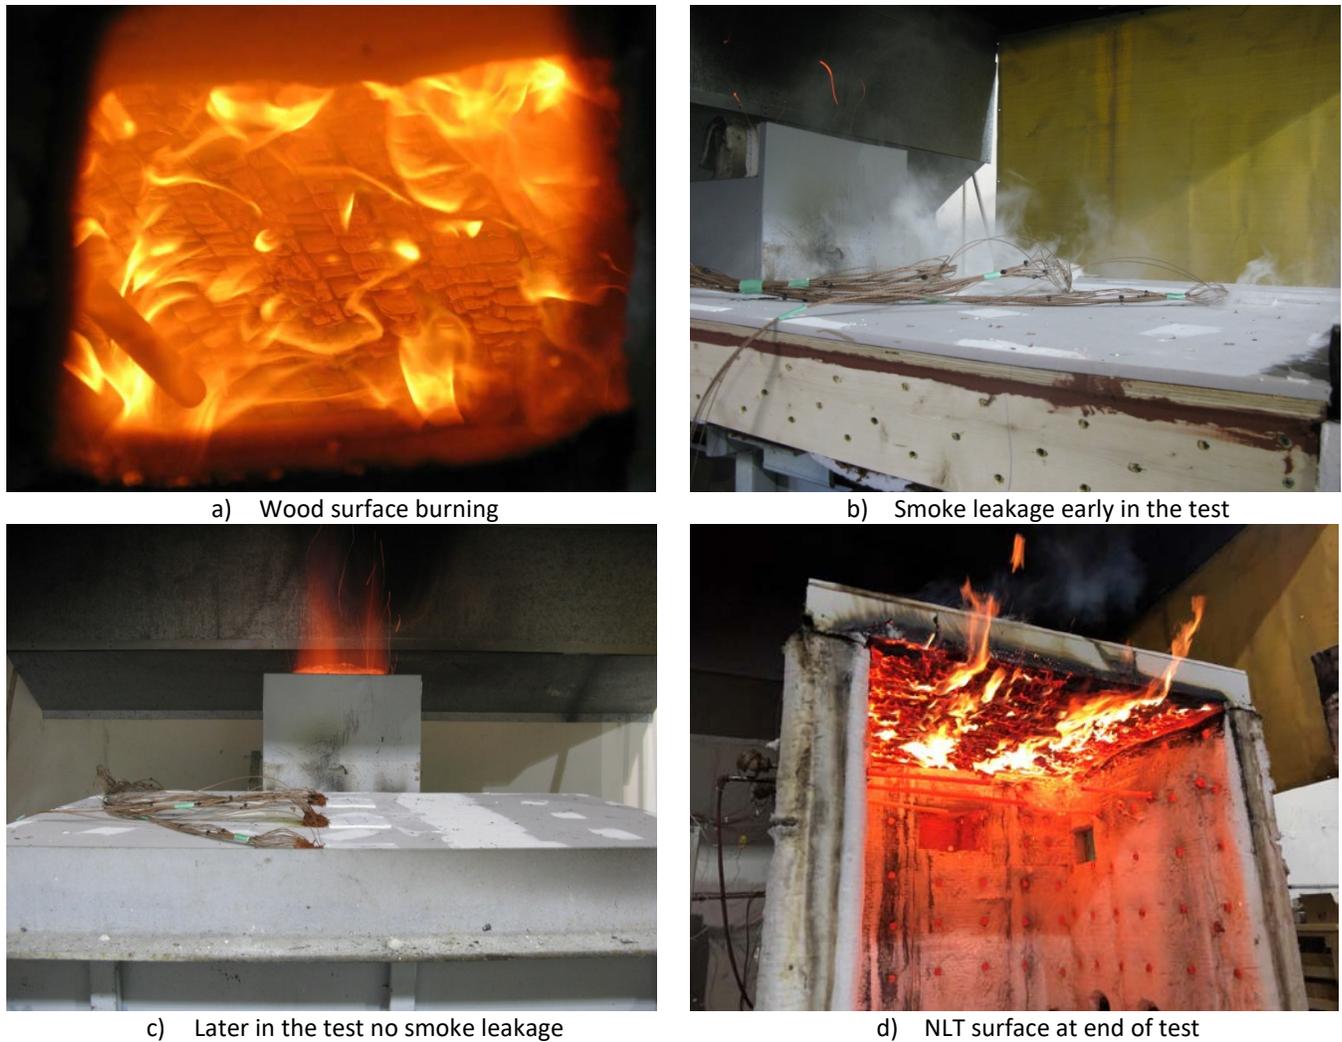
Figure 11. Images during testing

The 2x6 NLT panel with 1 mm, 2 mm, and 4 mm gaps was tested on June 5, 2018. Moisture content readings averaged 8.5% across the sample. The test report from QAI Laboratories can be found in Appendix I. The assembly was exposed to a standard fire for 1 h 30 min. There was some smoke leakage through the assembly in the beginning of the test, but it was mostly confined to where thermocouple wires exited the assembly, images during the test can be found in Figure 11. Once firestop sealant was added at these locations smoke leakage subsided.

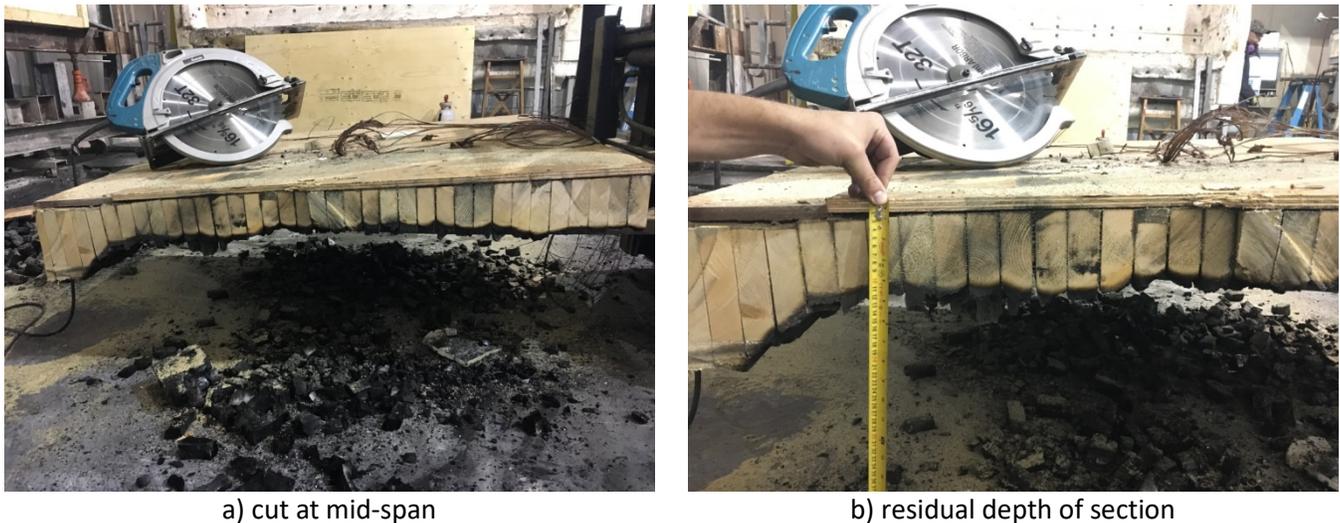
After the test a cross-section was cut to evaluate the depth of charring. The residual depth of the section varied between 85 to 100 mm, due to corner rounding. This roughly translates to a charring rate of 0.70 mm/min, not including corner rounding.

Figure 18. Residual depth, Test 2

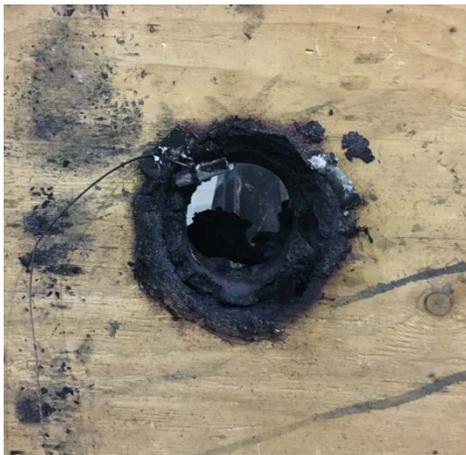
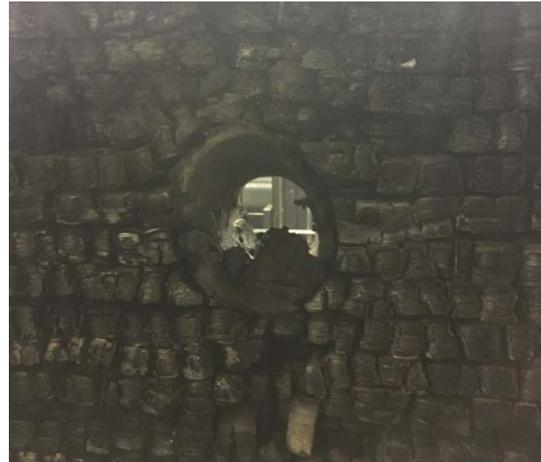
a) unexposed side

b) exposed side

Figure 20. Condition of firestop after Test 2

The copper penetration was instrumented with thermocouples to determine its firestop rating. The firestop remained in the opening during the test without permitting the passage of flames to the unexposed side, indicating that a 2 h F-rating was achieved. Temperatures at FS 1 exceeded 181°C, therefore the firestop did not achieve a T-rating. The temperature profiles for thermocouples on the firestop are shown in Figure 19. The condition of the opening and firestop after the test are shown in Figure 20. From the unexposed side, it was evident that the firestop had charred, but charring did not progress to the surrounding wood.

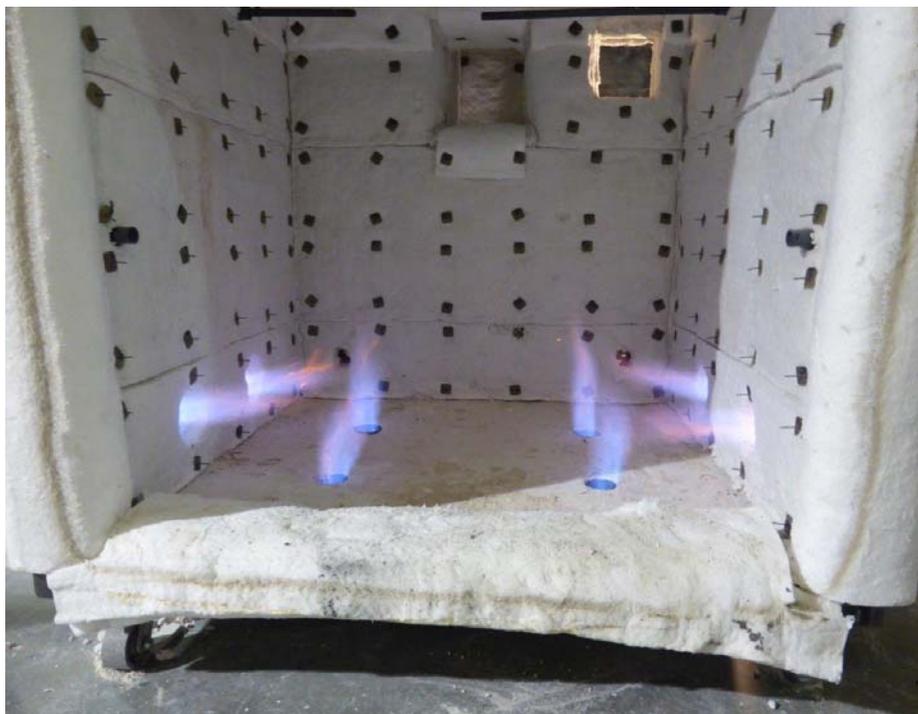
The furnace used in the tests is a pilot-scale fire burning apparatus with interior dimensions of 60 in. in height, 60 in. in width, and 52 in. in depth.

Figure 1: Burners Fired in the Furnace

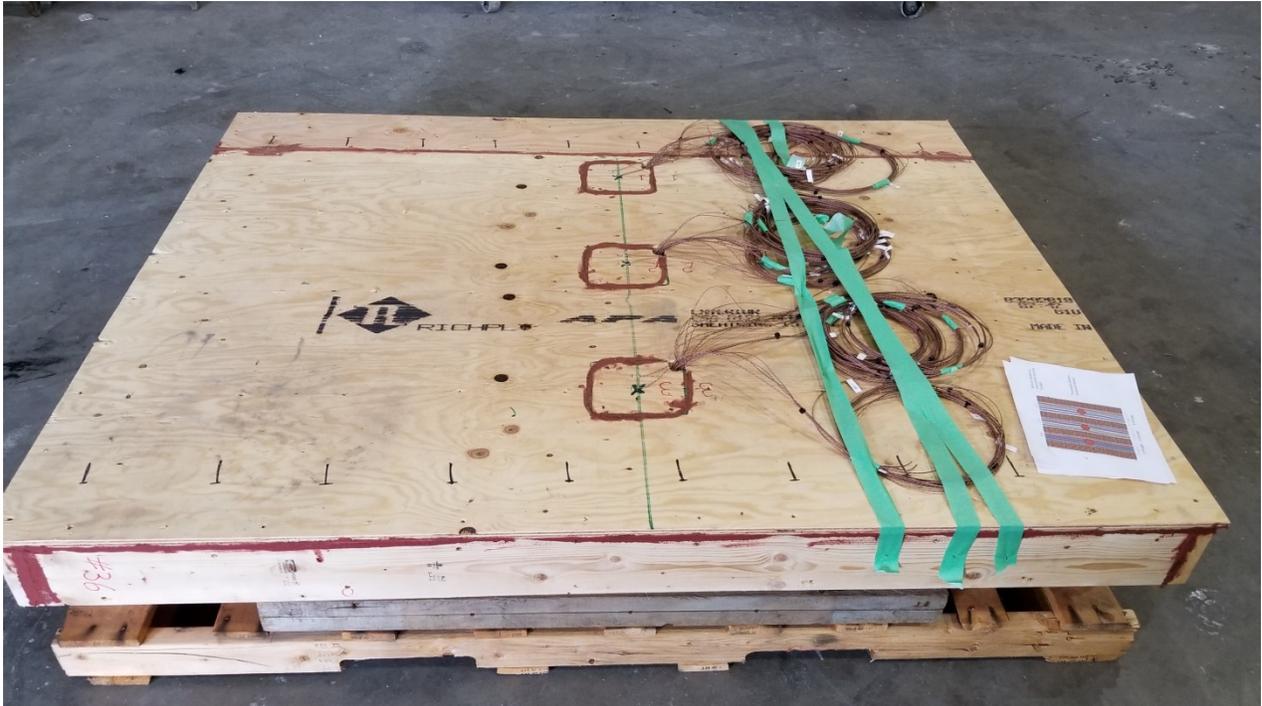
Figure 9: The unexposed side of the assembly prior to the gypsum being installed.

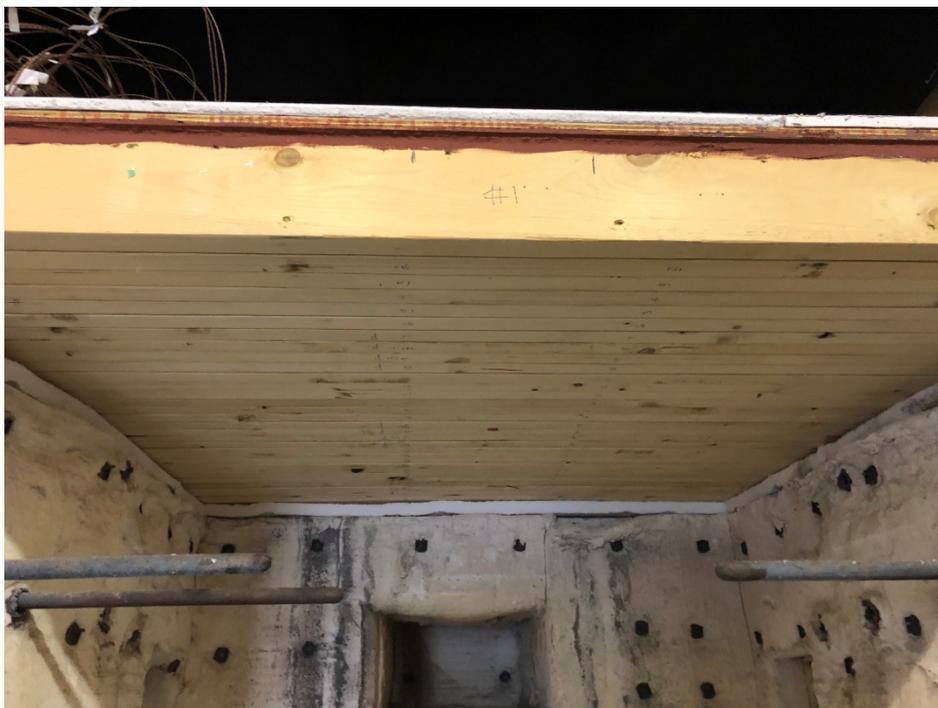
Figure 10: The exposed side of the assembly prior to the fire test.

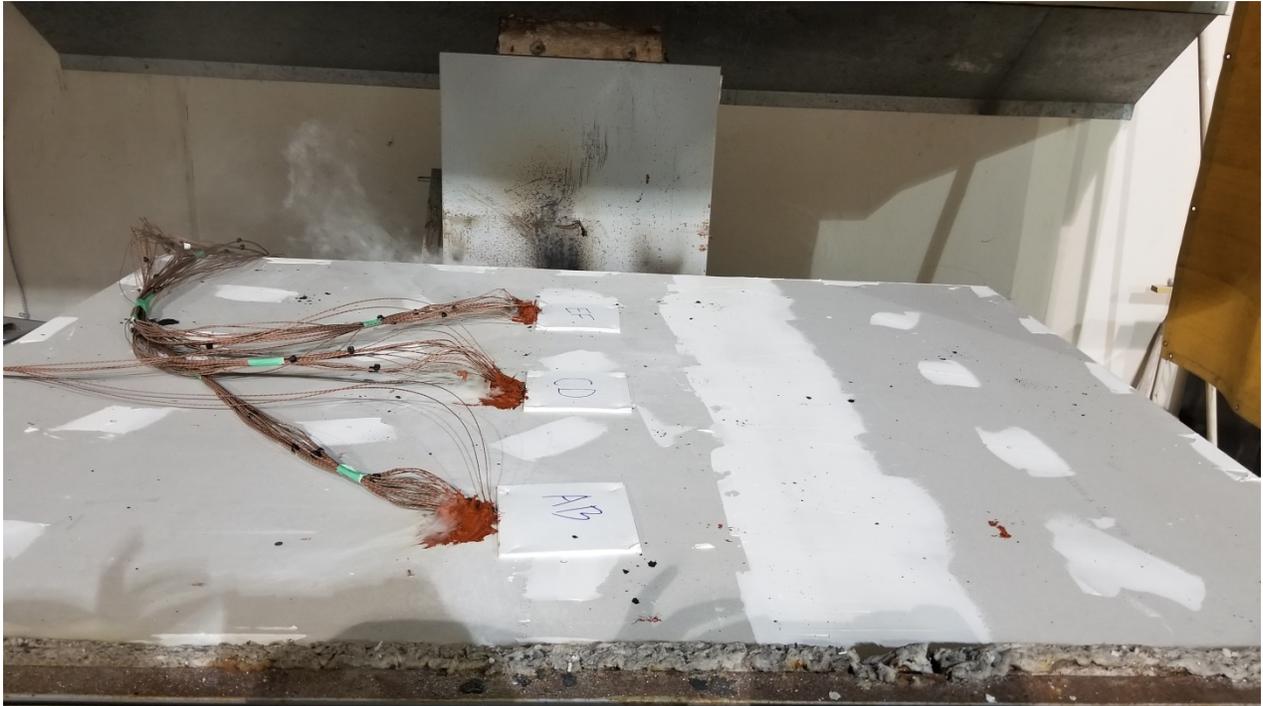
Figure 11: The unexposed side of the assembly during the fire test.

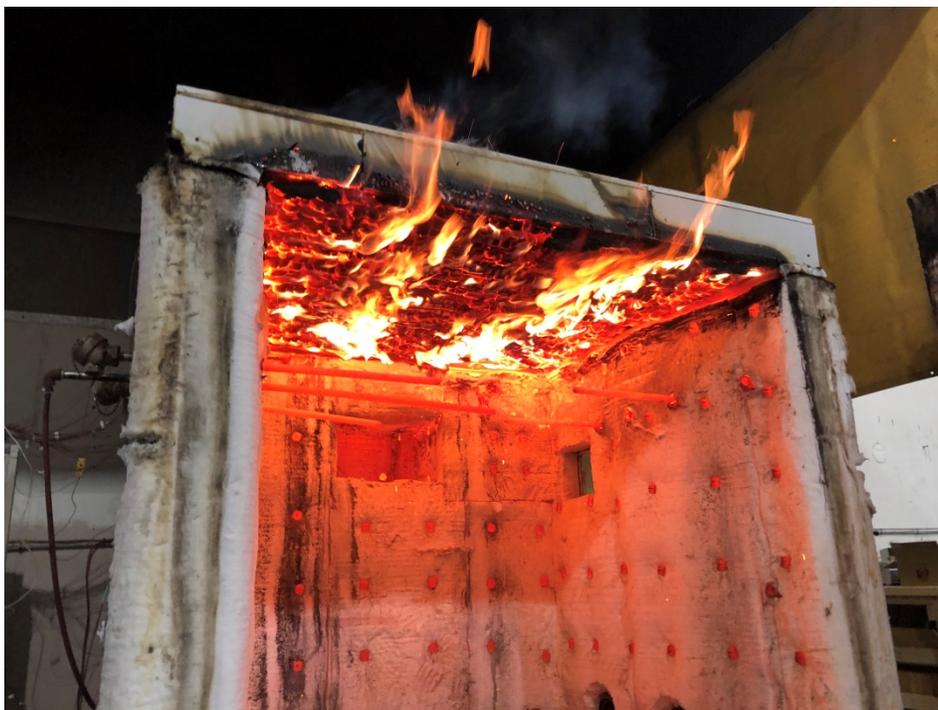
Figure 12: The exposed side of the assembly after the fire test.

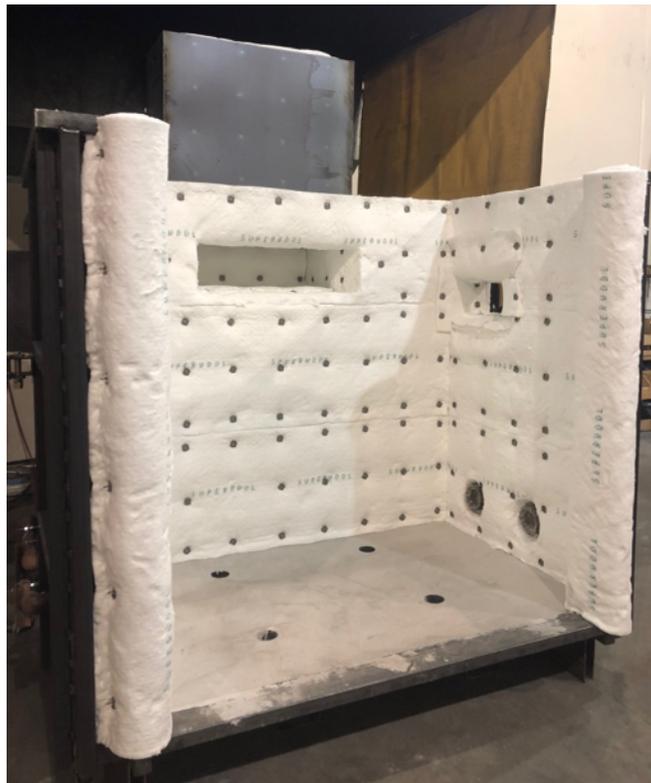
The furnace used in the tests is a pilot-scale fire burning apparatus with interior dimensions of 70 in. in height, 75 in. in width, and 52 in. in depth.

Figure 1: Pilot-Scale Furnace

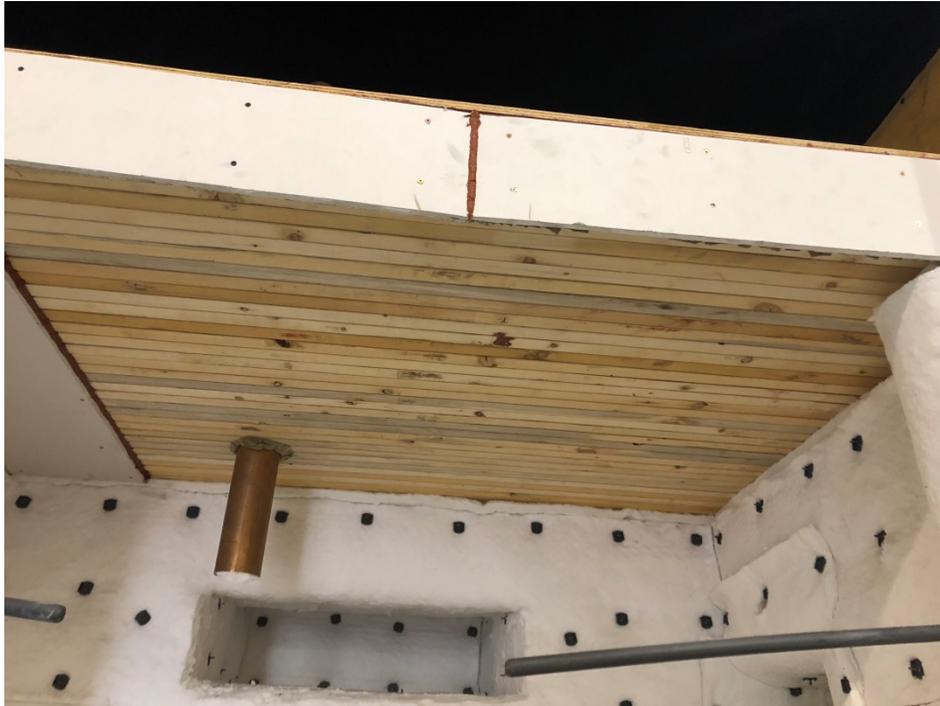
Figure 9: The unexposed side of the assembly prior to the gypsum being installed.

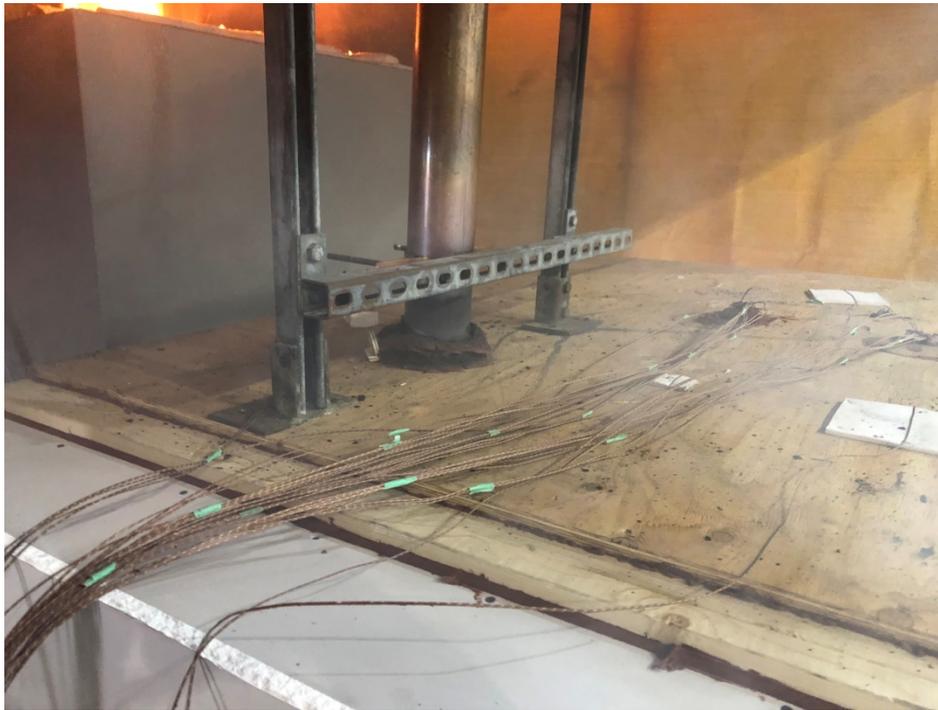
Figure 11: The unexposed side of the assembly at the end of the fire test.
